Technical Memorandum

October 3, 2022

To	Ryan Marquez, City of Pacifica	Contact No.	925 849 1019
Copy to	Paul Henderson	Email	satish.chilka@ghd.com
From	Satish Chilka PE	Project No.	11223688
Project Name	Pacifica Pier Handrail Repairs		
Subject	Condition Assessment of Pier Handrails - 2022

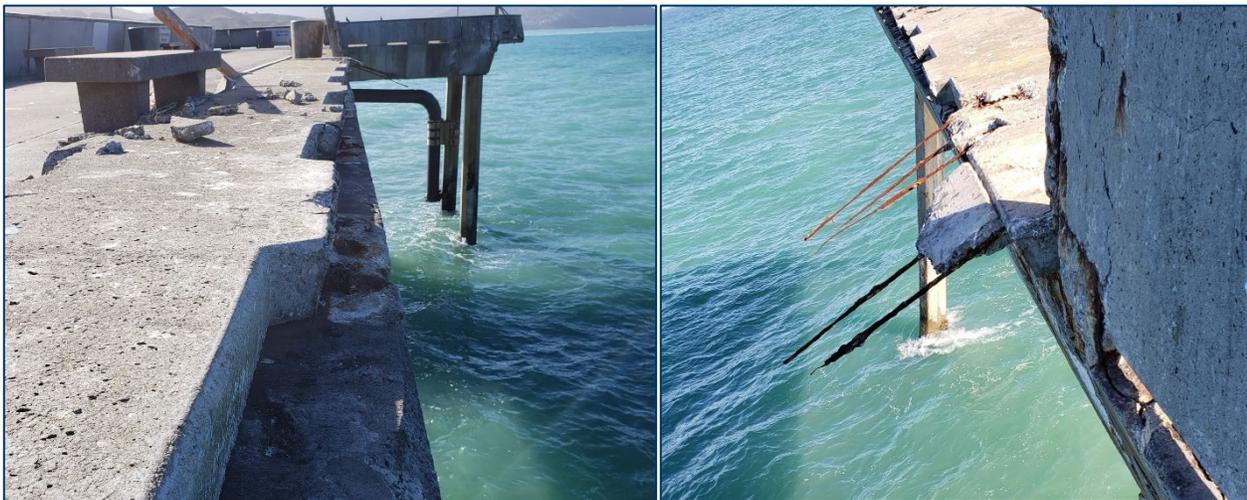
Figure 3.1 Collapsed Handrail, Photo 2021

The pier experienced high surf and/or wind forces in January 2021. A 41-ft portion of the handrail on the west edge of pier extension (deck spanning north to south) collapsed inward onto the deck. The entire extension has remained closed to public access and the condition of handrails on this span were not assessed.

The collapsed panels were previously noted to have severely corroded reinforcement at the joint between the handrail panels and deck. The concrete panels did not show signs of exposed spall hence the weakened connection due to corroded reinforcement and potential delamination in the side walls of the pier deck were determined to be the main cause of failure. The pier deck was visibly damaged as the handrail reinforcement pulled out indicating spall in the pier deck.

The collapsed handrail at the pier extension should be replaced or the extension should remain closed to the public.

At handrail panels with severe and major damage extending across two or more supports, as well as at the fully collapsed panels, full replacement of the panels is recommended.

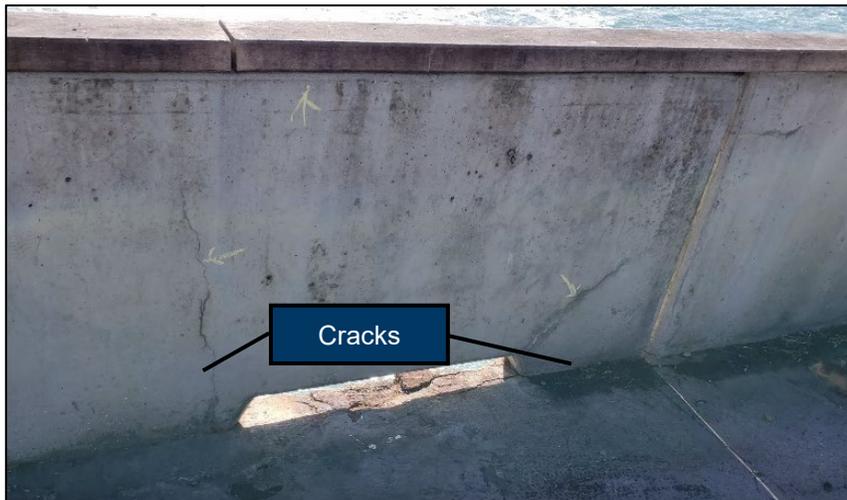
Figure 3.2: Typical Damage Rated Minor

The minor and moderate damages, characterized by cracks less than 1/16” in width and spalled concrete of less than 1” depth, are not expected to significantly impact the existing strength of the handrails. The primary cause for the collapsed handrail was due to weakened connection between the panel and deck. Hence, if

At panels with minor to moderate damage, patching superficial cracks and spalled concrete would mitigate further damage. Providing additional supports at panels to supplement existing corroded reinforcement would extend the functional life of the panels and reduce the likelihood of future collapses.

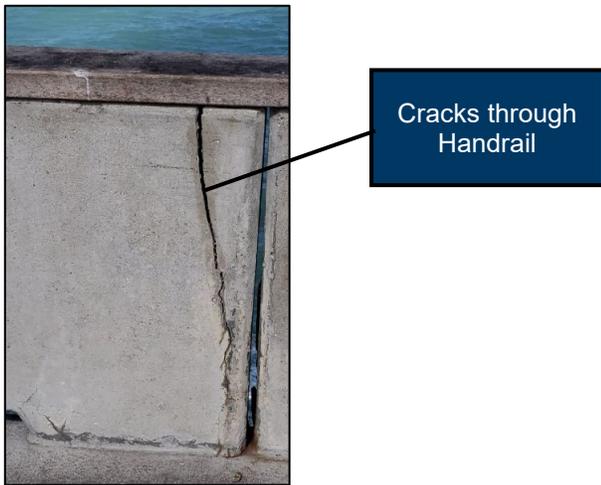
Figure 3.4: Typical Damage Rated Major

cracks, spalls, or rust stains were observed along the length of bottom connection to deck, those damages are categorized as major or severe damage.

More substantial cracks and spalls of concrete result in a significant loss of area in the structural concrete at supports, and generally leave existing reinforcement exposed to weather and subject to corrosion. In several instances, large spalls and reinforcement corrosion at handrails was accompanied by visible corrosion and spalling extending into the concrete below deck level.

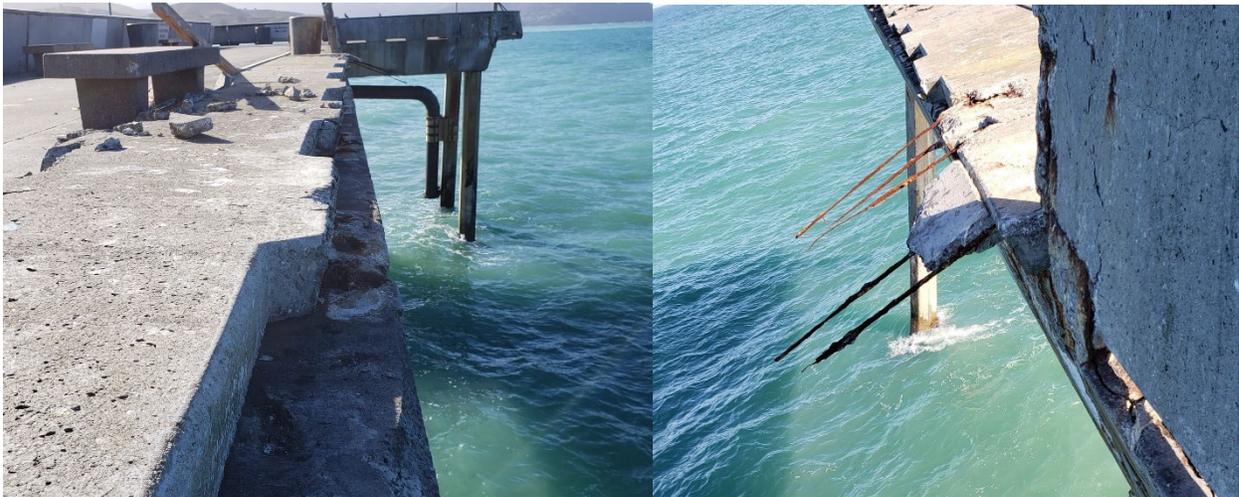
Figure 4: Photos of Collapsed Handrail

At the pier extension, an approximately 41' portion of west-facing handrail panels have collapsed inward onto the deck, probably resulting from high surf and/or wind forces sometime during January 2021. At the collapsed panels, the reinforcement is severely corroded at the joint between handrail panels and deck concrete, weakening the connection. Although the concrete panel itself did not show signs of spalls or delamination, the connections were the main cause of failure.

At the south end of the damaged panel, the reinforcement has pulled out of the concrete deck, indicating that there is a weakened bond within the deck concrete. The damage to handrails has also damaged the side wall of the deck. The underside of the deck was not accessible for further assessment during this inspection.

The collapsed handrail at the extension pier should be replaced or the extension closed to the public. The recommended timeline for other panels is provided in Table 5-1, referenced to Year 2021 as baseline i.e., Year 0.

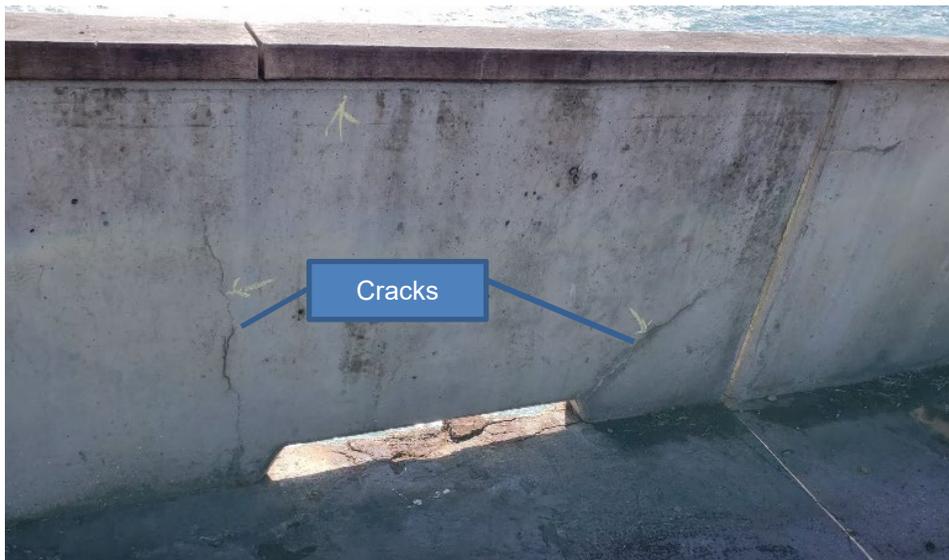
Figure 5: Typical Damage Rated Minor

The minor and moderate damage, characterized by cracks less than 1/16" in width and spalled concrete of less than 1" depth, is not expected to significantly impact the existing strength of the handrails. The primary cause for the collapsed handrail was due to weakened connection between the panel and deck. Hence, if cracks, spalls, or rust stains were observed along the length of bottom connection to deck, those damages are categorized as major or severe damage.

At panels with minor to moderate damage, patching superficial cracks and spalled concrete would mitigate further damage. Providing additional supports at panels to supplement existing corroded rebar would extend the life of the panels and reduce the likelihood of future collapses.

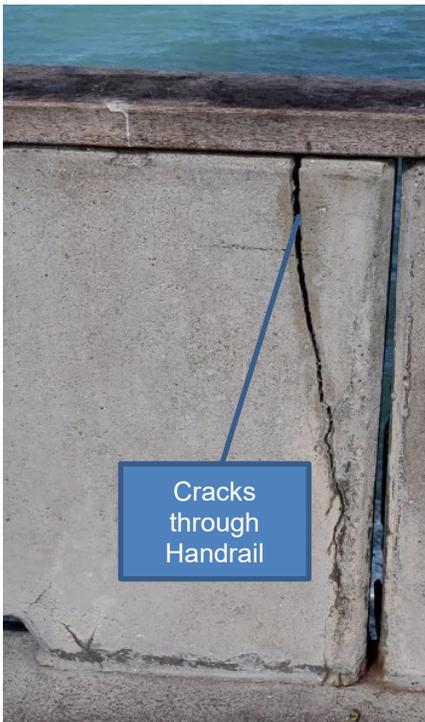
Figure 7: Typical Damage Rated Major

More substantial cracks and spalls of concrete result in a significant loss of area in the structural concrete at supports, and generally leave existing reinforcement exposed to weather and subject to corrosion. In several instances, large spalls and reinforcement corrosion at handrails was accompanied by visible corrosion and spalling extending into the concrete below deck level.

At railing panels with severe and major damage extending across two or more supports, as well as at fully collapsed panels, full replacement of the panels is recommended. At panels with major or severe damage concentrated at supports, a retrofit consisting of repairing damaged concrete, repairing corroded reinforcement, and providing additional support mechanism may be a feasible alternative to full replacement.

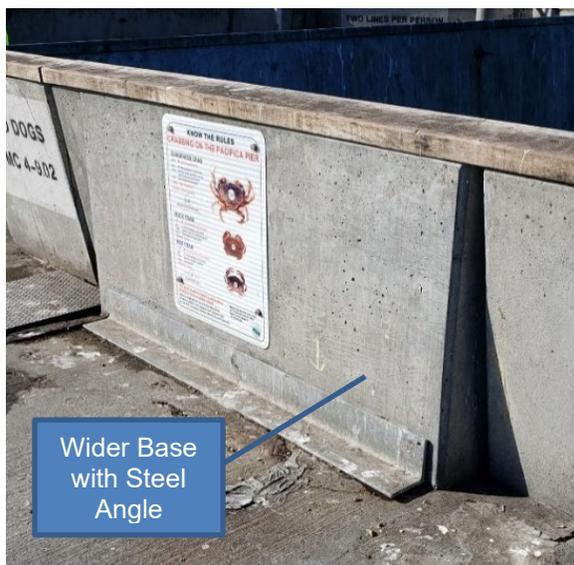
Figure 10: Repaired Handrail Panel

One panel has been previously repaired. The exterior surface follows the profile of other panels, but the inside face is vertical, creating a wider base for stability. A galvanized steel angle section has been installed at the inside face, with anchors embedded into the panel and presumably into the deck to provide an improved connection.

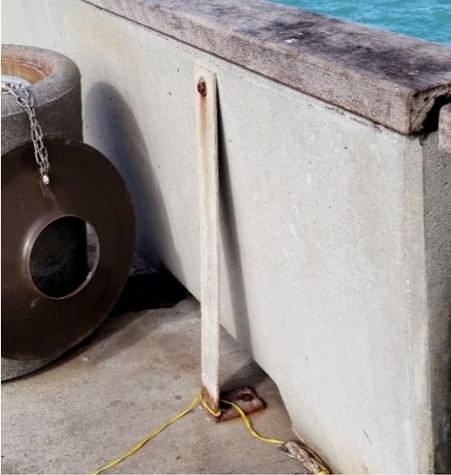
Figure 11: Steel Brace at Handrail

Some panels have a 1/4" thick bent steel plate supports anchored at the inside face and at the deck to provide additional bracing. The anchors and hardware at these plate braces are significantly corroded, and at one location the plate has 100% section loss at mid-height.

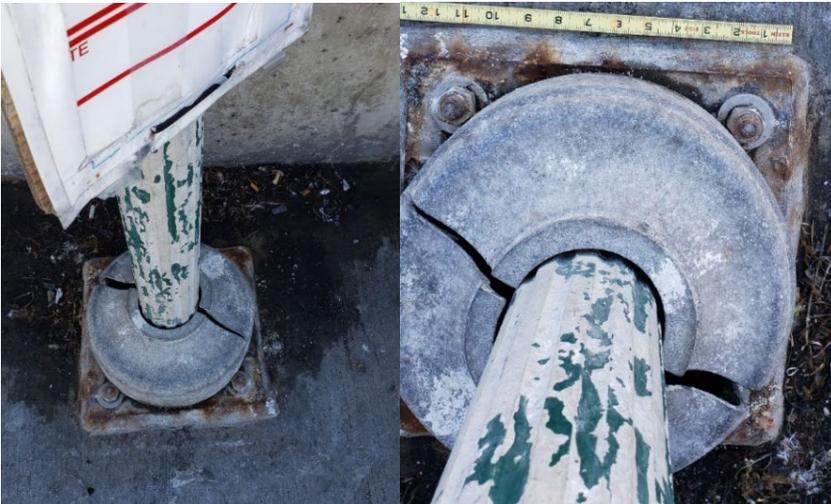
Figure 9: Typical Light Post Foundation

The light posts on the pier are connected to the pier deck using 4 bolts and steel base plate. The base plate and anchor bolts show signs of corrosion. The nuts seem to be stainless steel material, showed some discoloration but didn't show significant corrosion. There was no visible damage to the connections or grout pad around the base plate indicating movement of the light post due to a weakened connection.
