# Tree Management Experts

**RE: Carmel-Paloma ADA sidewalk project**  
**Tree Protection and Preservation Plan**

## ARBORIST REPORT

Tree Protection and Preservation Plan

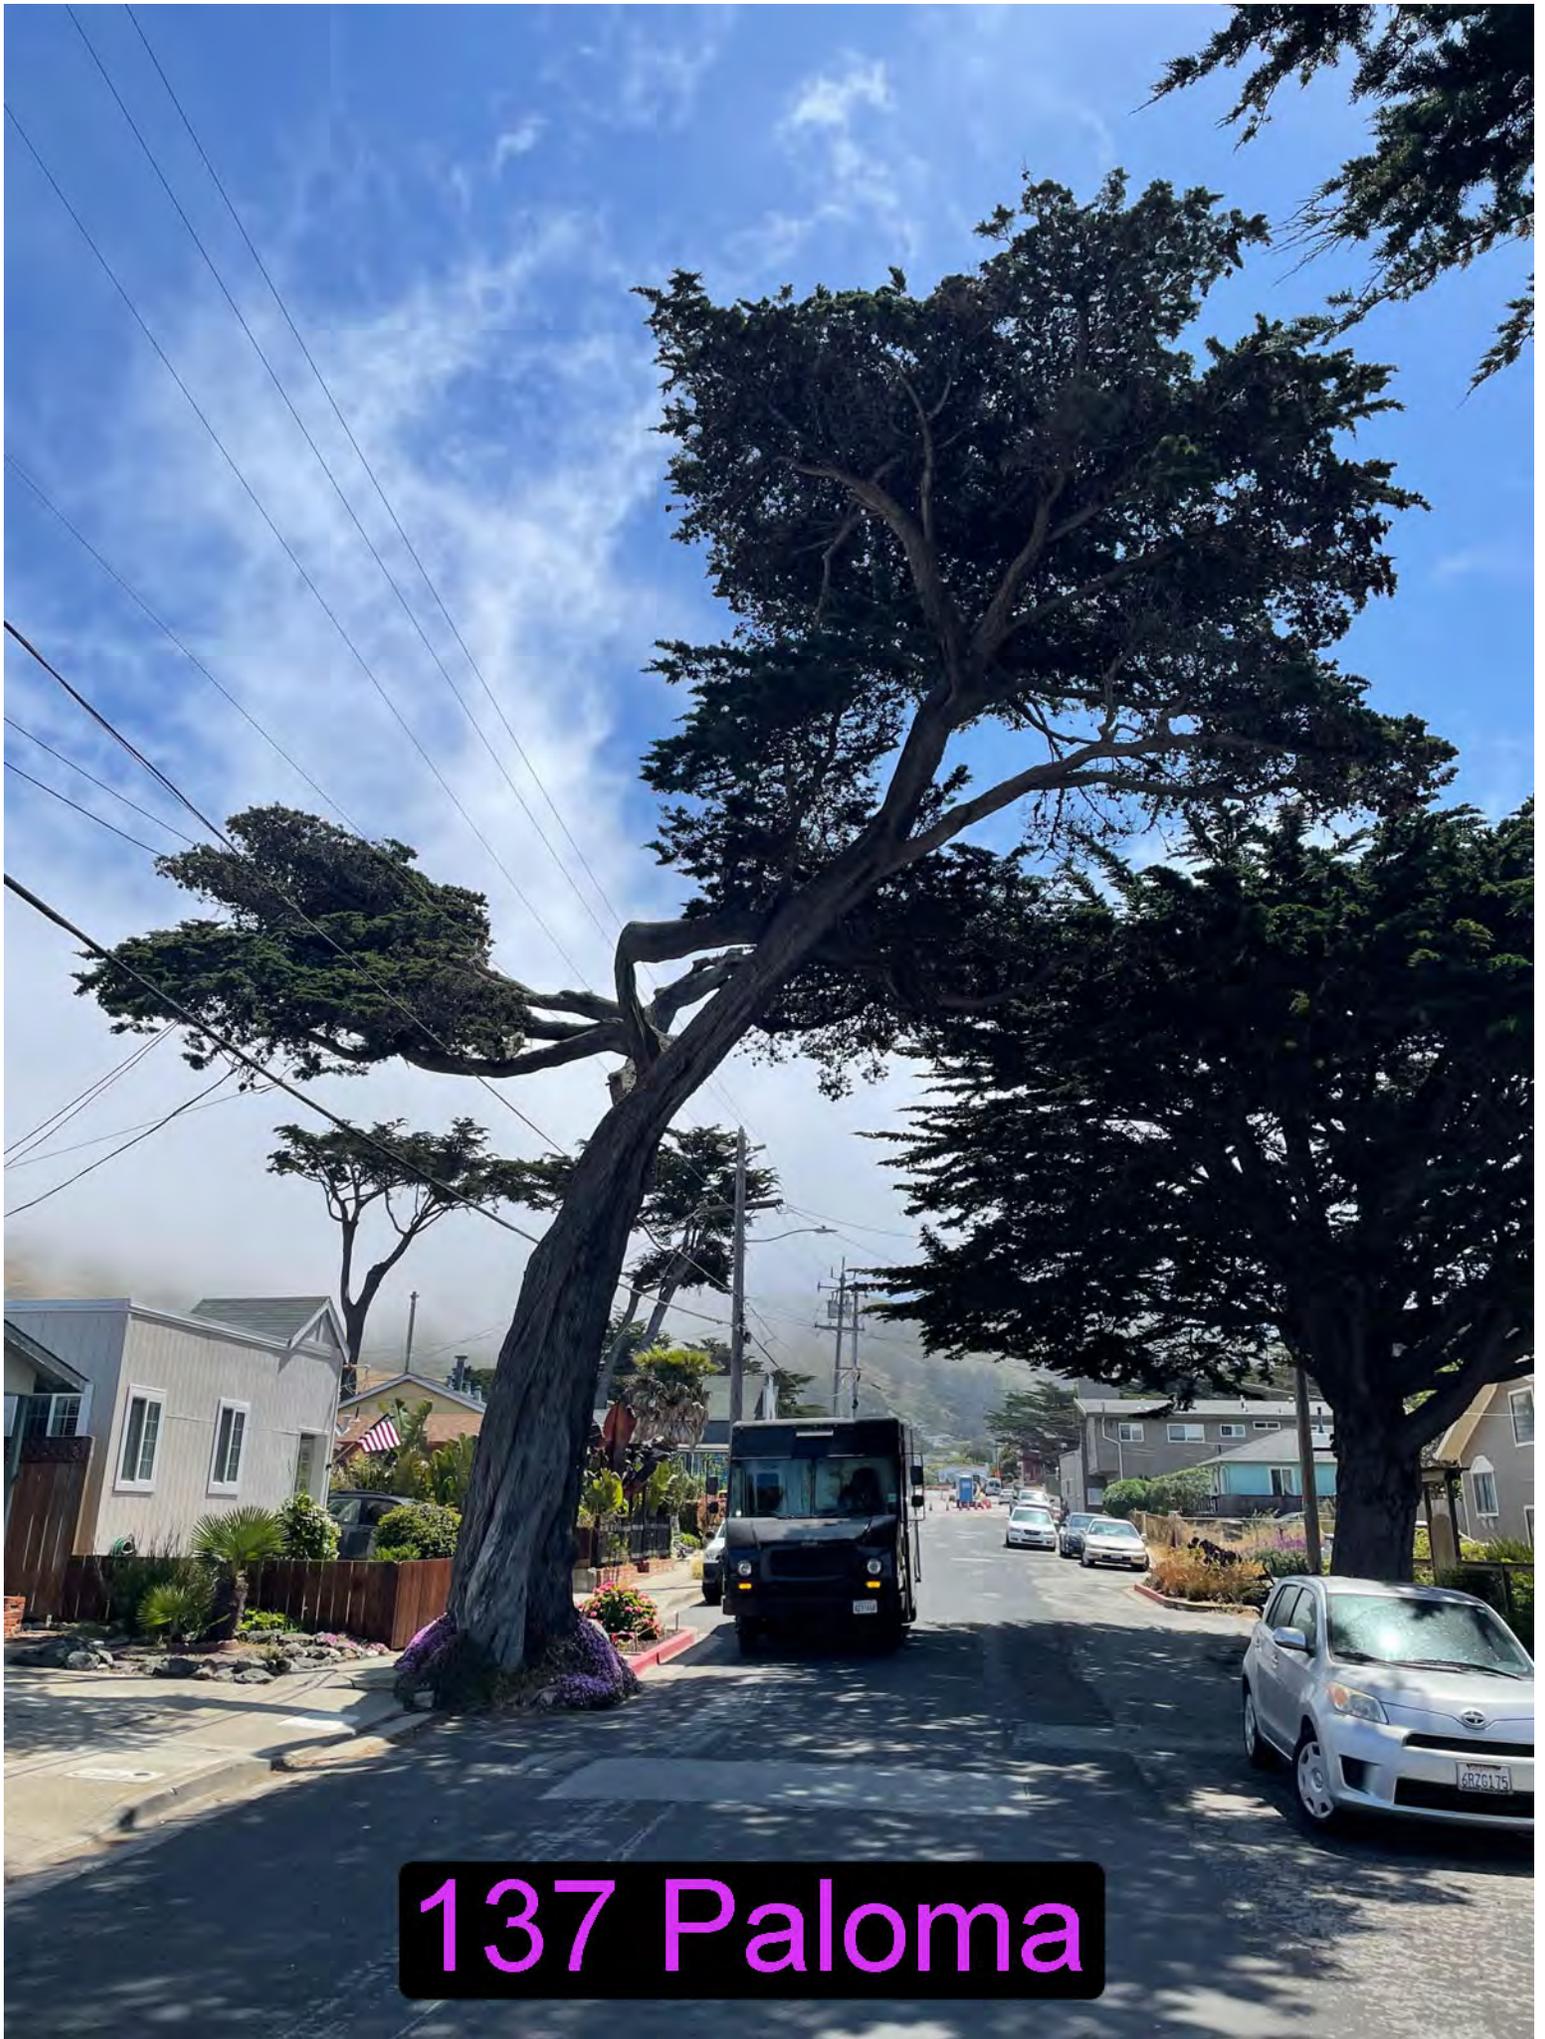
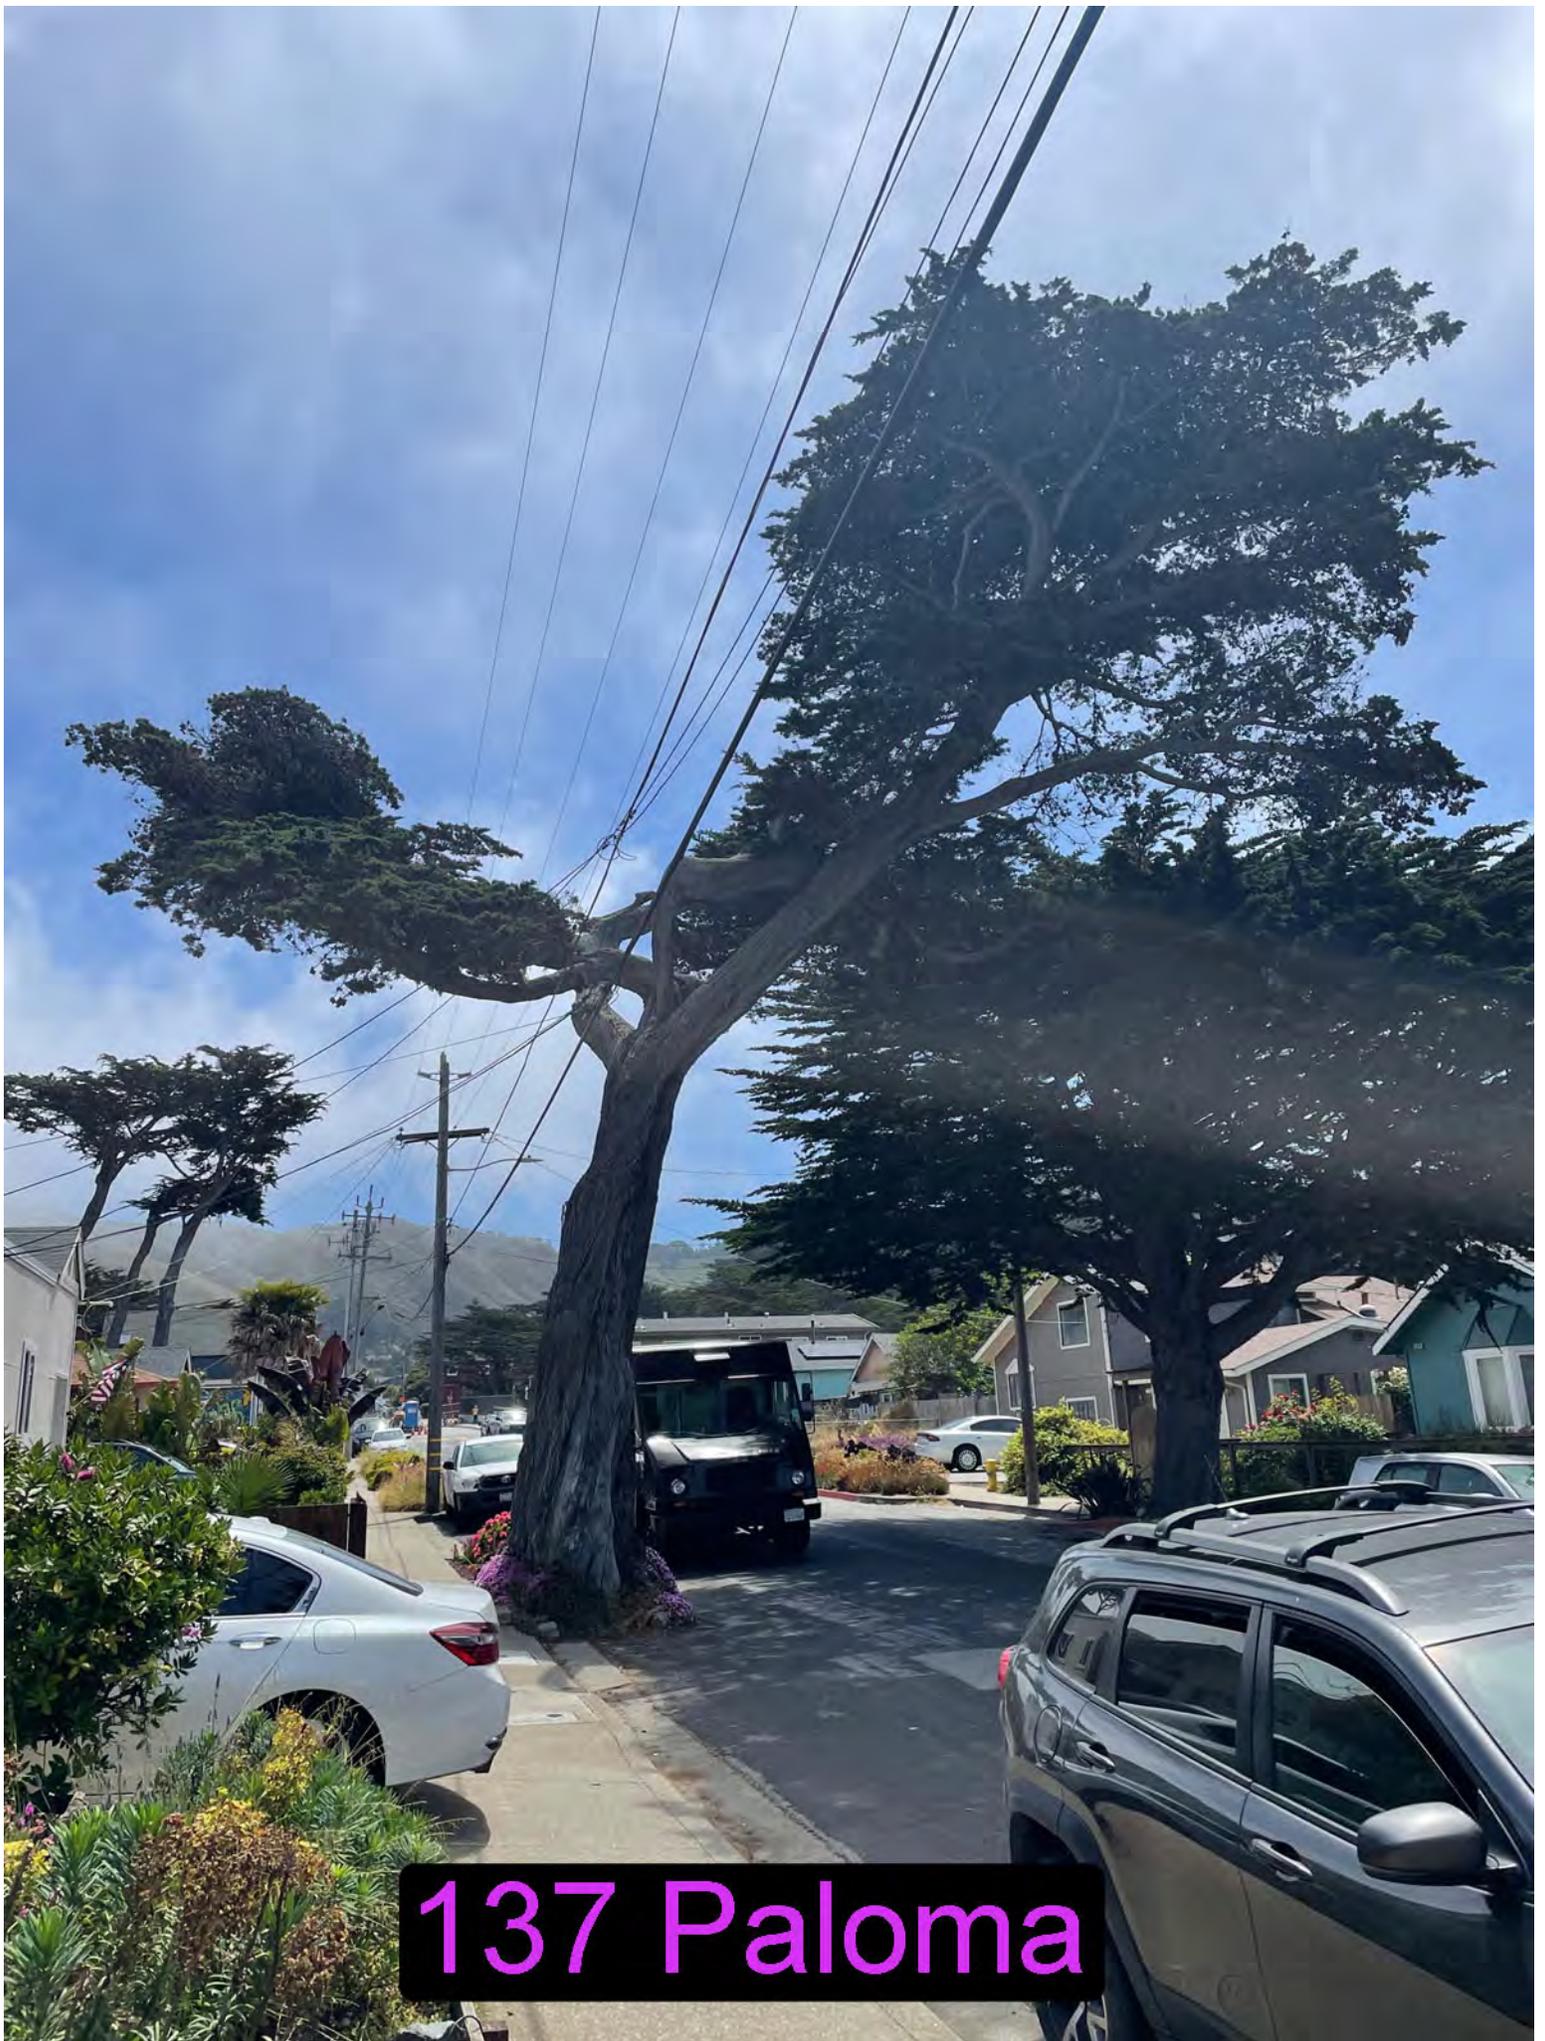
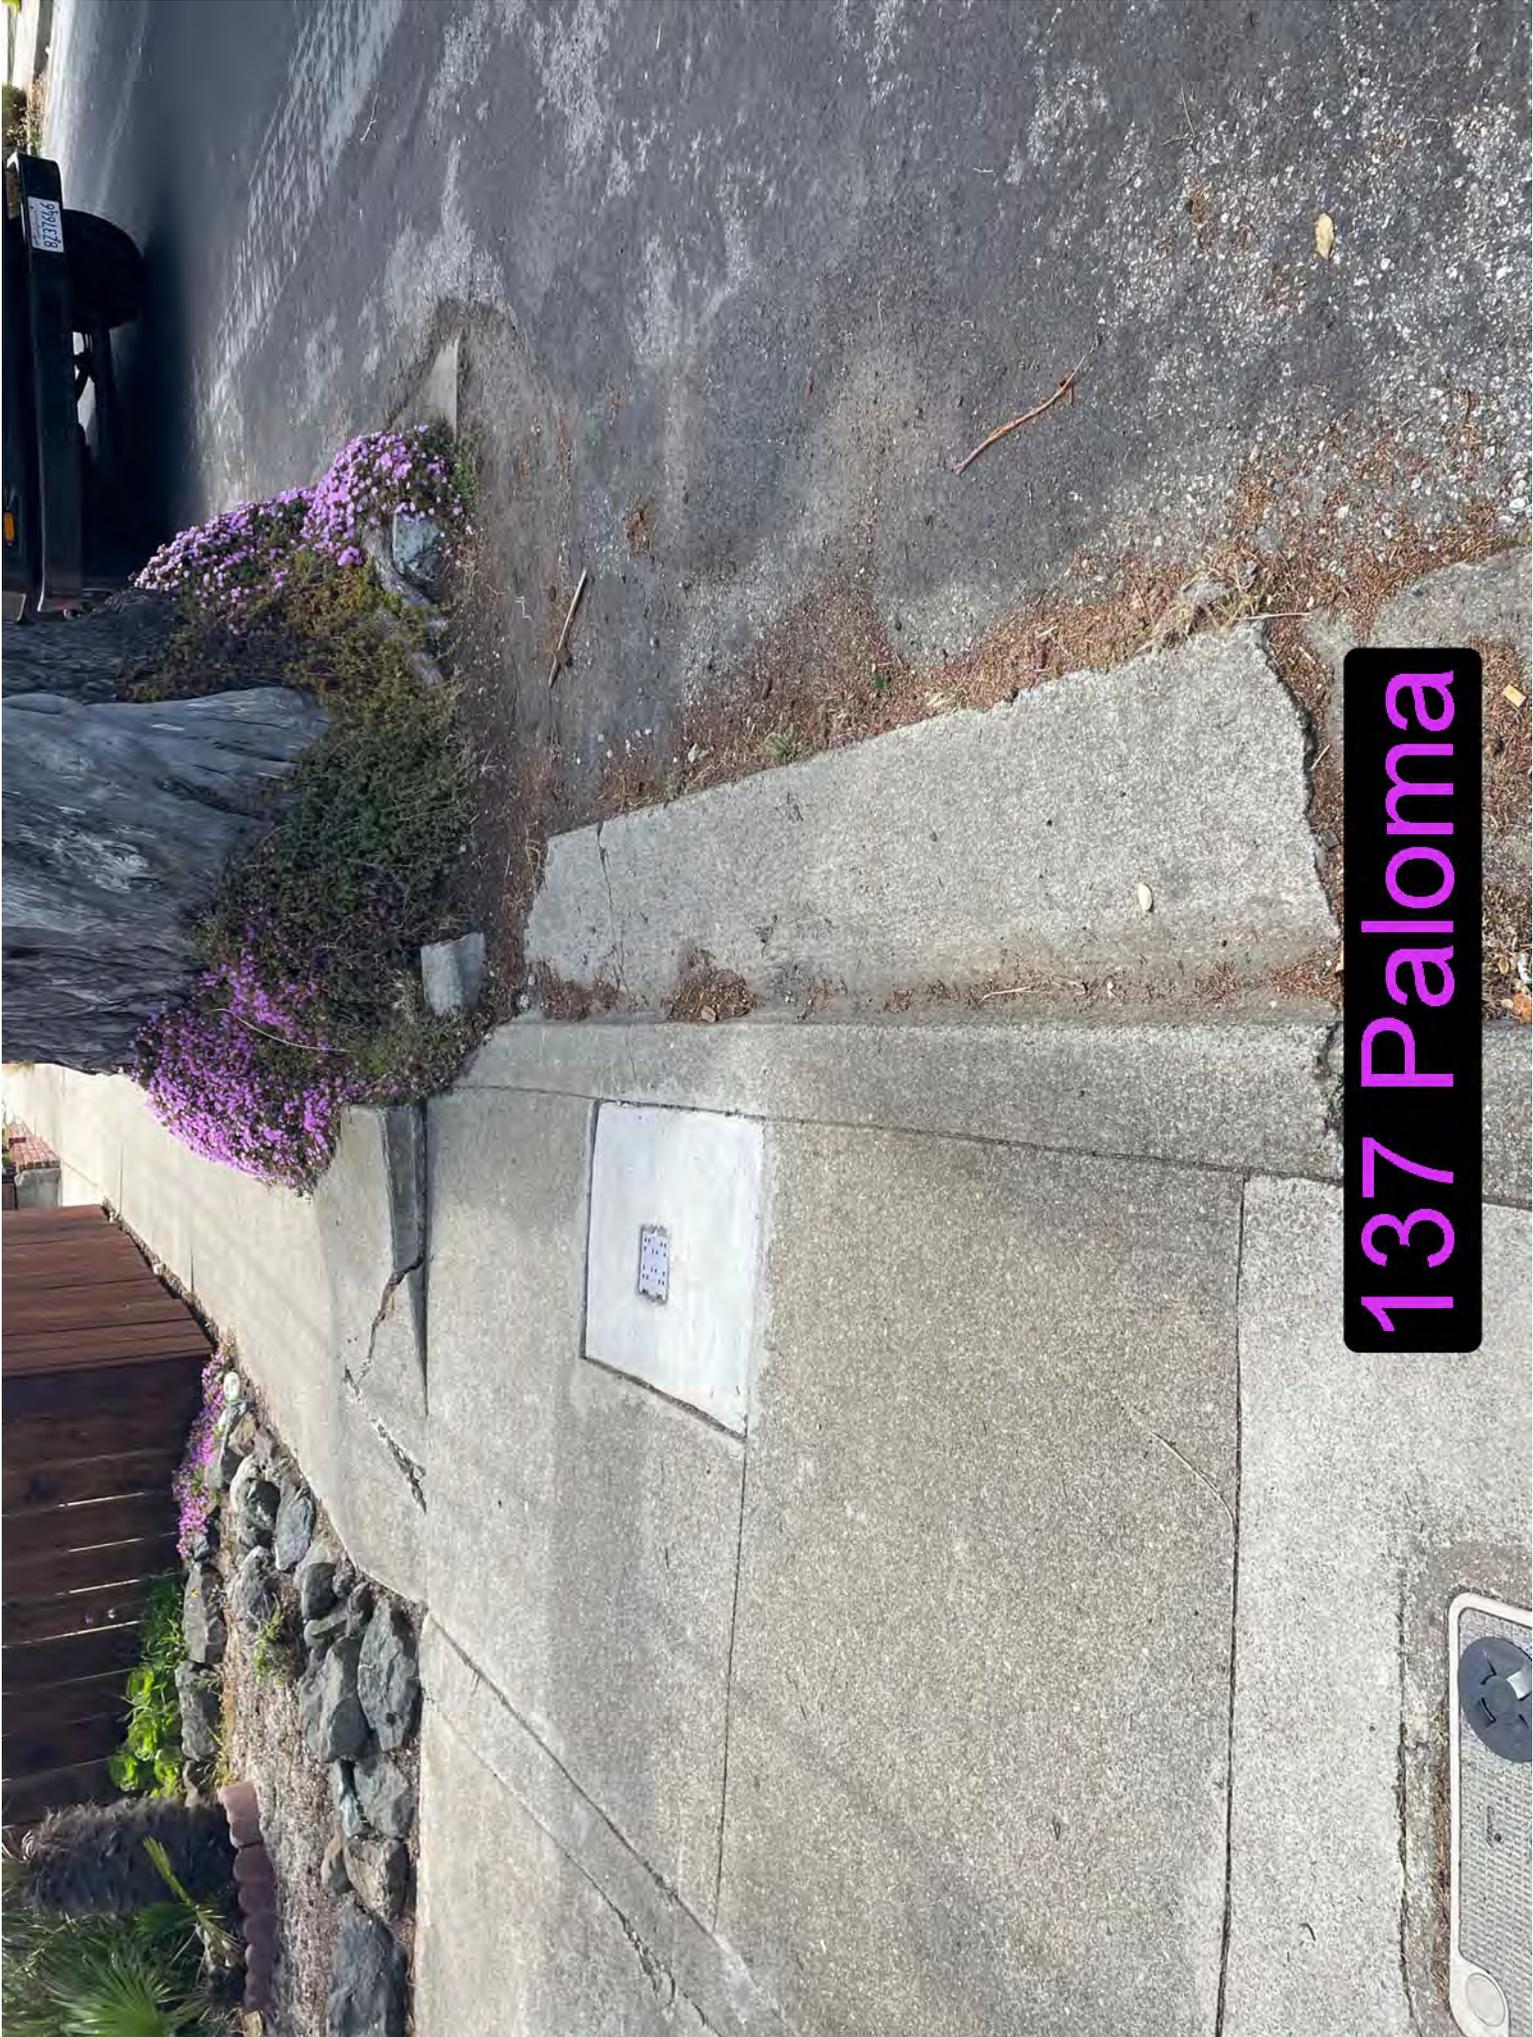
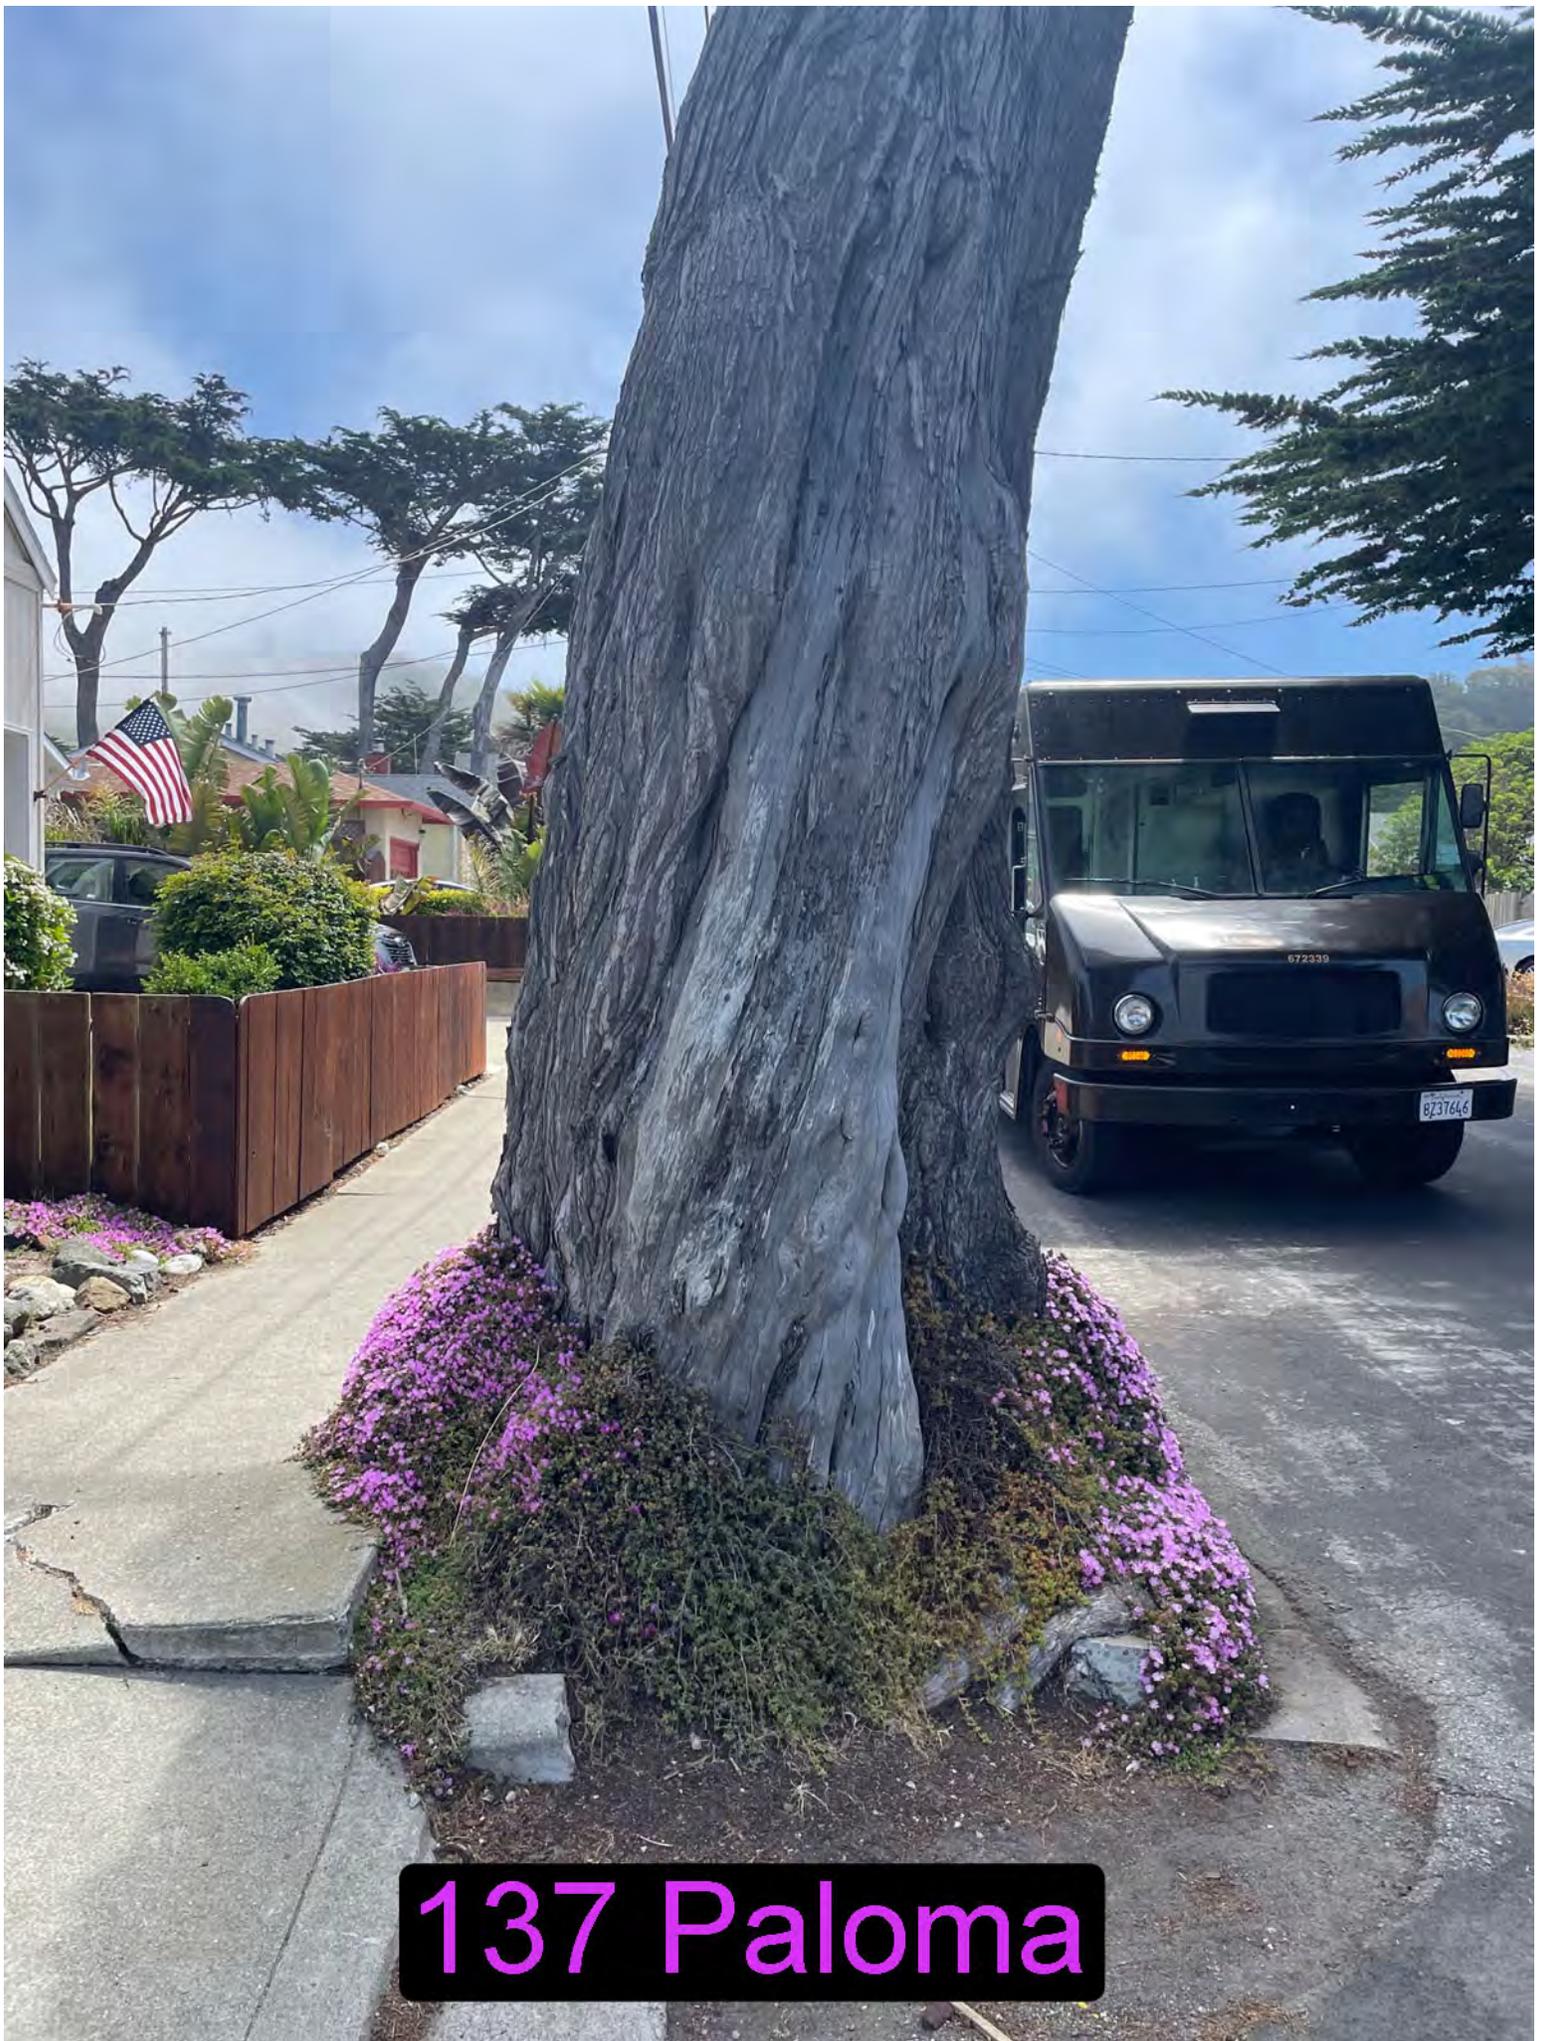
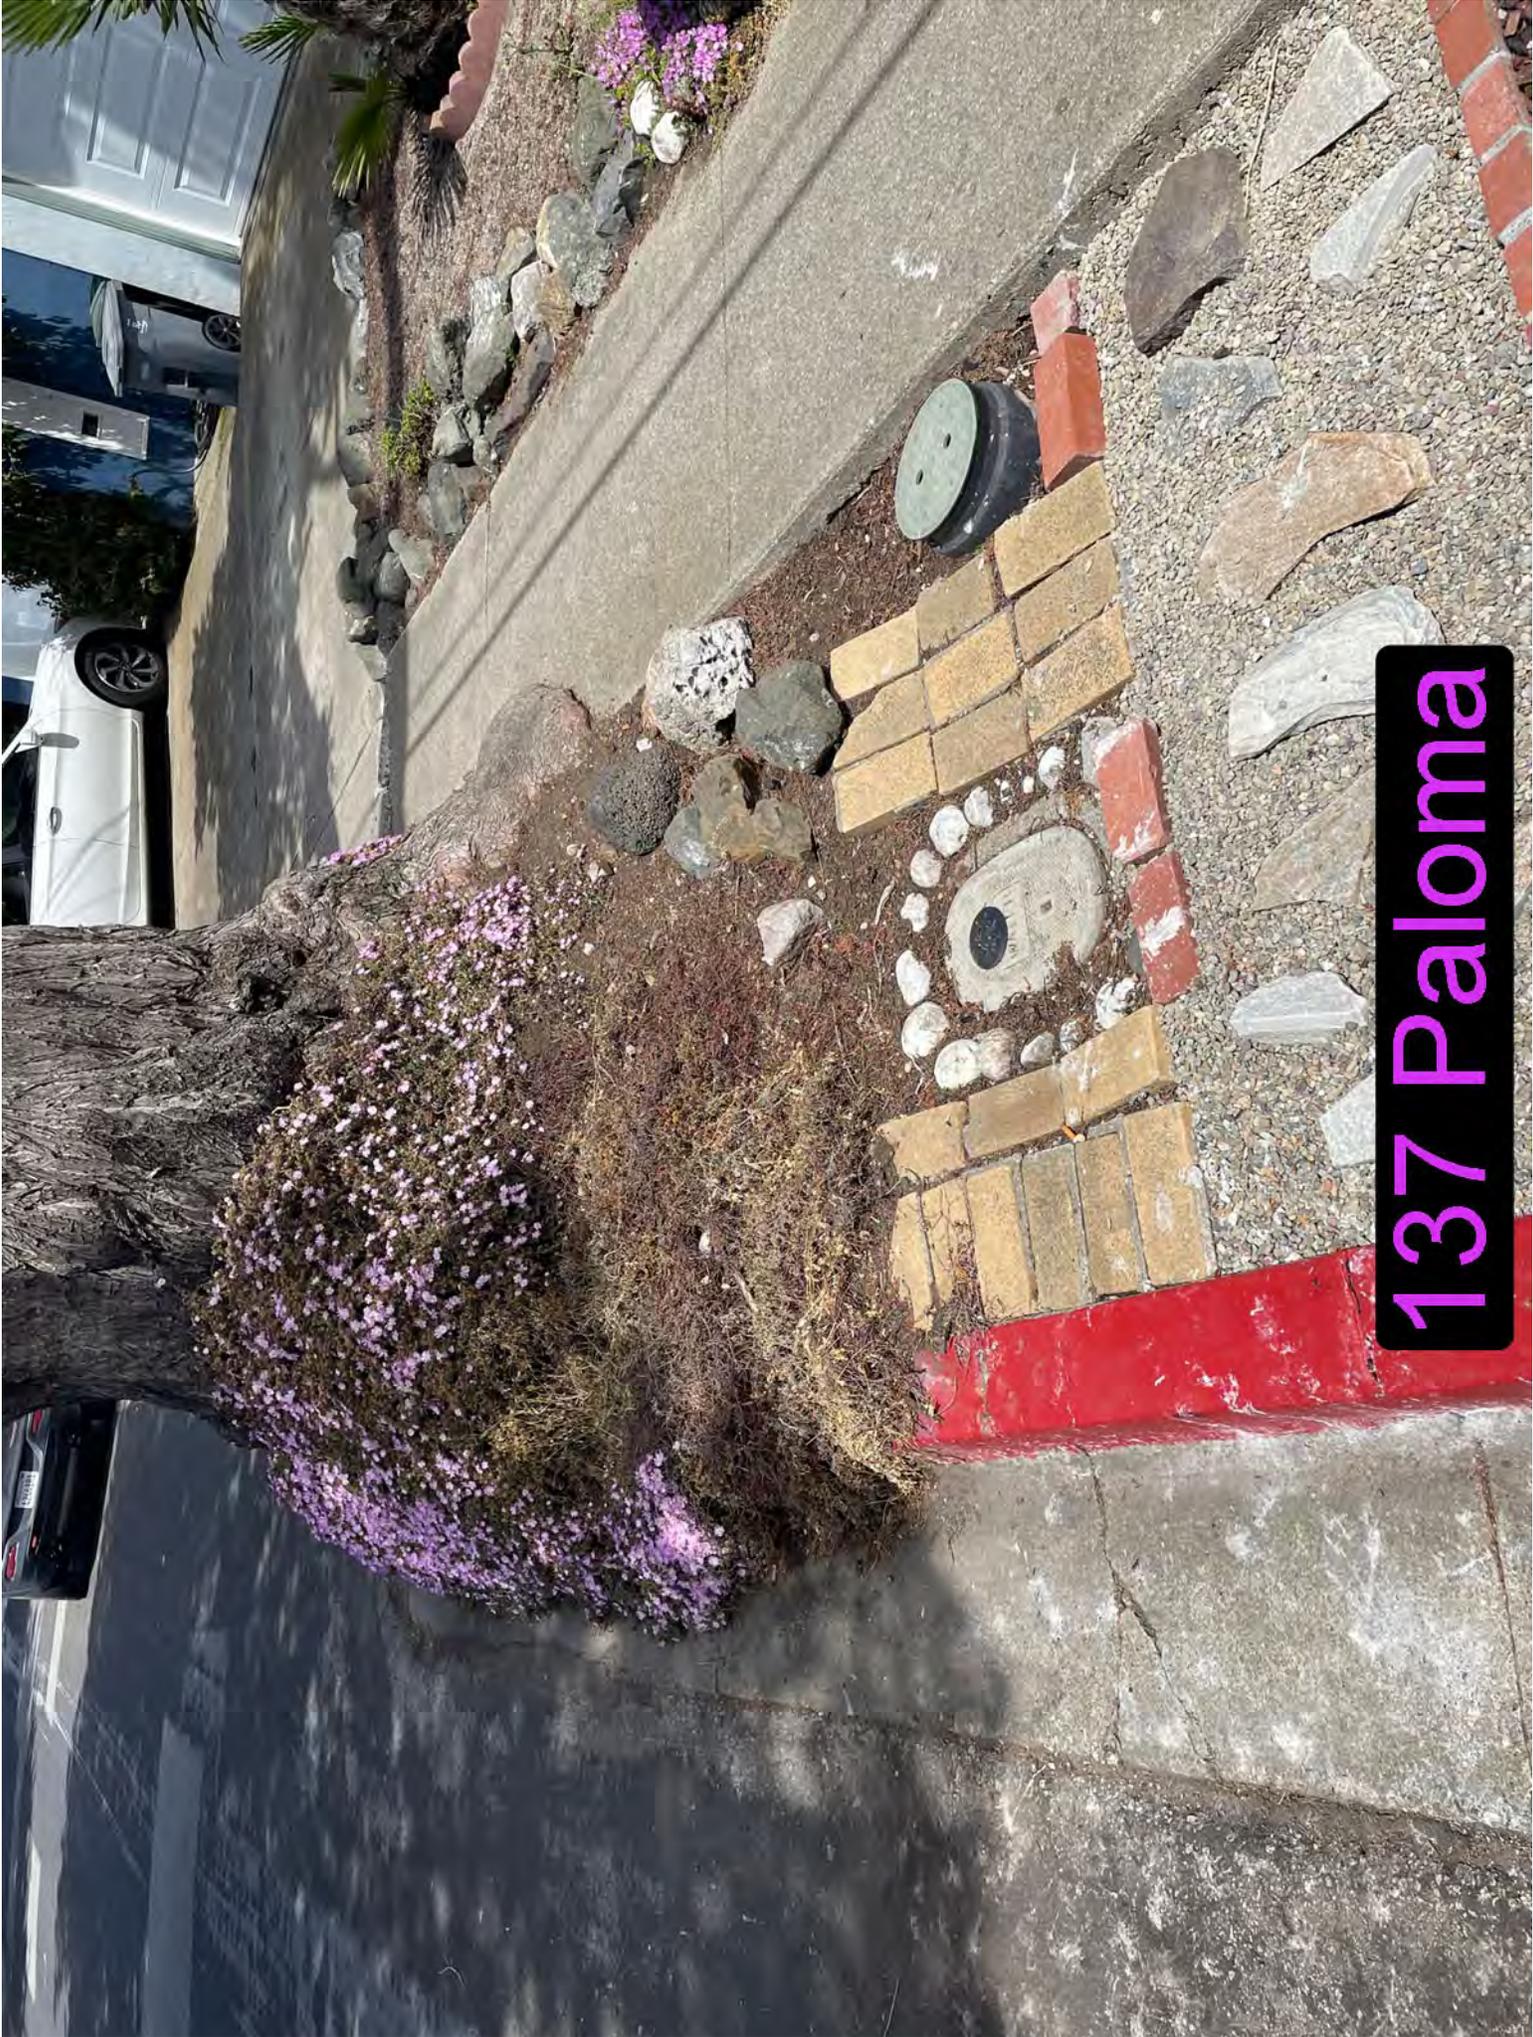
137 Paloma

History of failures Branches: (2) 12" diameter, (6) 6" diameter (recent) Topography Flat  Slope  % Aspect \_\_\_\_\_  
 Site changes None  Grade change  Site clearing  Changed soil hydrology  Root cuts  Describe road, sidewalk, utilities  
 Soil conditions Limited volume  Saturated  Shallow  Compacted  Pavement over roots  100 % Describe street, sidewalk  
 Prevailing wind direction NW Common weather Strong winds  Ice  Snow  Heavy rain  Describe Constant wind, seasonal storms

Vigor Low  Normal  High  Foliage None (seasonal)  None (dead)  Normal 70 % Chlorotic \_\_\_\_\_ % Necrotic 30 %  
 Pests/Biotic \_\_\_\_\_ Abiotic \_\_\_\_\_  
 Species failure profile Branches  Trunk  Roots  Describe branch failures very common, trunk and root failures common

Part Size 6" Fall Distance 45'  
 Load on defect N/A  Minor  Moderate  Significant   
 Likelihood of failure Improbable  Possible  Probable  Imminent
