City of Pacifica San Mateo County Library

Library Facility Assessment

November 12, 2014

GROUP 4

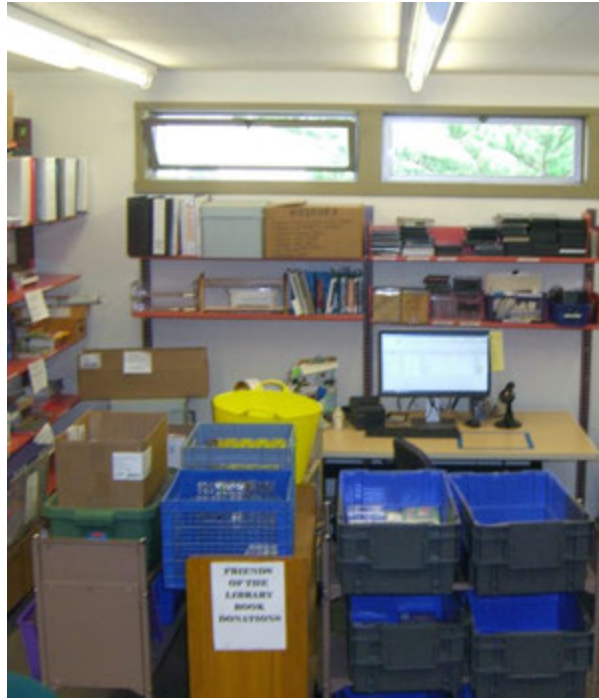
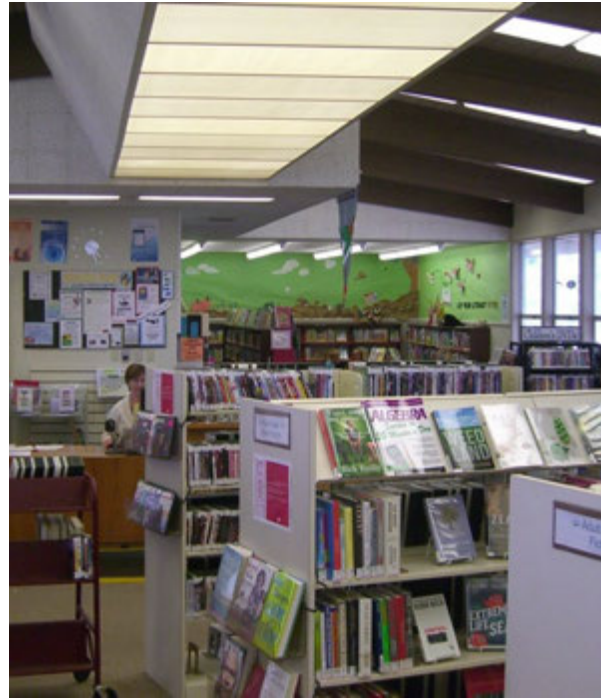
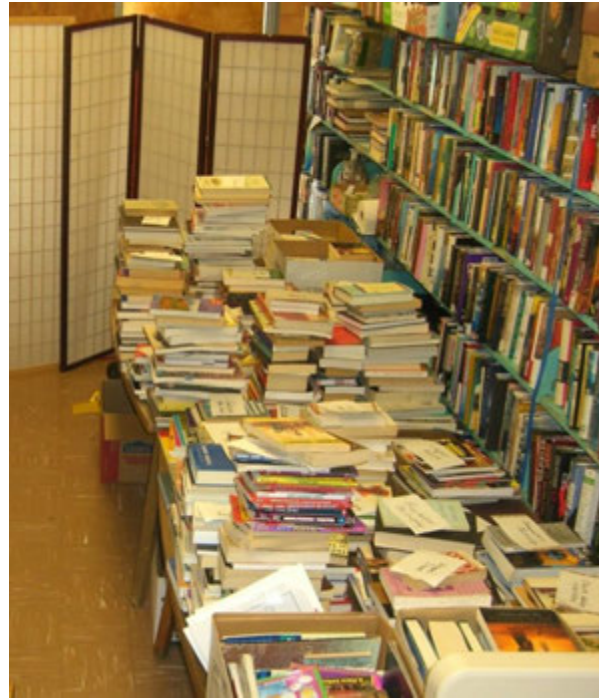
Inadequate Storage

Friends' storage is noticeably makeshift and undersized. It is currently hidden behind a screen in the Program Room

Undersized Spaces for Collections

Collection areas are generally overcrowded, and cannot meet all of the Library needs for the Pacifica Community per the 2011 Needs Assessment

Inadequate Seating

Seating is limited in the Library with a total of 49 patron seats

Inflexible Spaces

No flexibility within Library to support informal programs within Library spaces – spaces are overcrowded, have immovable furniture + stacks, and aren't acoustically separated

Undersized Staff Space

Staff spaces are crowded and do not have the capacity to upgrade to Automated Materials Handling systems

Overall, the existing Sharp Park Library is undersized for its current uses, and lacks many of the amenities needed by the Pacifica Community per the 2011 Needs Assessment

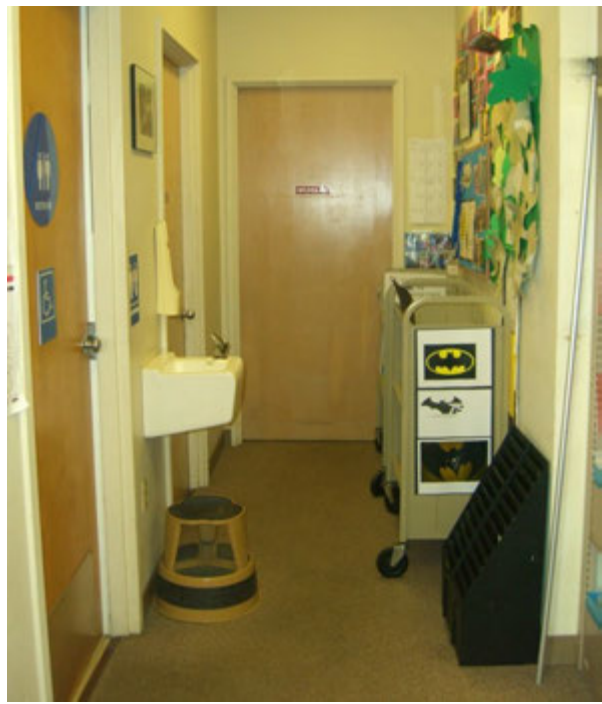
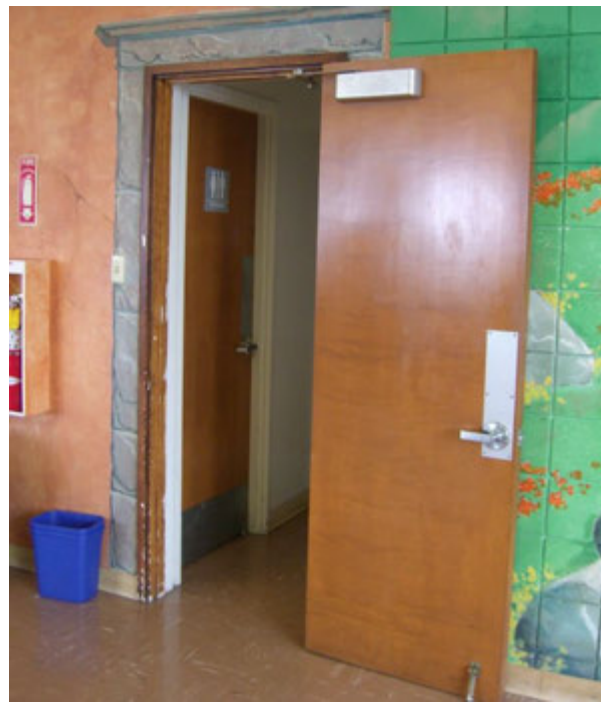
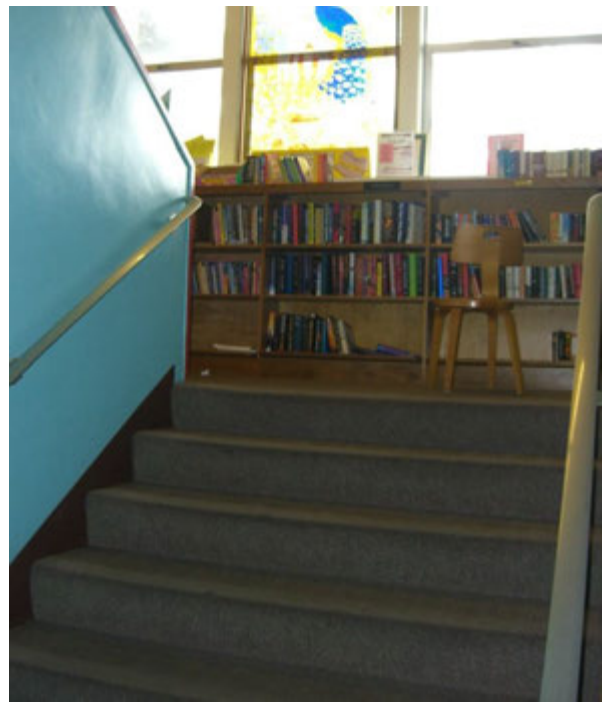
Inadequate + Inaccessible Parking
The limited number of spaces limits the use of the facility

Inaccessible Entries
Both entrances are inaccessible, and to enter the 2nd level of the Library from the parking lot requires the use of stairs or a steep sidewalk

Inaccessible Paths of Travel
Lack of accessible paths of travel to teen area, program room restrooms, parking lot, and between 1st and 2nd floors.

Non-Conforming Areas
Restrooms, stacks, paths of travel, and other spaces throughout the building do not meet code requirements

Inaccessible Exits
Program room emergency exit requires use of stairs

Non-Conforming Devices/Hardware
Handrails, door handles, push buttons, faucets, etc. do not meet code requirements

The building does not provide equal access to all Library patrons and staff.

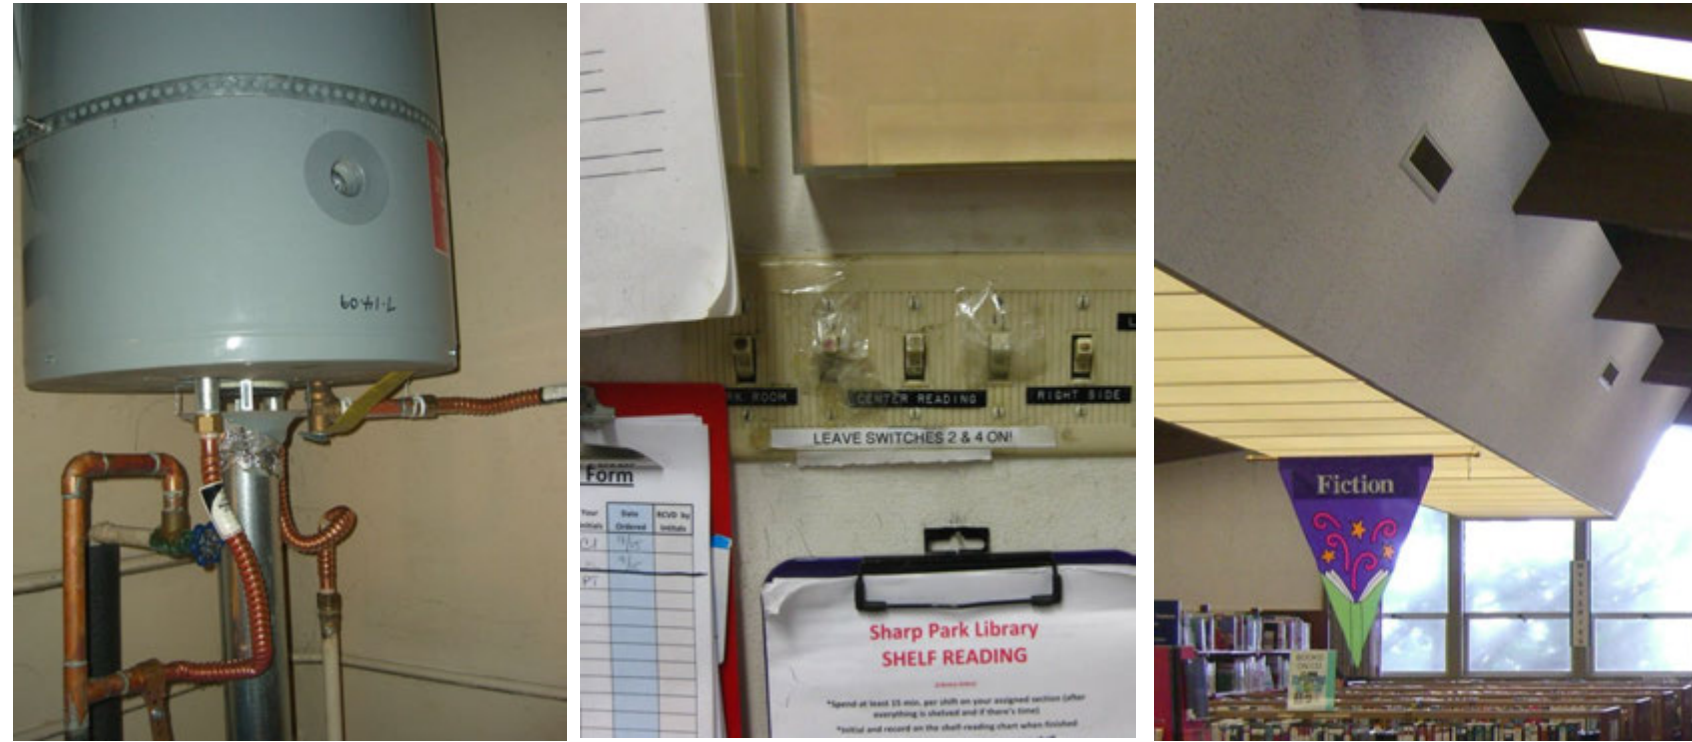
Insufficient Ventilation System

Multiple areas of library were stuffy, and had noticeably inadequate air flow. Though furnaces are relatively new, the air distribution system is insufficient

Outdated Lighting Systems

Lights do not meet current energy efficiency standards, provide uneven lighting levels, and have poor controls

Recently Updated Plumbing

Water heater was installed in 2009; other fixtures were installed recently as well

While there has been limited deferred maintenance work recently, the majority of the building systems, including the envelope, electrical, lighting, data, and mechanical systems, require upgrades

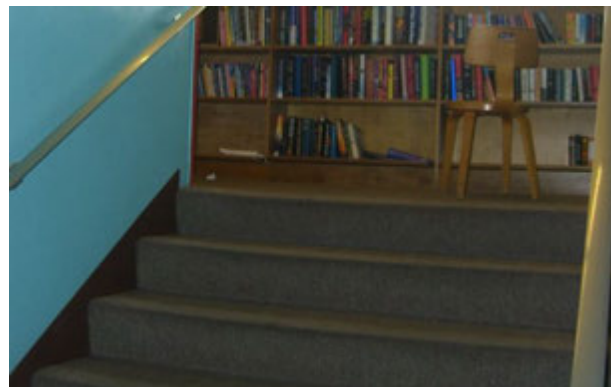
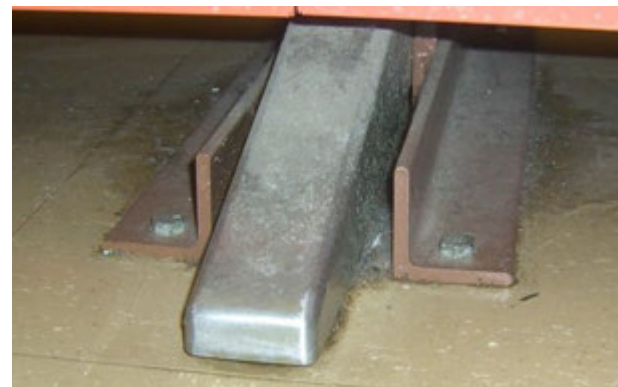
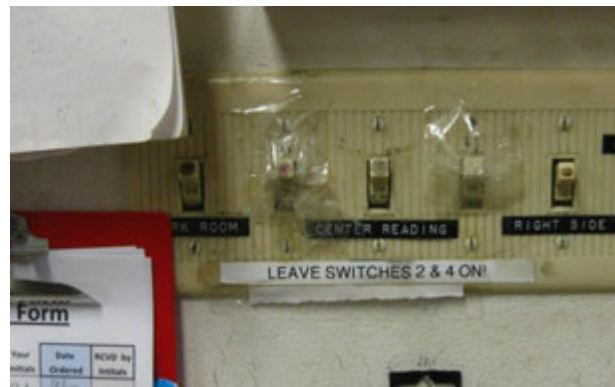
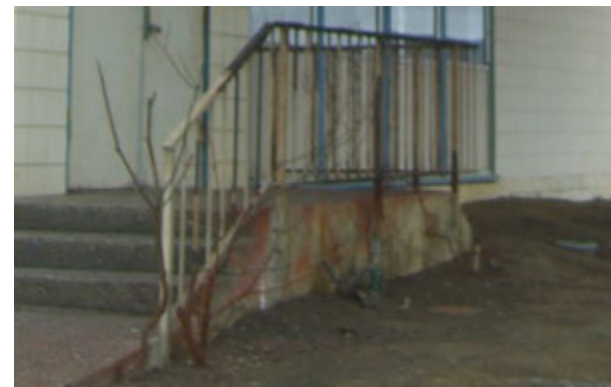
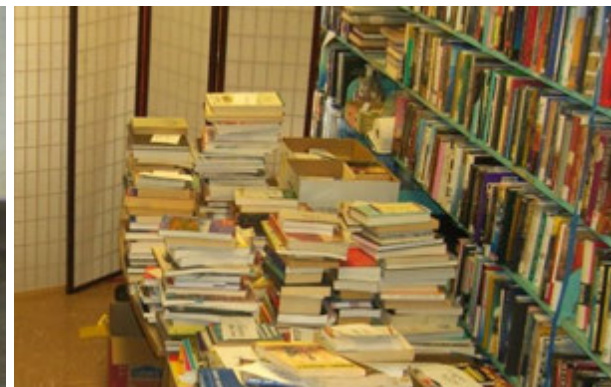
Uneven Floors

Floors creak and flex noticeably as they are walked upon

Worn Finishes

Interior and exterior finishes are worn from age and frequently salt damaged

Poor Acoustics

Noise travels between floors; floors creak audibly in program room when people walk on it

Damaged/Discontinued Hardware

Window/door hardware is easily damaged by salty air, no longer manufactured, and therefore difficult to replace. Many windows are screwed shut.

The building's finishes and door & window hardware are in need of replacement or significant repairs

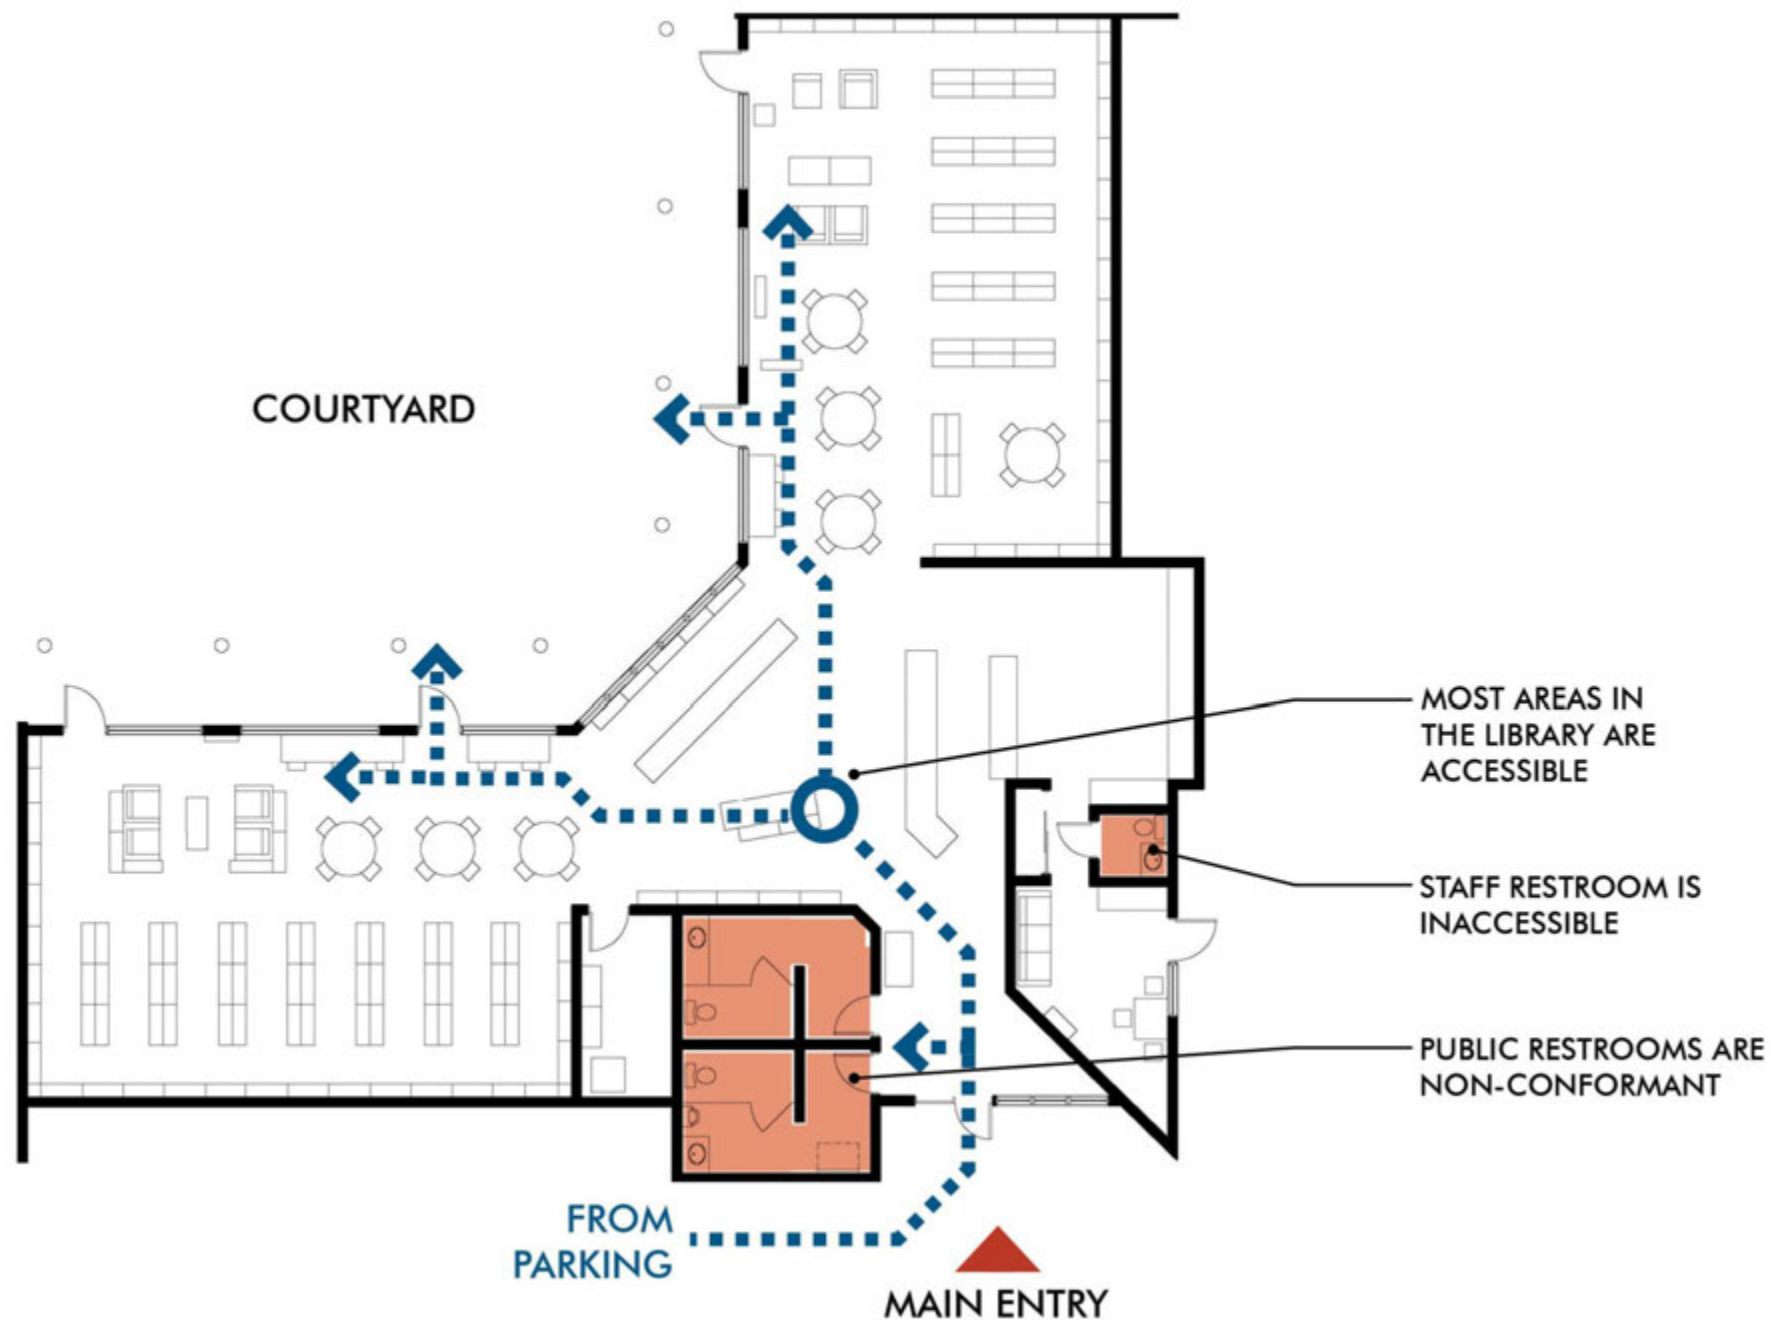
Non-Conforming Parking

Multiple elements of the existing parking do not meet current code

Non-Conforming Areas

Restrooms and paths of travel are non-conforming.

Non-Conforming Devices/Hardware

Handles, push buttons, faucets, etc. do not meet current code requirements

Some areas of the building require upgrades to be fully ADA conformant, but the building is generally accessible

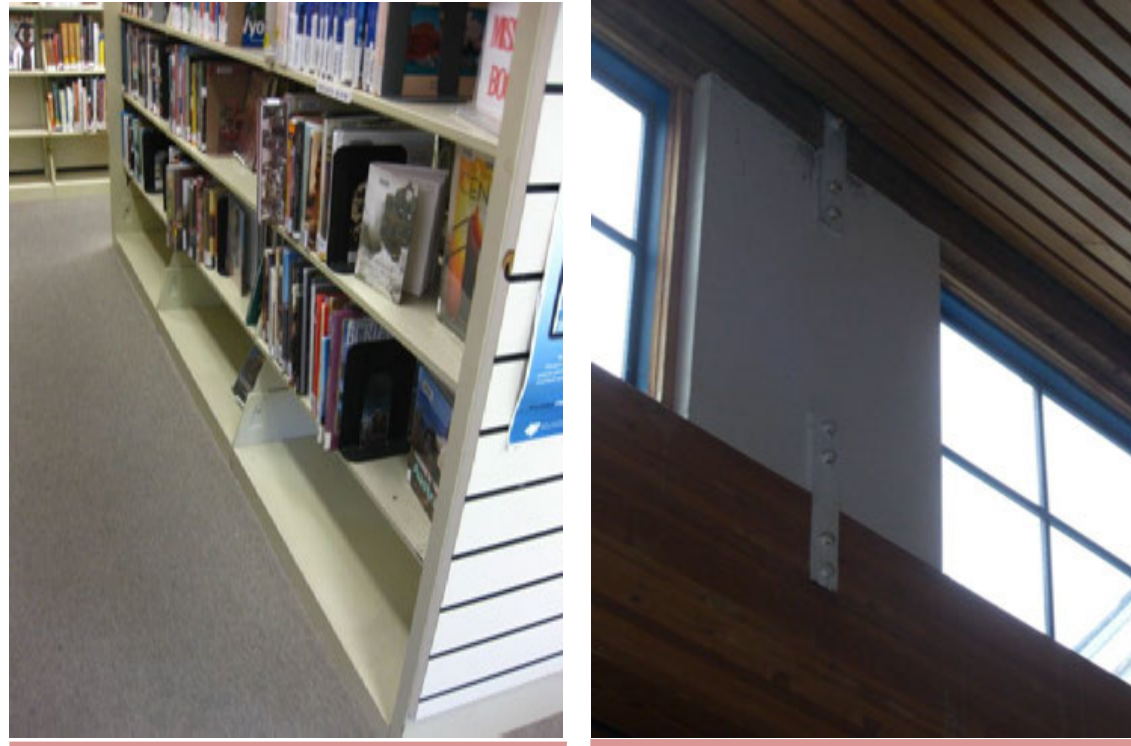
Insufficient Fire Life-Safety

The building lacks fire sprinklers and has inadequate alarm and detection systems

Potential Structural Deficiencies

Some areas of the building, such as the clerestory windows and the workroom and mechanical room, may be under-engineered to withstand a seismic event. Further analysis is needed to determine conclusively

Under-supported Tall Shelving

Further testing is required to determine if shelving is anchored to allow it to withstand a seismic event.

The building meets today's standards for structural life-safety, but does not meet standards for fire safety and has some other minor deficiencies that could be corrected

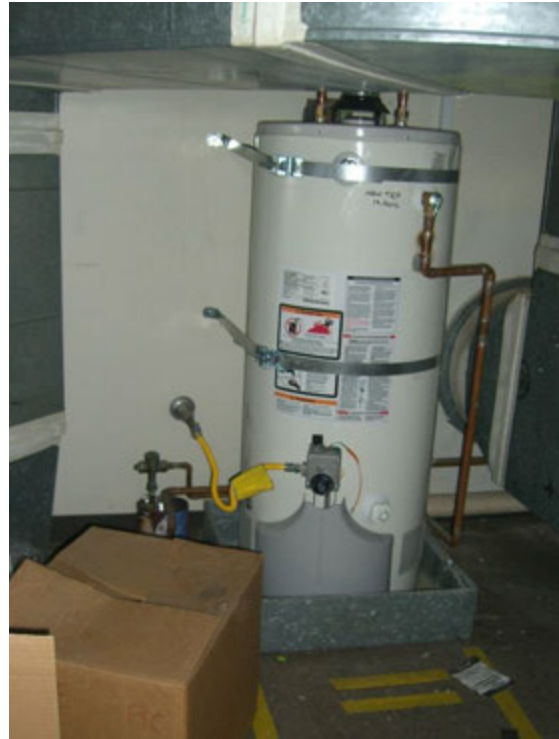
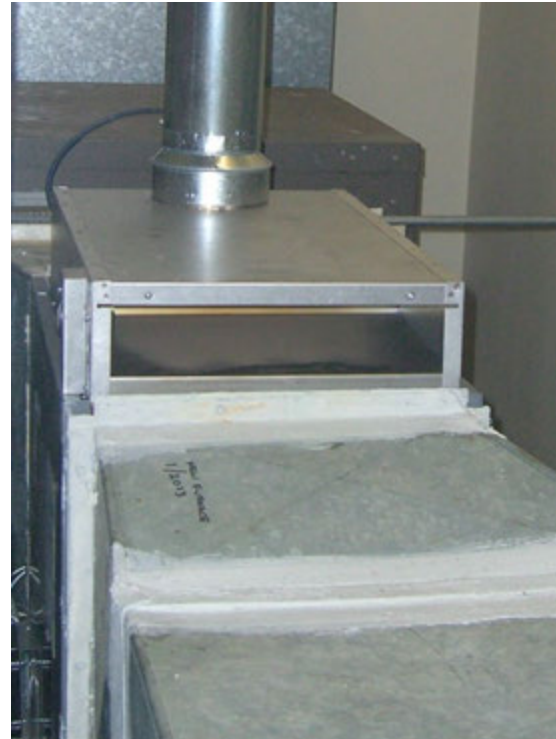
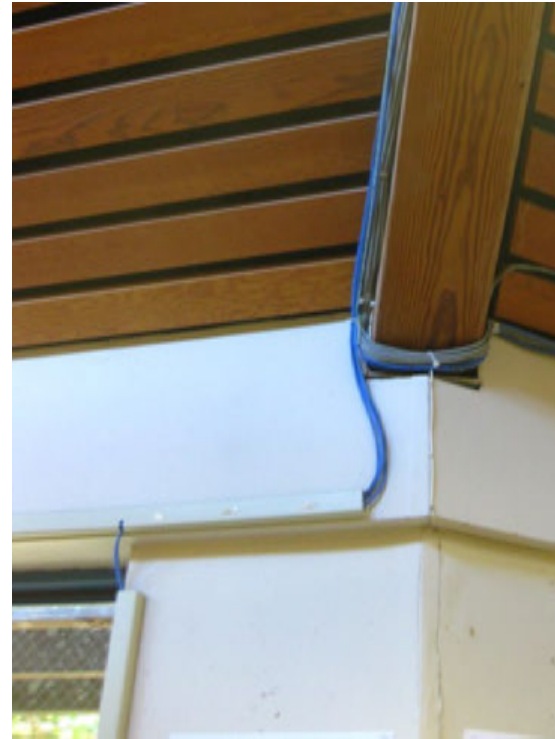
Poorly Integrated Telecom Upgrades

As internet capacity and other upgrades have been introduced to the Library over time, they have been poorly integrated and wires are visible throughout

Inefficient Lighting Systems

Lighting systems could be upgraded to be more efficient

Insufficient Air Circulation

Opening windows/doors without screens is only means for ventilating building

While some systems could be upgraded and integrated more effectively, most systems appear to be sufficient for the Library's current size

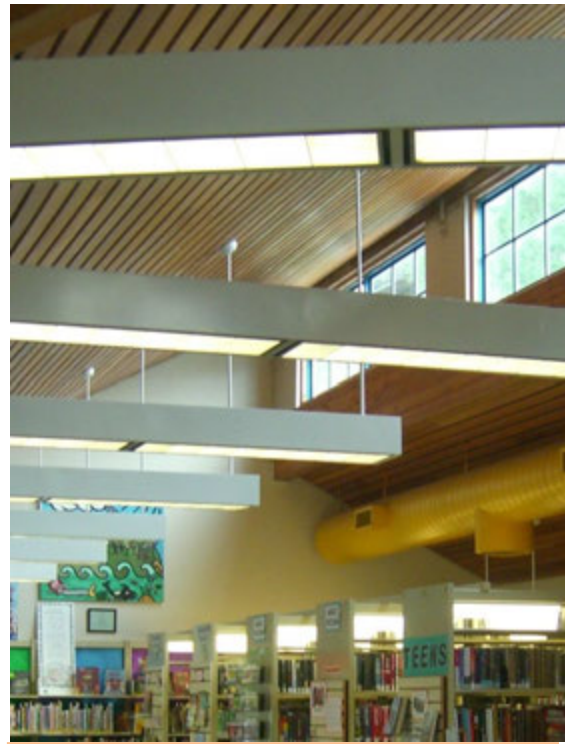
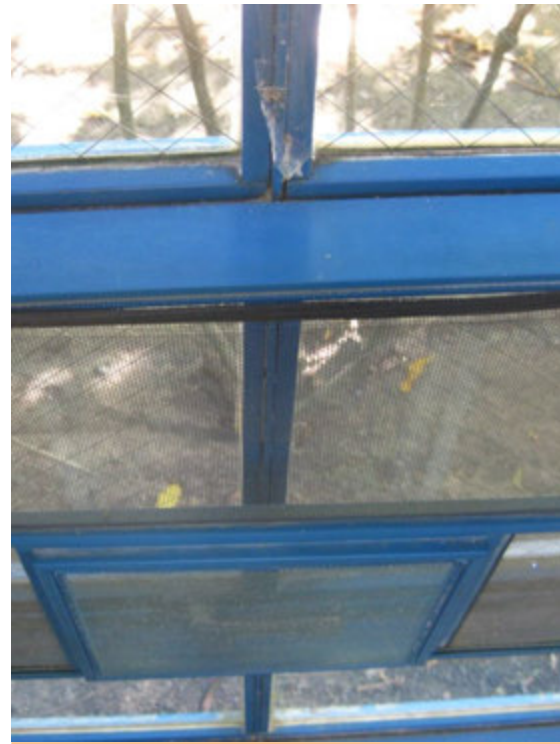
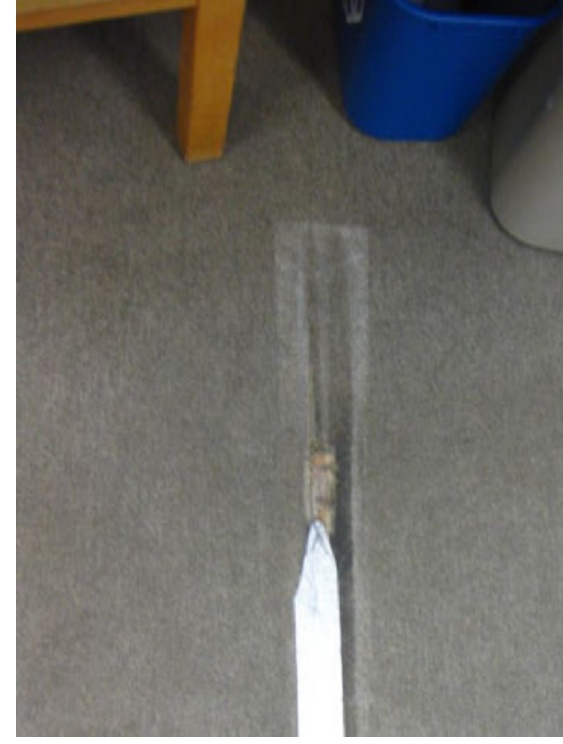
Worn Finishes

Some finishes are worn and require replacement

Damaged Window Screens

Some window screens have holes

Damaged Hardware

Some minor window hardware appeared to be in moderate disrepair, but could be replaced

Building finishes and window hardware need to be replaced, but the building is generally in good condition

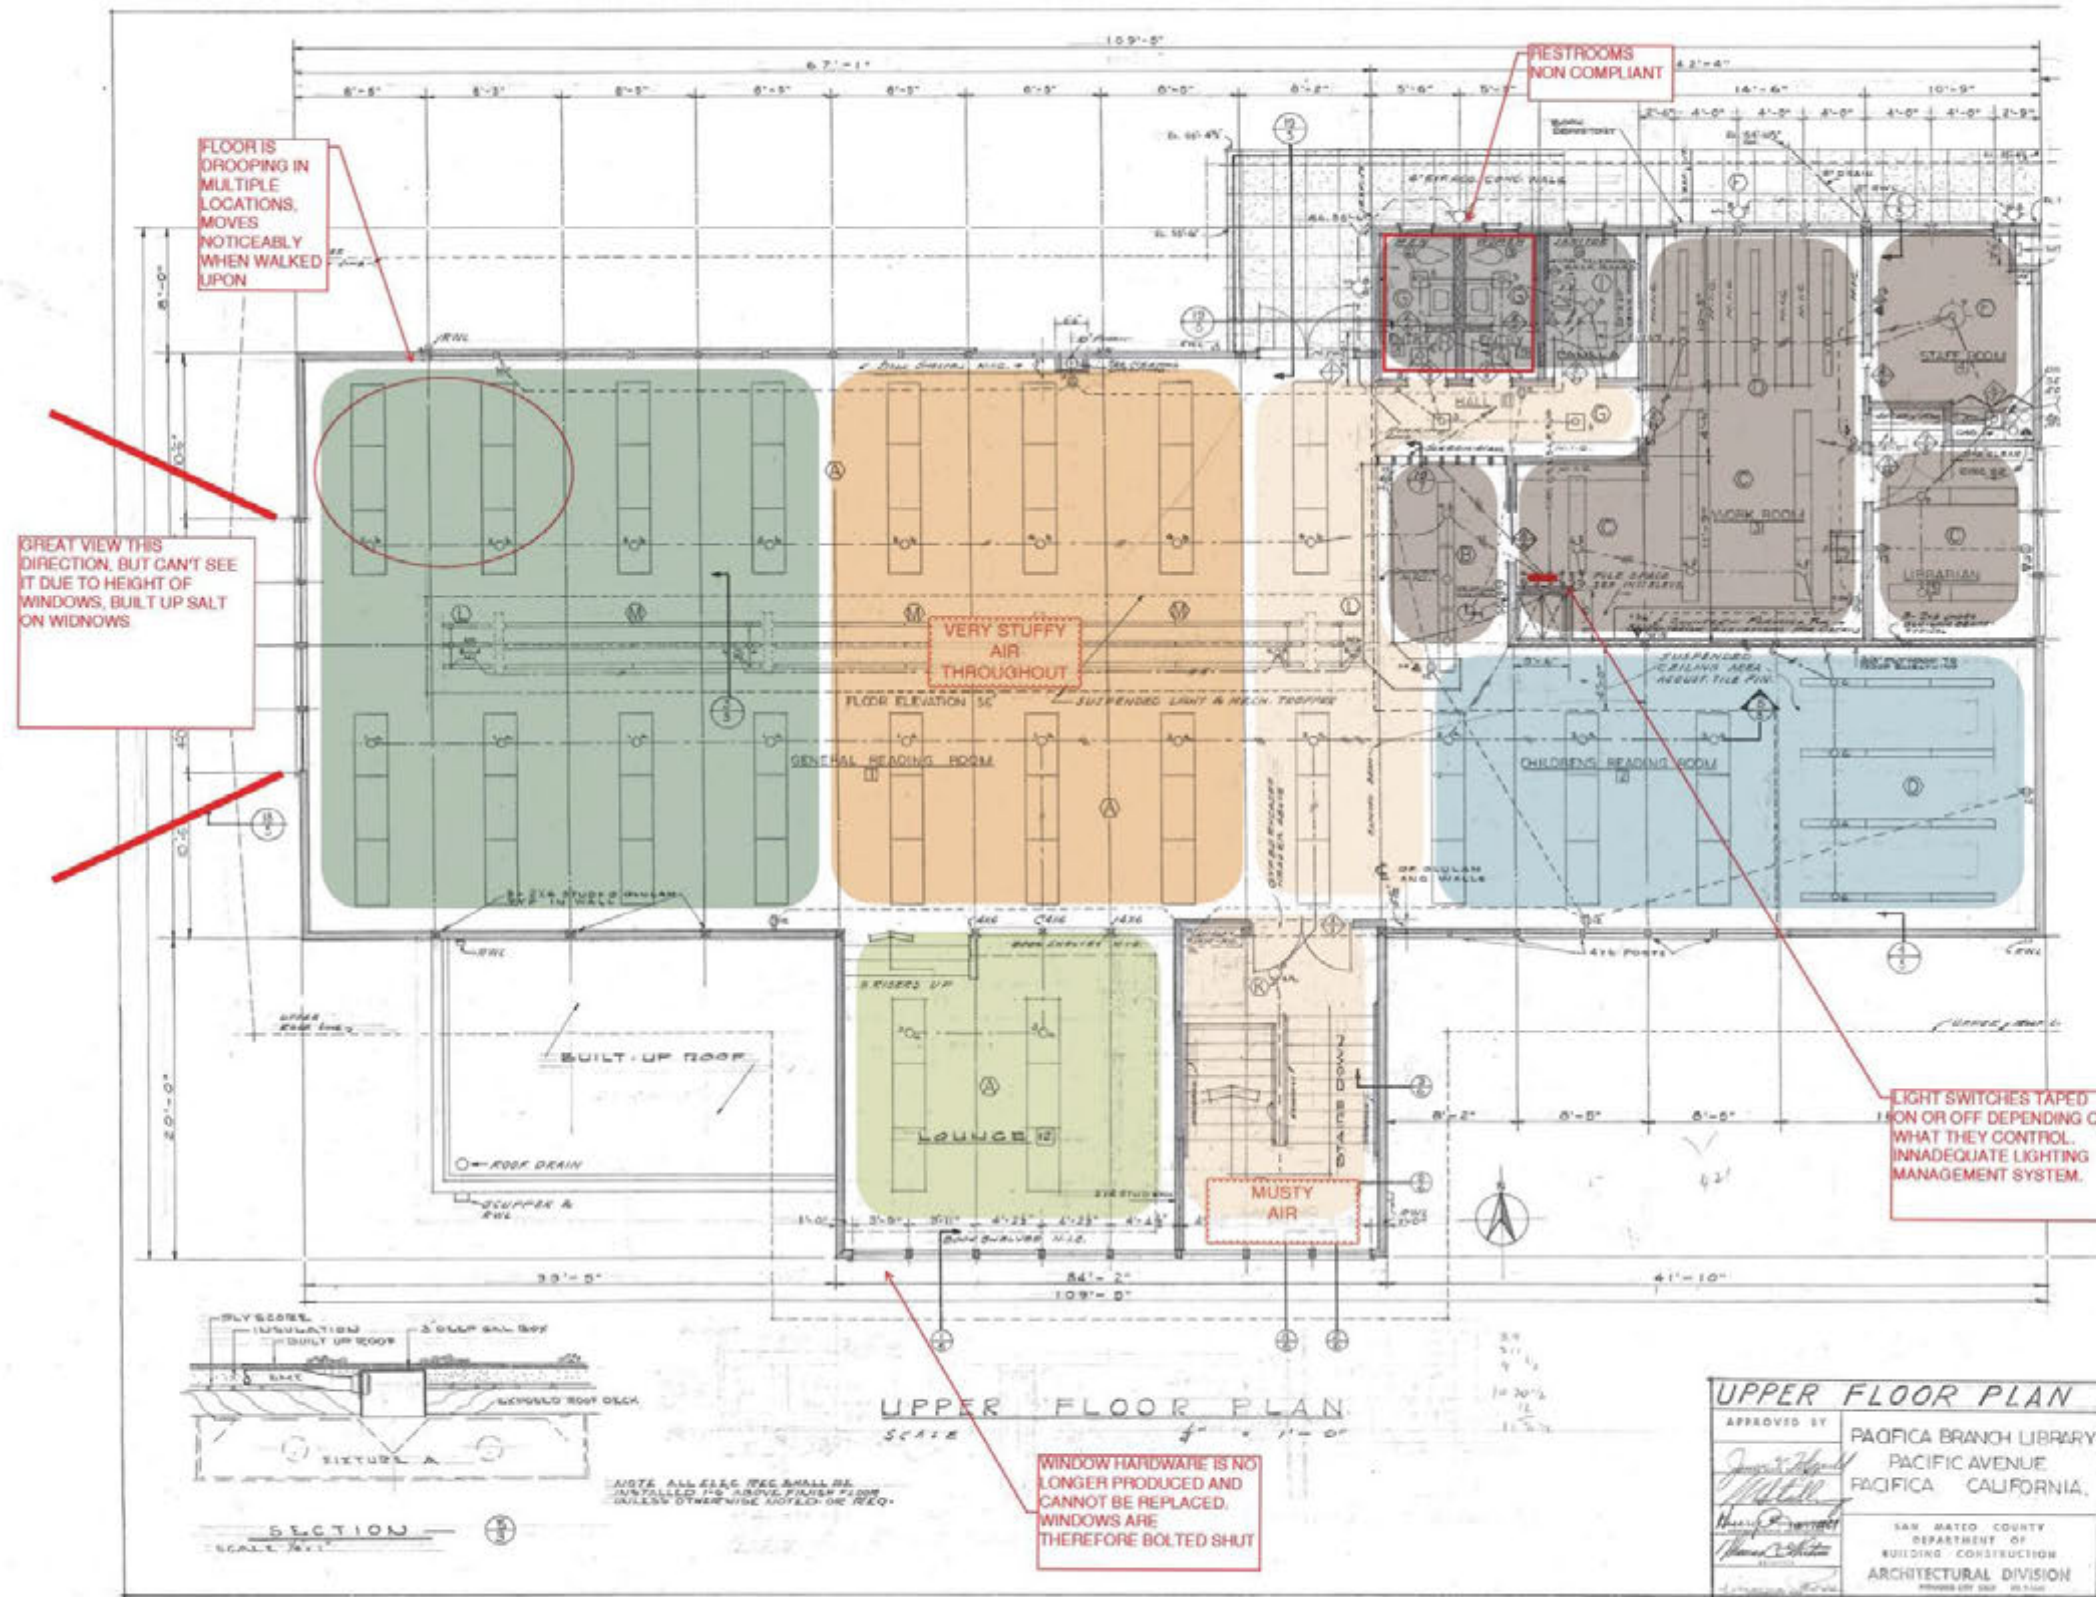
UPPER LEVEL PHYSICAL DEFICIENCIES

- Extensive salt/humidity damage
- Old, discontinued hardware
- Insufficient air circulation
- General wear & tear
- General ADA non-compliance due to sizes of rooms, hallways, doors, etc.
- Uneven floor

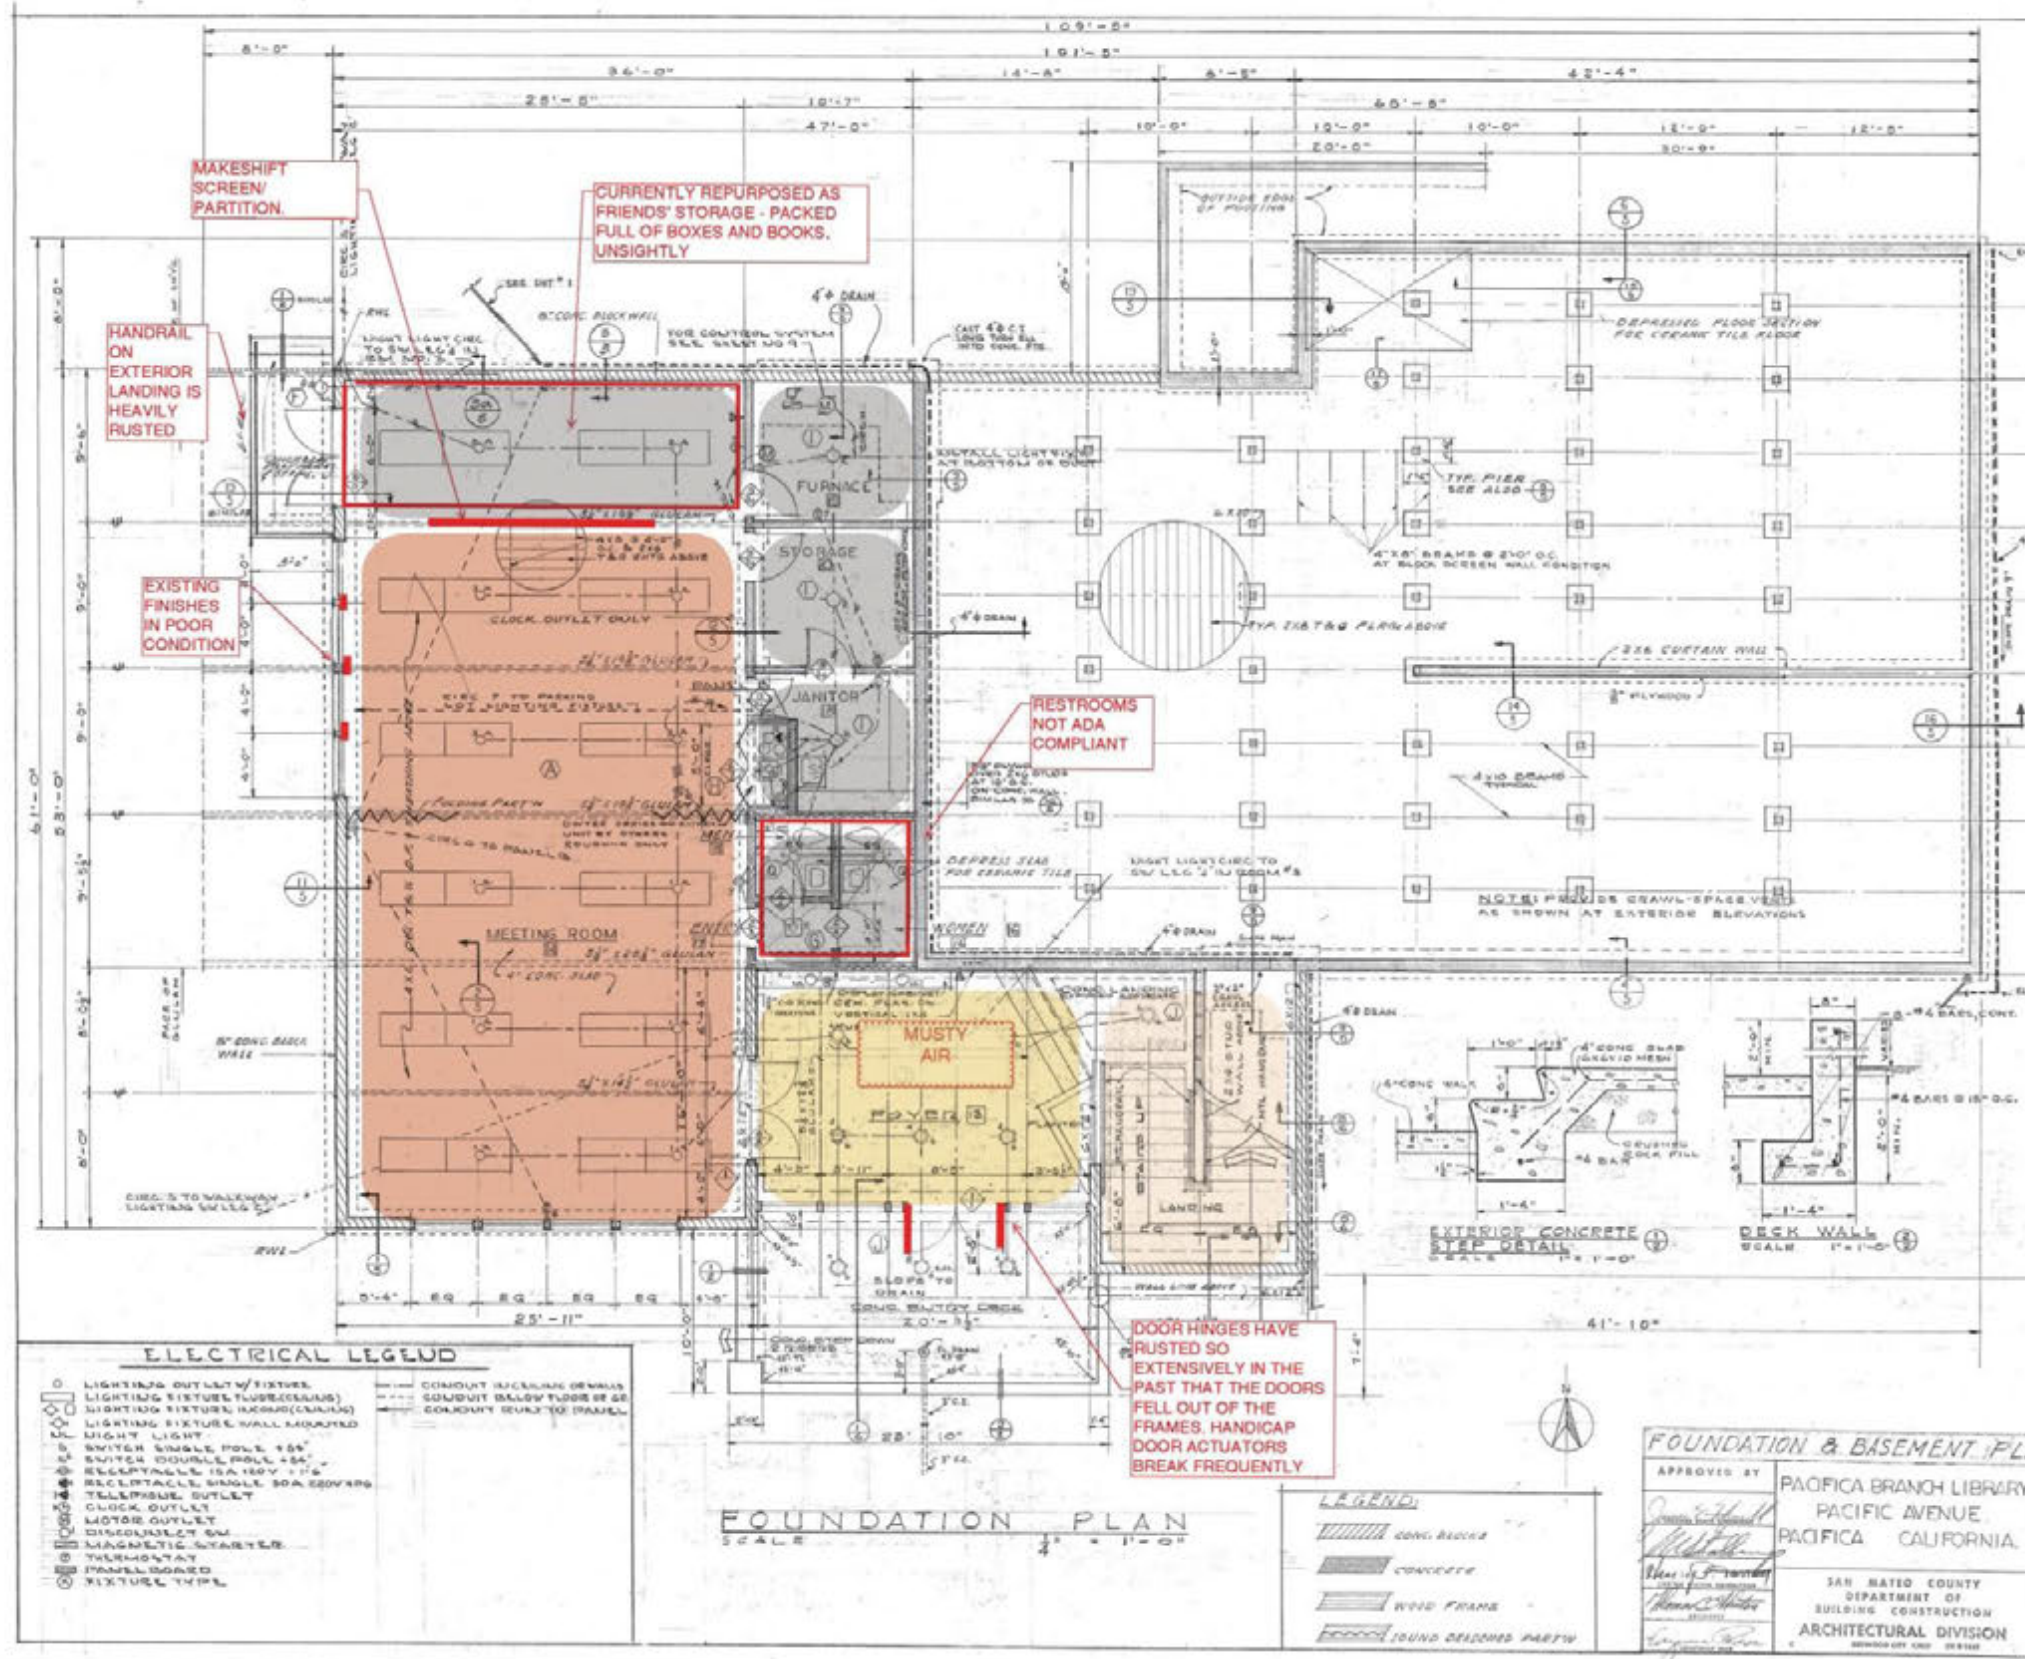
LOWER LEVEL PHYSICAL DEFICIENCIES

- Extensive salt/humidity damage
- Old, discontinued hardware
- Insufficient air circulation
- General wear & tear
- General ADA non-compliance due to sizes of rooms, hallways, doors, etc.

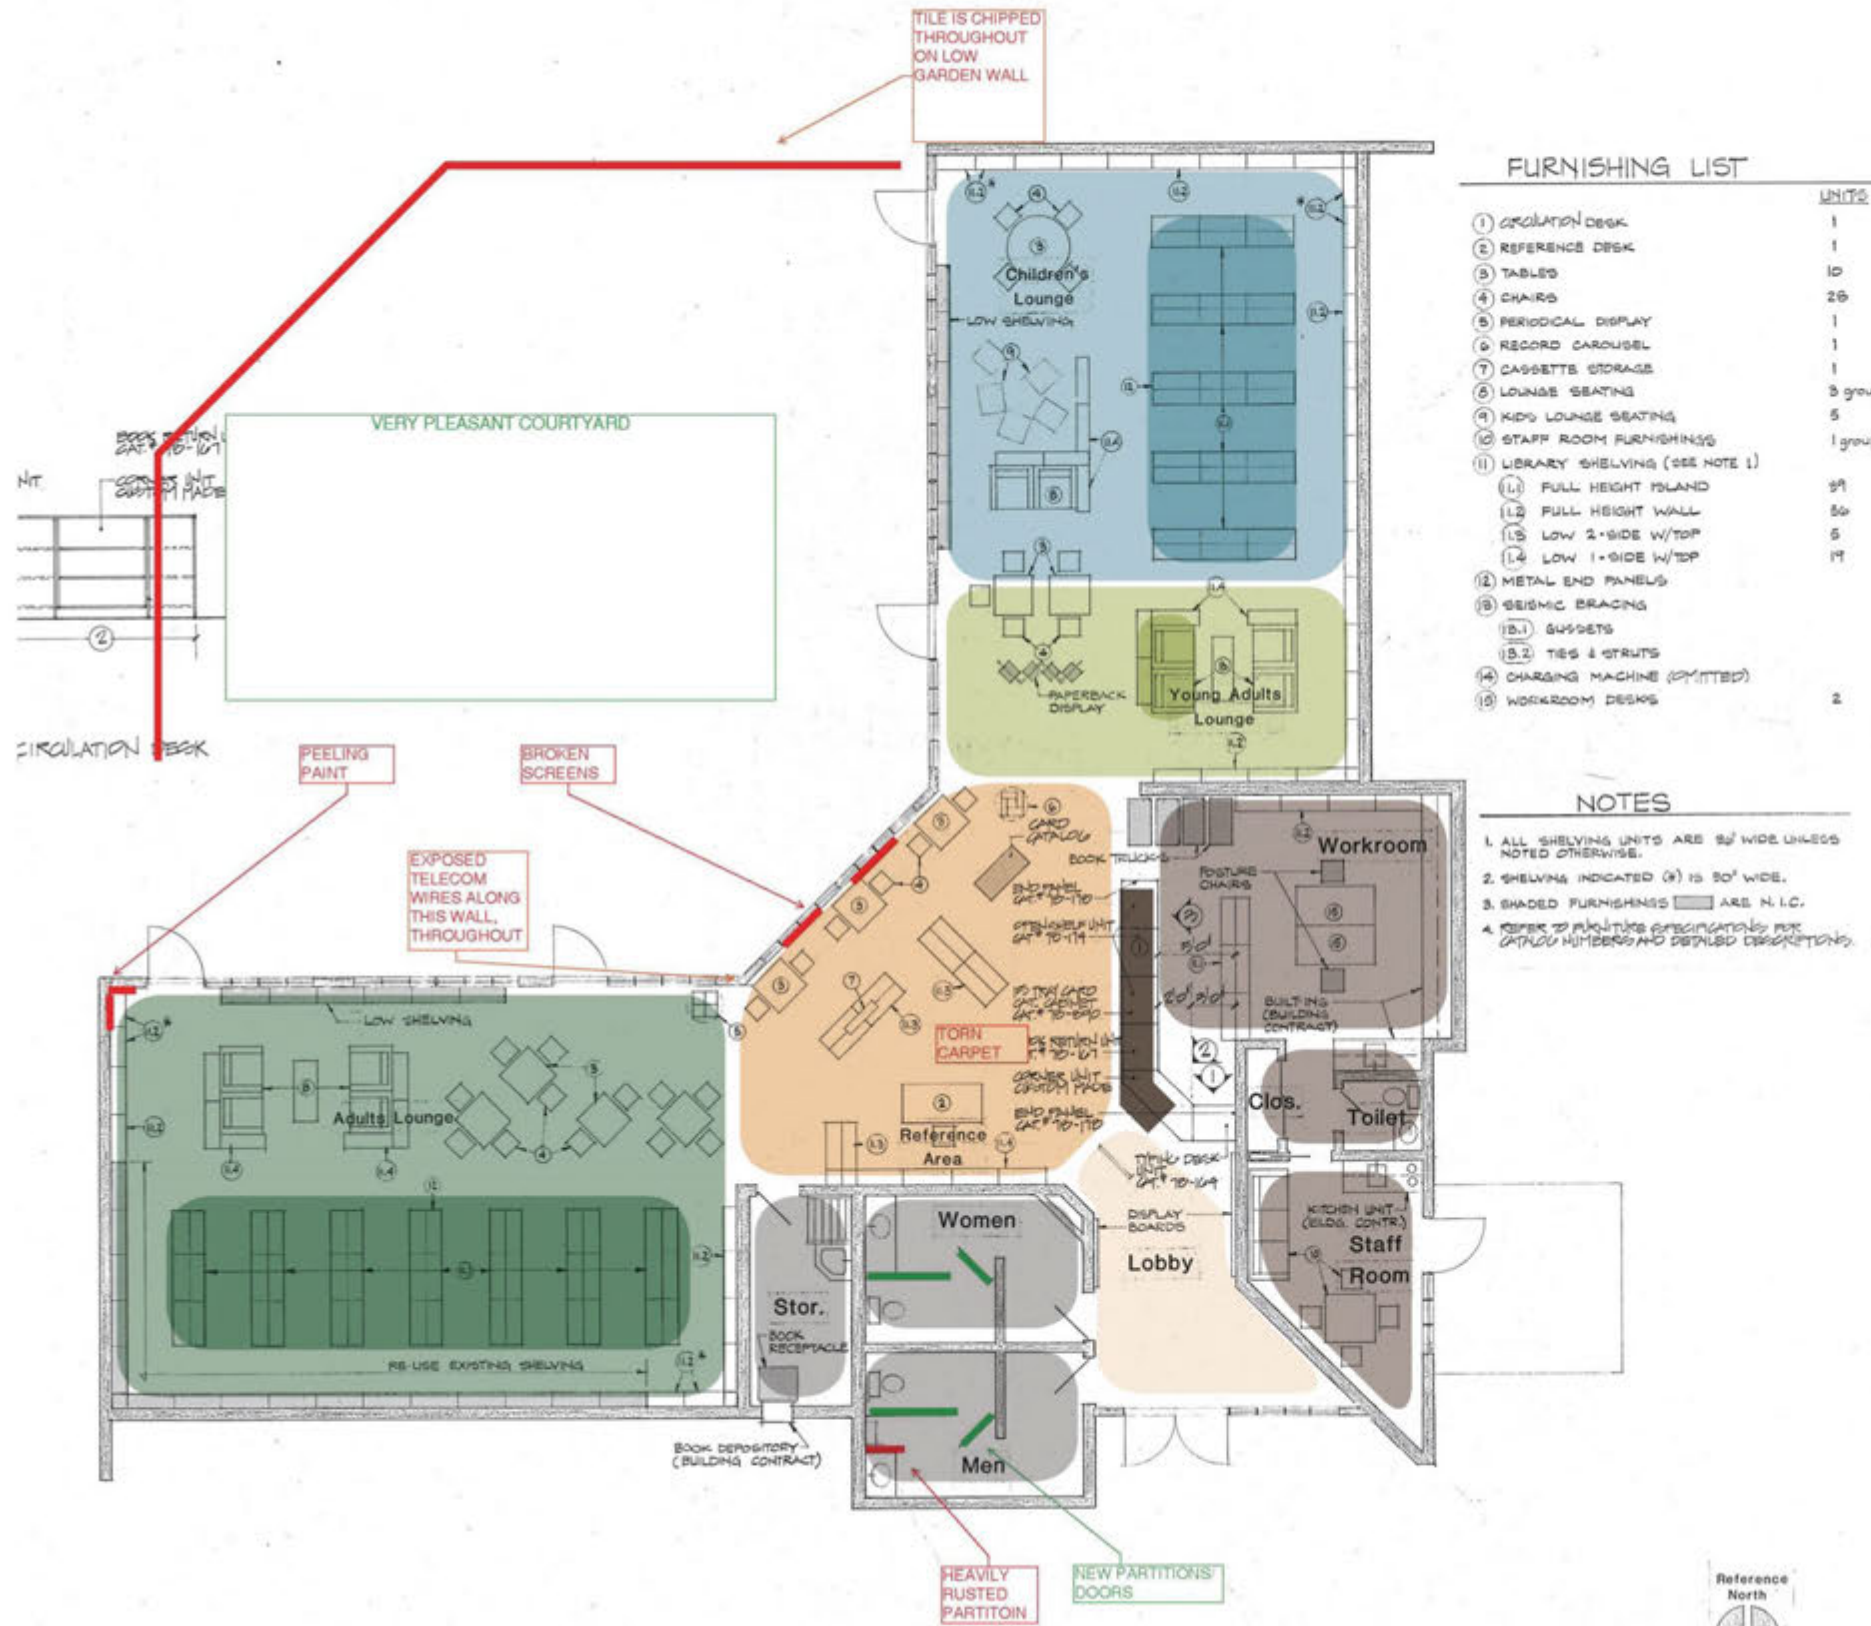
SANCHEZ LIBRARY PHYSICAL DEFICIENCIES

- Relatively limited physical deficiencies in building
- General wear & tear to finishes
- Modernized telecom systems are not well integrated into building - there are many visible wires
- Damaged window screens
- General ADA non-compliance - some areas could be upgraded
