Kielty Arborist Services LLC

July 11, 2017

Site: Empty lot adjacent to 751 San Pedro Terrace Road, Pacifica CA

Empty lot adjacent to 751 San Pedro Terrace Road

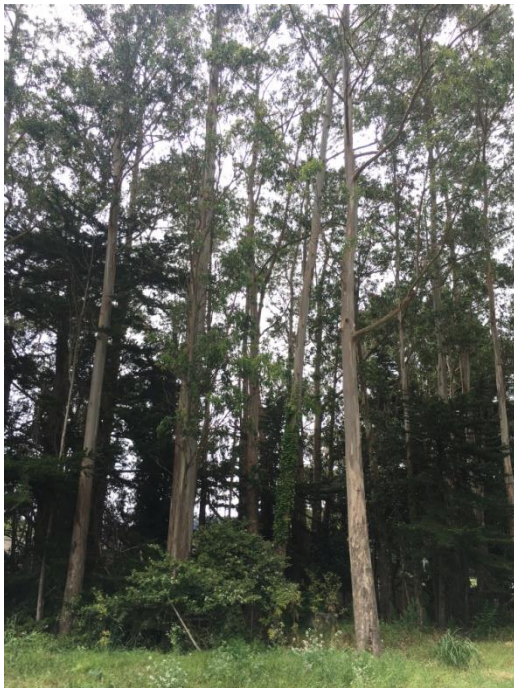
Showing suppressed conditions created by eucalyptus trees

The majority of the Monterey cypress trees surveyed on the site are in poor condition with the exception of Monterey cypress tree #2 that is in fair condition. These trees are in poor condition as a result of the suppressed conditions created by the large number of eucalyptus trees. All of the Monterey cypress trees are growing underneath the canopies of the eucalyptus trees. As a result, the cypress trees are growing wider instead of taller in order to find sunlight. This has created large lateral limbs that are prone to failure. All of the cypress trees on site have a history of large limb loss, as seen throughout the canopies. Past tree failures were also observed on the site, likely from the heavily suppressed conditions. All of the trees on site are proposed for removal to facilitate the proposed construction. Trees with a diameter of 16 inches or larger are protected trees in the city of Pacifica, excluding eucalyptus trees. The only trees that fall into the protected tree definition are Monterey cypress trees #1, #4 and #5. The city of Pacifica states the a tree removal permit may be conditioned upon tree

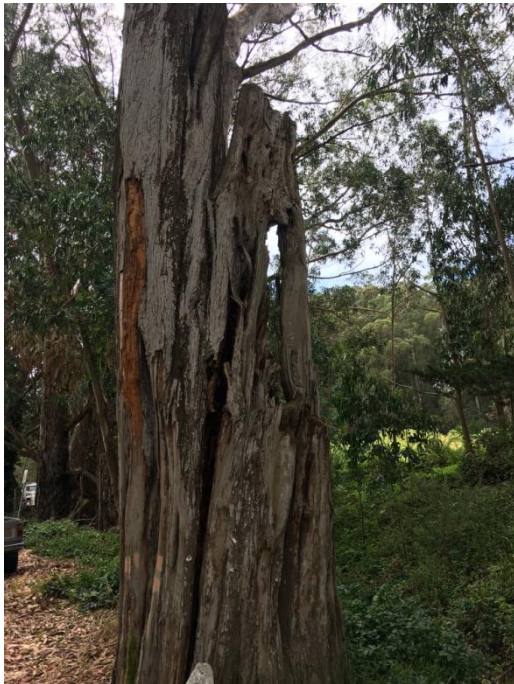
Monterey cypress tree #5 is located off site across the street from the property. This tree has poor vigor and poor form, as a heavy amount of decay was located on the tree's trunk. A history of large limb loss was also visible in this tree's canopy. This tree is extremely hazardous to anyone walking or driving (in the future) on San Pedro Terrace road. It is recommended to remove this tree as soon as possible.

Showing hazardous cypress tree #5

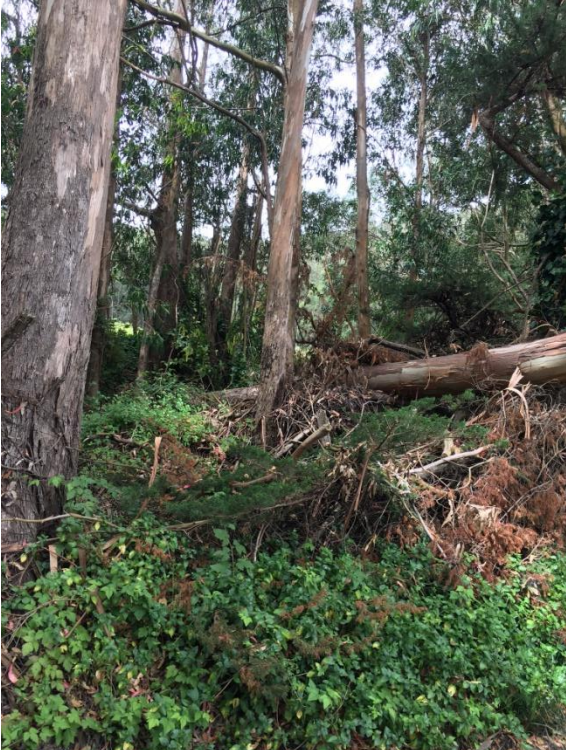
Showing past tree failure

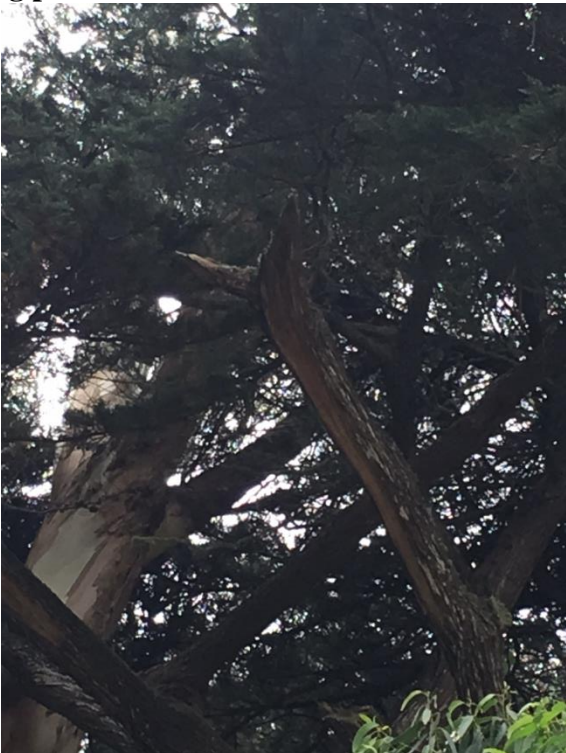
Showing history of limb loss
