**AGENDA**  
**Parks, Beaches, and Recreation Commission**  
**City of Pacifica**

A. Tree Appeal #HT-015-23 1164 Rosita Road Continued

A. Priority Park -Skyridge Park

# Arborist Report

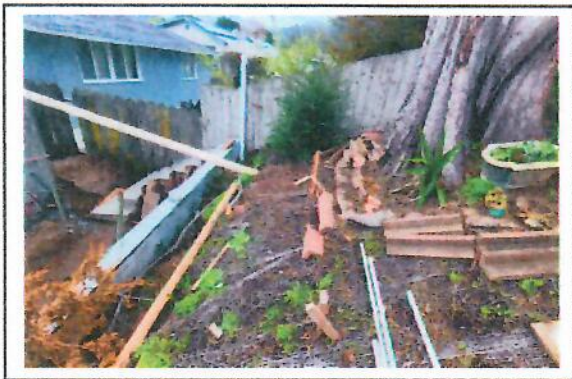
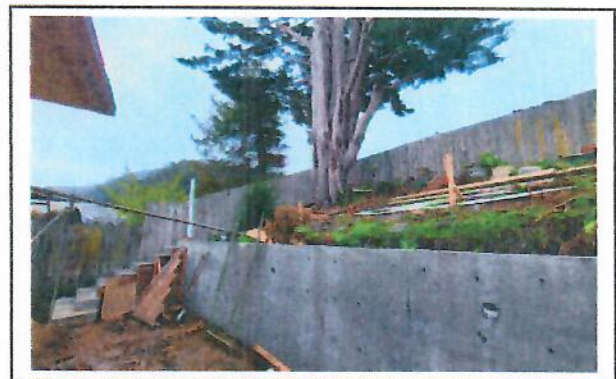
*Compromised root plate. Root cutting at less than eight feet from the tree trunk.*

The Tree Condition Assessment (**Attachment D**) prepared and signed on May 30, 2023 by Donald W. Cox, ISA Certified Master Arborist, analyzed the tree's structural root zone (SRZ) and root protection zone (RPZ). The SRZ is closer to the trunk and contains larger sized structural support roots that are important to the stability of the tree. The RPZ is further from the SRZ which contains finer feeder and hairy absorbing root systems that gather resources for tree survival, travel further than the dripline of the tree, and dominate the top 30-centimeters of soil. The report concluded that the major structural roots located in the SRZ have been severed at approximately seven (7) feet from the tree trunk and the SRZ is essential to be undisturbed at a minimum of 15-feet measured from the tree trunk. As mentioned in the report, encroaching into the SRZ places the tree at risk of catastrophic failure and removal of the tree is recommended to avoid structural failure by wind-throw toppling within two to five years.

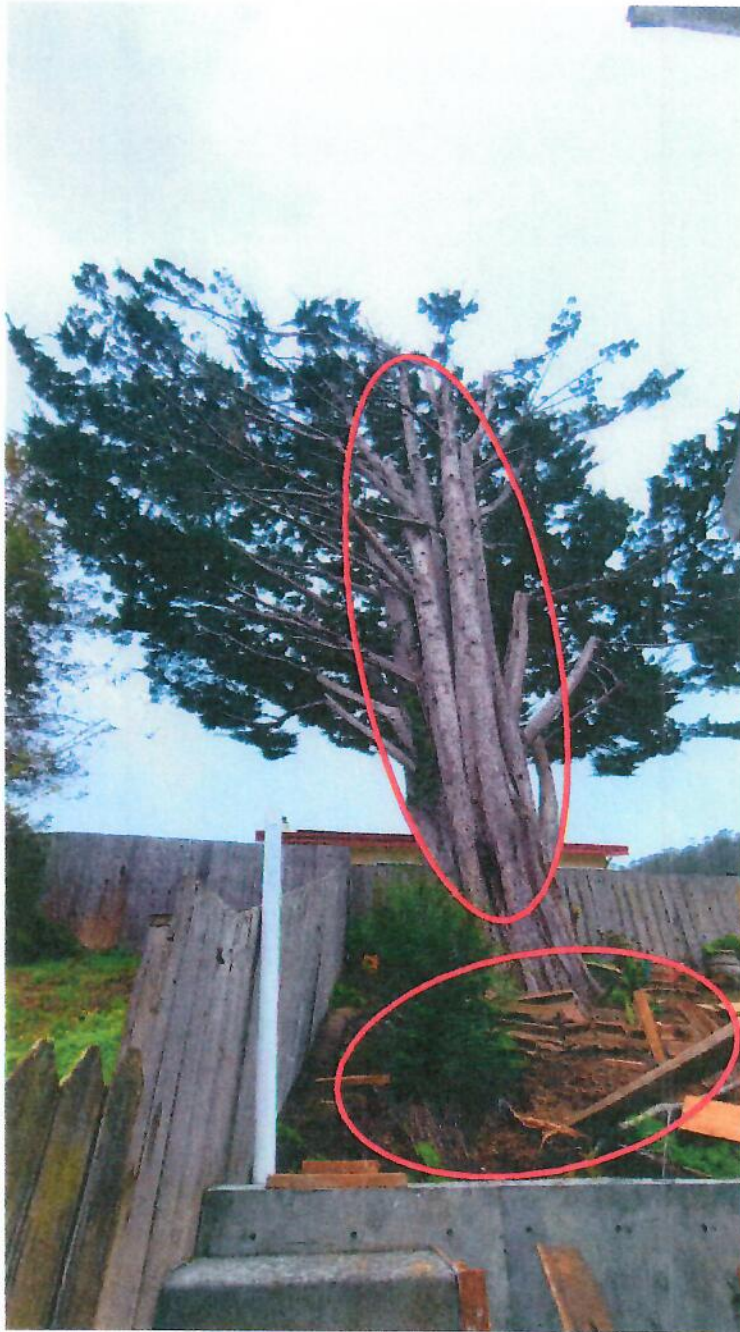
***Leaning one-sided tree with multiple co-dominant stems – prone to failure  
Compromised structural root zone***

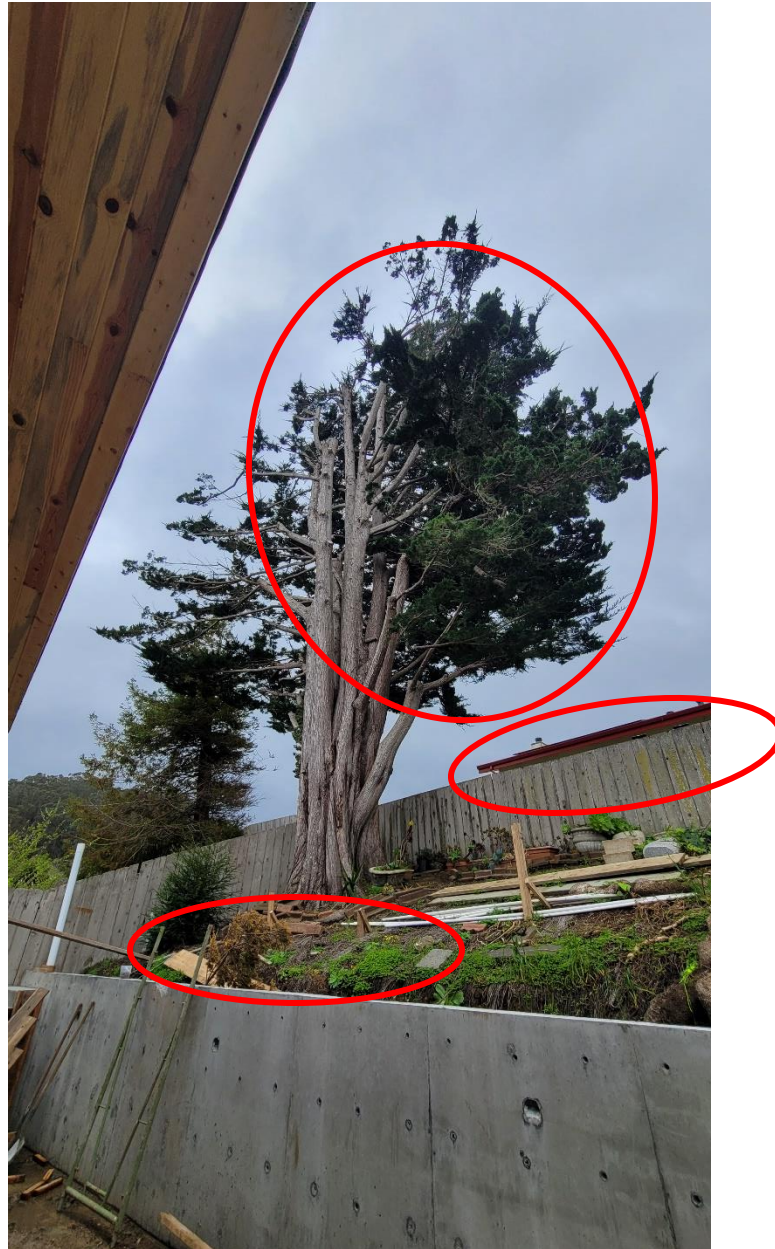
***Compromised structural root plate. Unbalanced weighted crown. Neighbor's house***

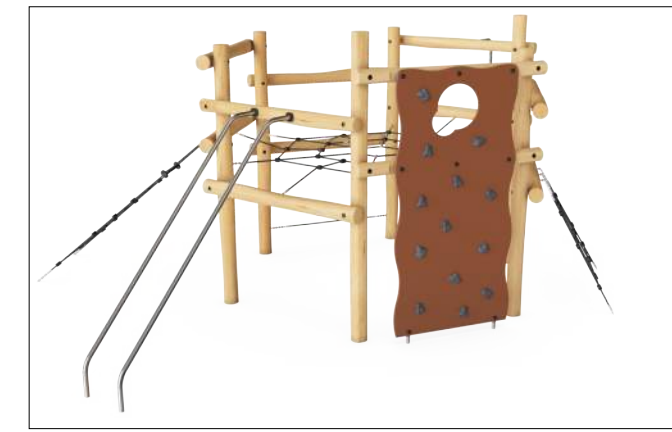
**A. Six-Sided Climbing Structure**

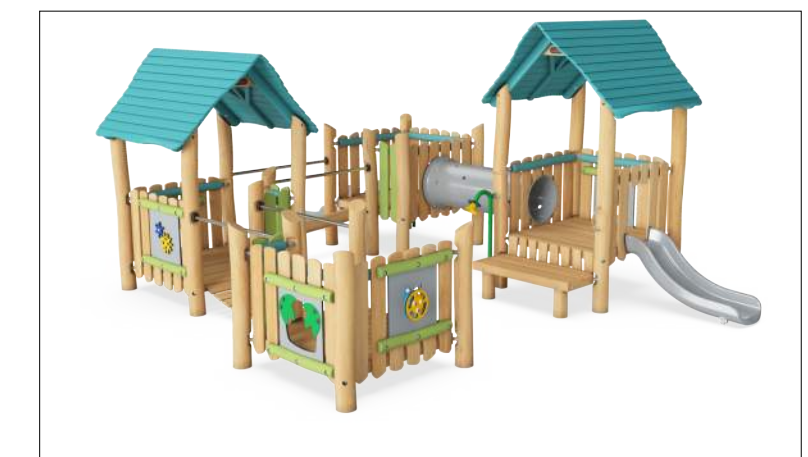
**B. Little Turtle's Town**

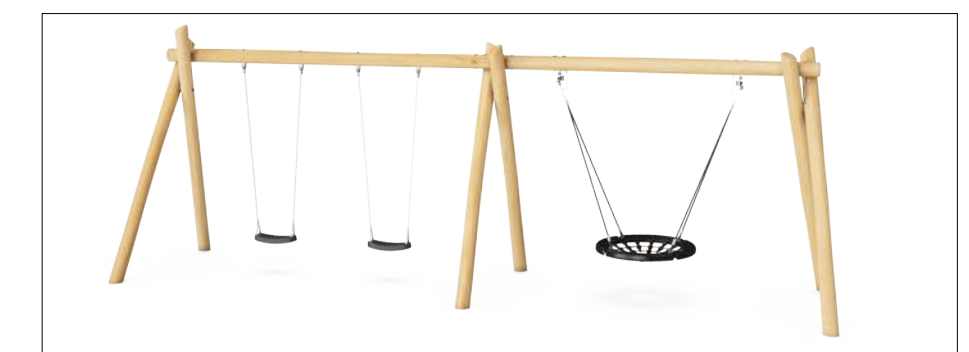
**C. Double Swing Combination**
