San Pedro Terrace Final Wetland Delineation Report

FINAL
January 18, 2017

This report provides final jurisdictional determination for wetlands identified on for the proposed project. The delineation was performed in accordance with the 1987 USACE Wetland Delineation Manual (Environmental Laboratory 1987) and the 2008 USACE Regional Supplement to the Corps of Engineers Wetland Delineation Manual for the Arid West Region (Environmental Laboratories 2008). The wetland boundaries were confirmed in the field by Army Corps personnel on December 14, 2016.

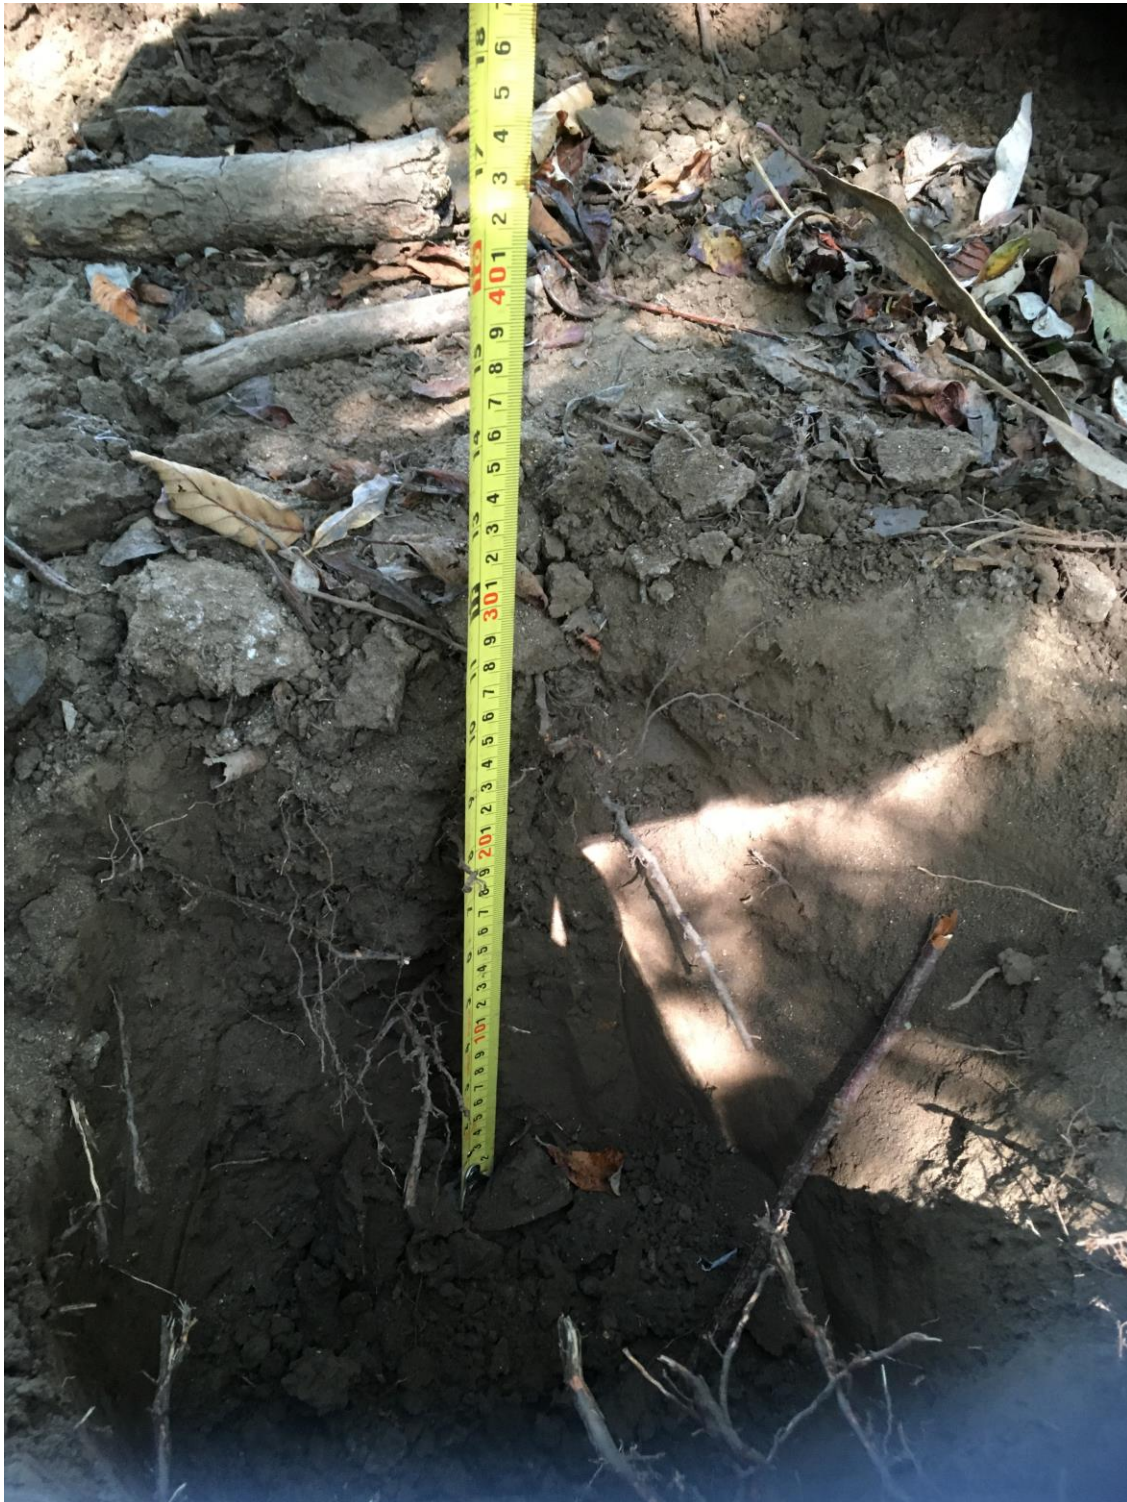
Photo 1: Sampling Point SPT-1

Point	Sample Profile	NRCS Soil Type	Hydric Indicator	Hydric	Wetland
SPT-1	0 – 5” Sandy Clay	Barnabe-Candlestick complex	Sandy Mucky Mineral	Y	Y
SPT-1	5 – 10” Loam	Barnabe-Candlestick complex	Redox Dark Surfaces	Y	Y
SPT-2	0 – 12” Sandy Loam	Barnabe-Candlestick complex	None	N	N

Sampling Point	Hydrological Feature Observed	Wetland
SPT-1	Salt Crusts (Primary) Surface Soil Cracks (Primary) Drift Deposits Riverine (Secondary) Drainage Patterns (Secondary)	Y
SPT-2	None	N

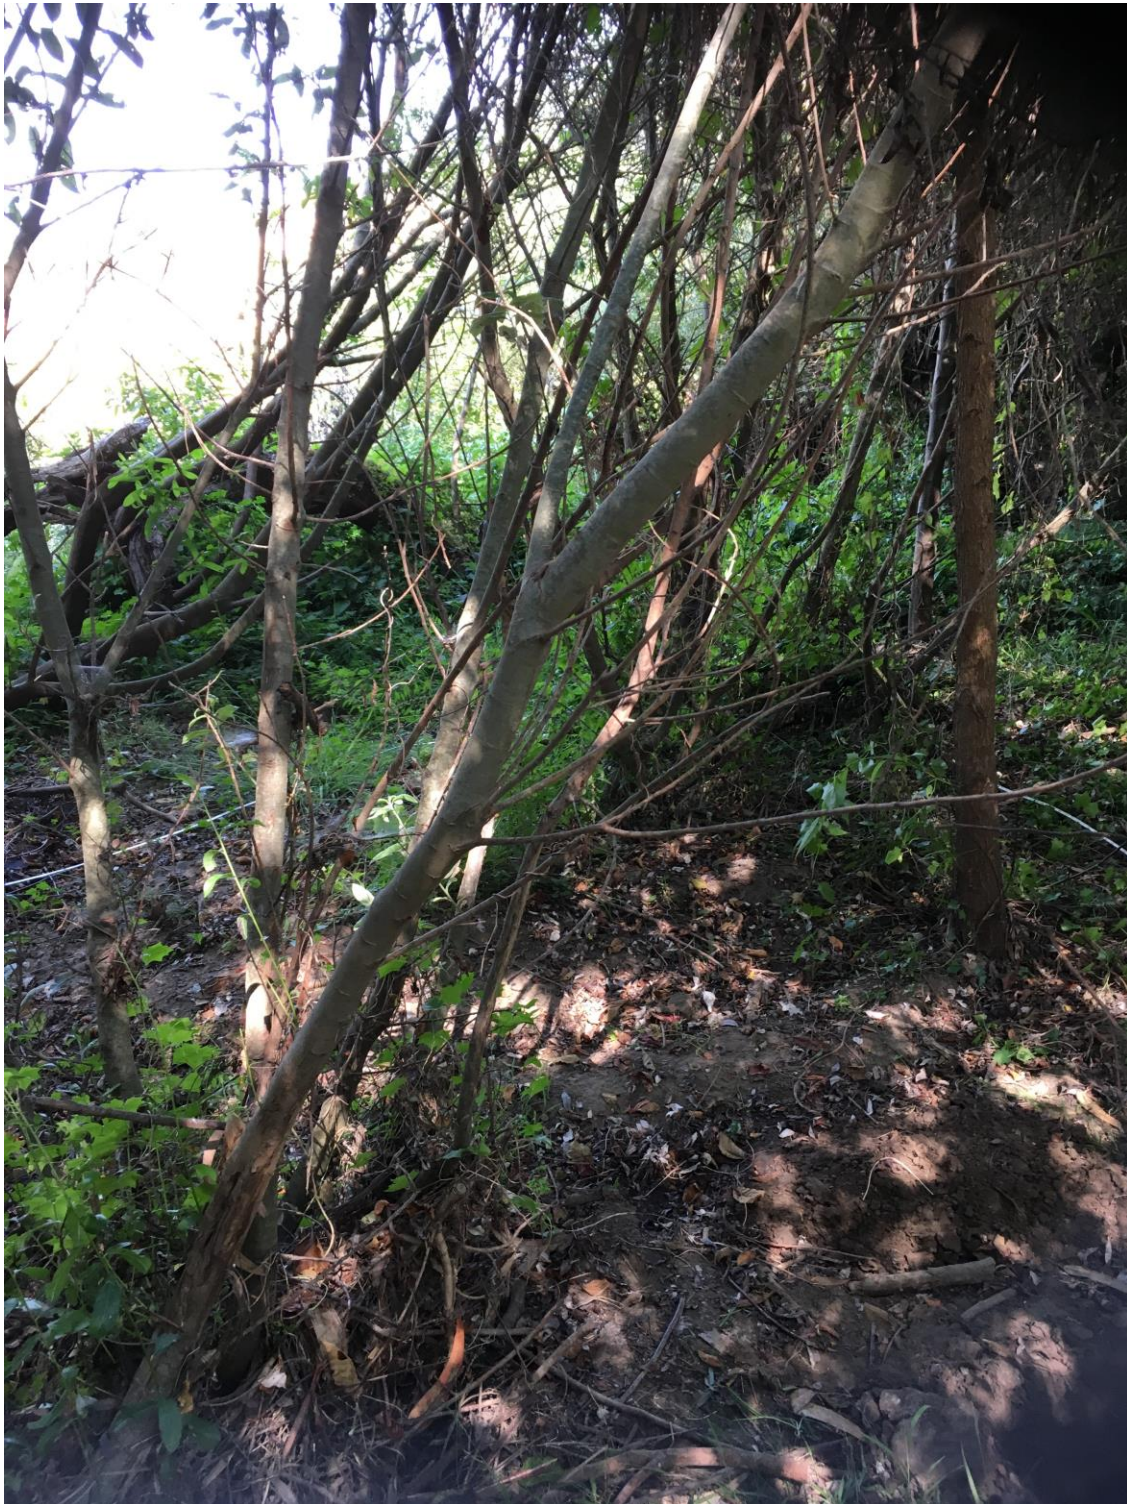
Photo 3: Vegetation at SPT-1

Sampling Point	Species	Stratum	Wetland Indicator Status
SPT-1 – Wetland	<i>Salix laevigata</i>	Tree	FACW
	<i>Equisetum arvense</i>	Herb	FAC
	<i>Melica imperfecta</i>	Herb	NL (UPL)
	<i>Rubus ursinus</i>	Vine	FAC
SPT-2 – Non-wetland	<i>Eucalyptus globulus</i>	Tree	NL (UPL)
	<i>Baccharis pilularis</i>	Shrub	NL (UPL)
	<i>Phalaris aquatica</i>	Herb	FACU
	<i>Vinca major</i>	Herb	NL (UPL)

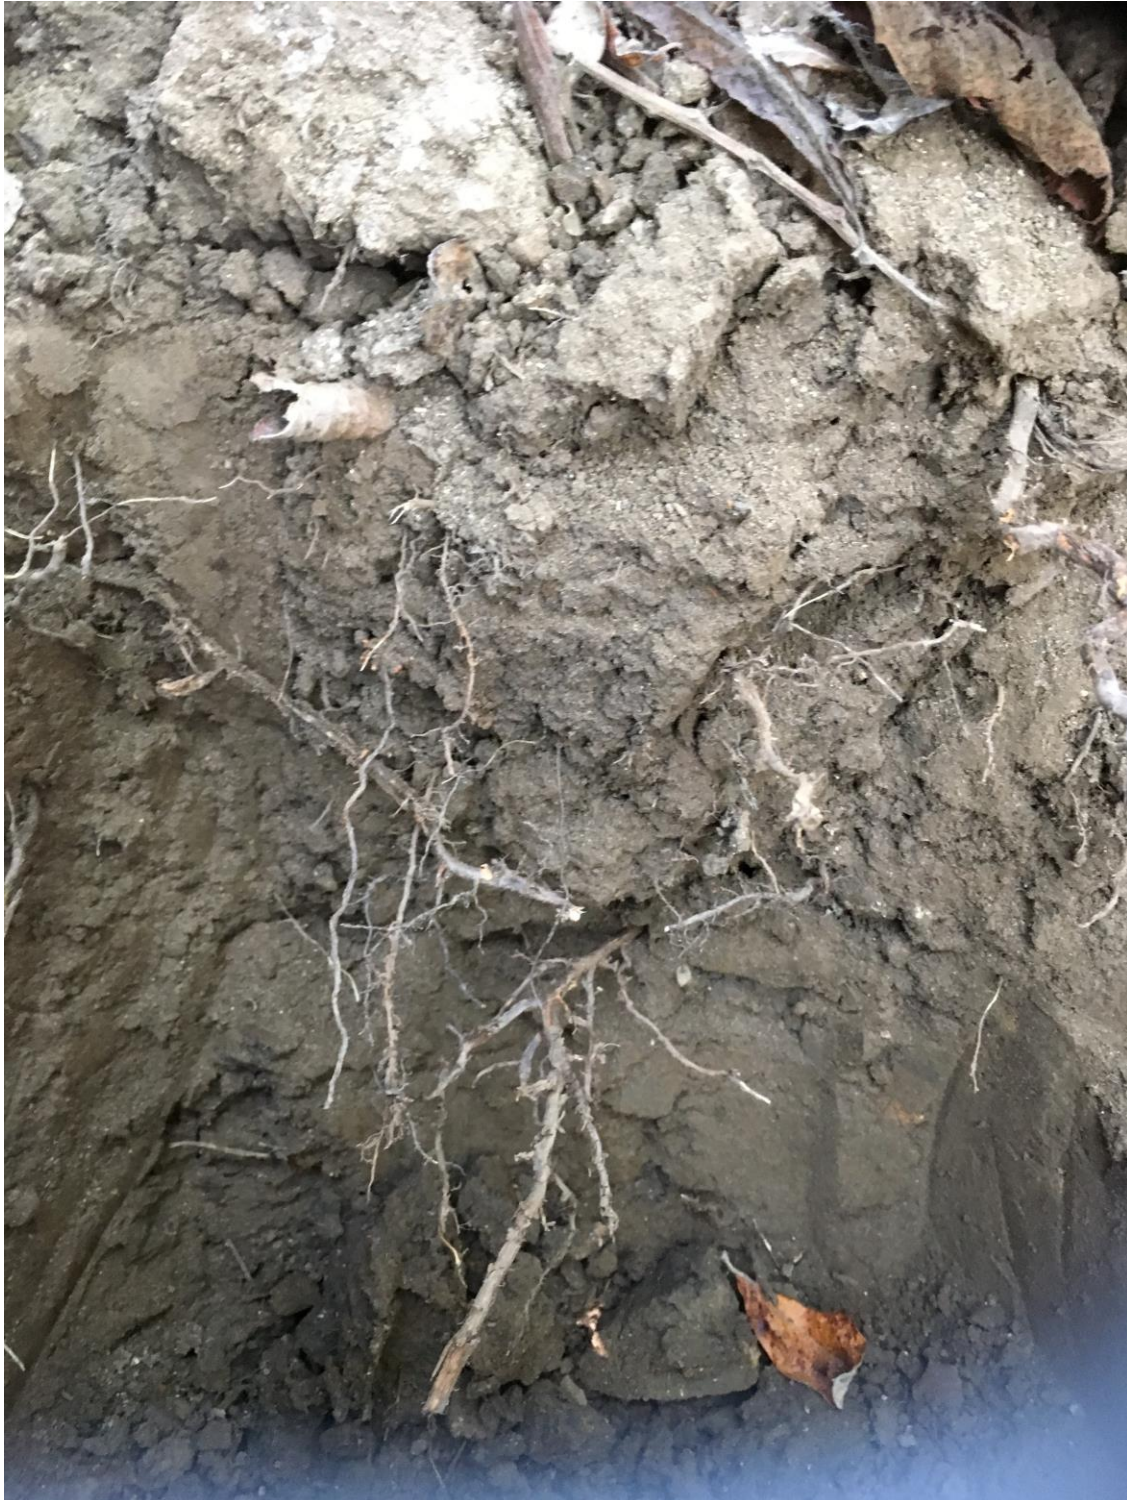
**Photo 5: Hydric Soil Indicator at SPT-1
Sandy Mucky Mineral**

Table 4 summarizes the results of the soil samples taken at each sampling point. Photos 5 and 6 show soils with hydric indicators found on the site at SPT-1.

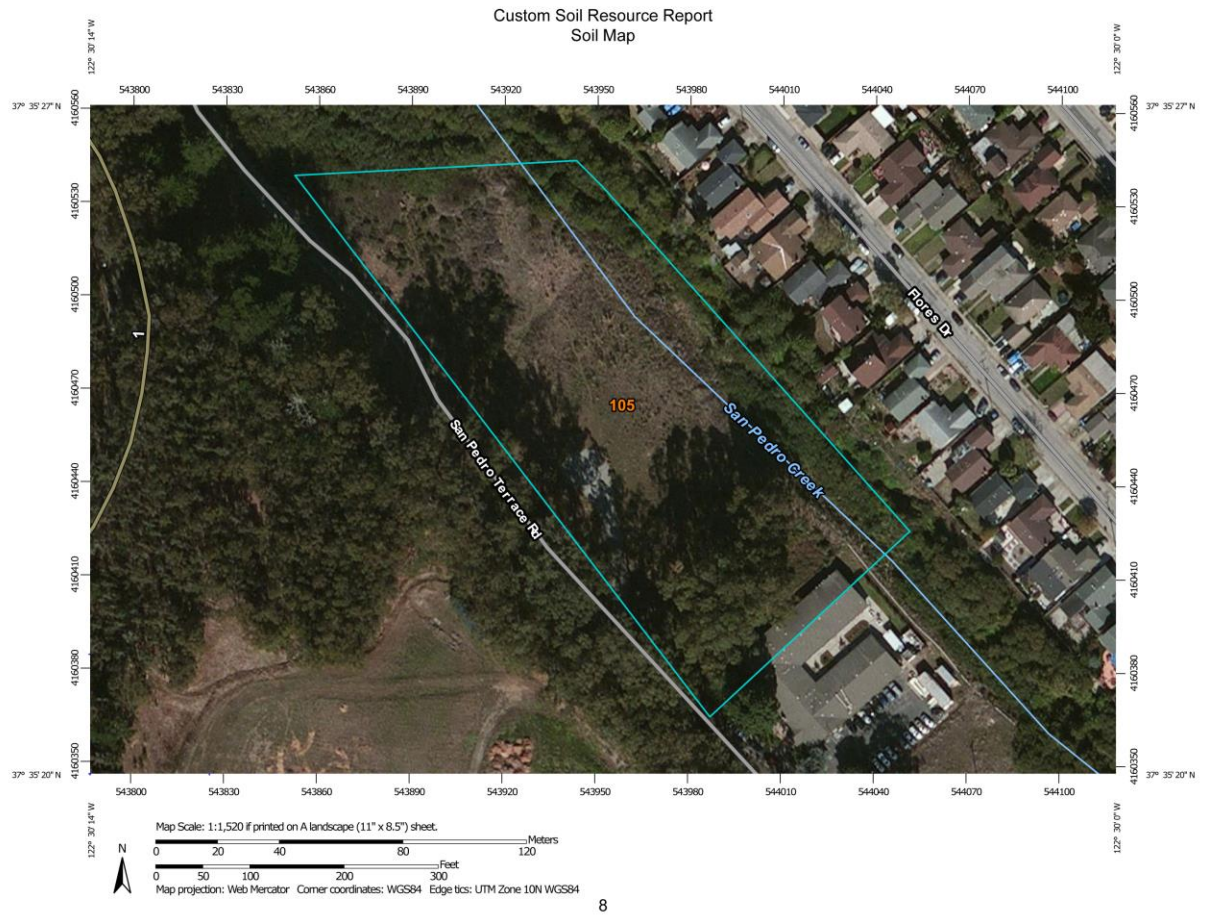
Figure 4: Soil Survey Map (See Appendix B for Full Soil Report)

On August 16, 2016, a soils report was generated for the project site using the Natural Resource Conservation Service Web Soil Survey online database (NRCS 2016). The full report is provided in Appendix B. The soil survey map is provided in Figure 4.

One soil type is expected to occur within the areas identified in this report: Barnabe-Candlestick complex. Summary description of this soil is provided below.

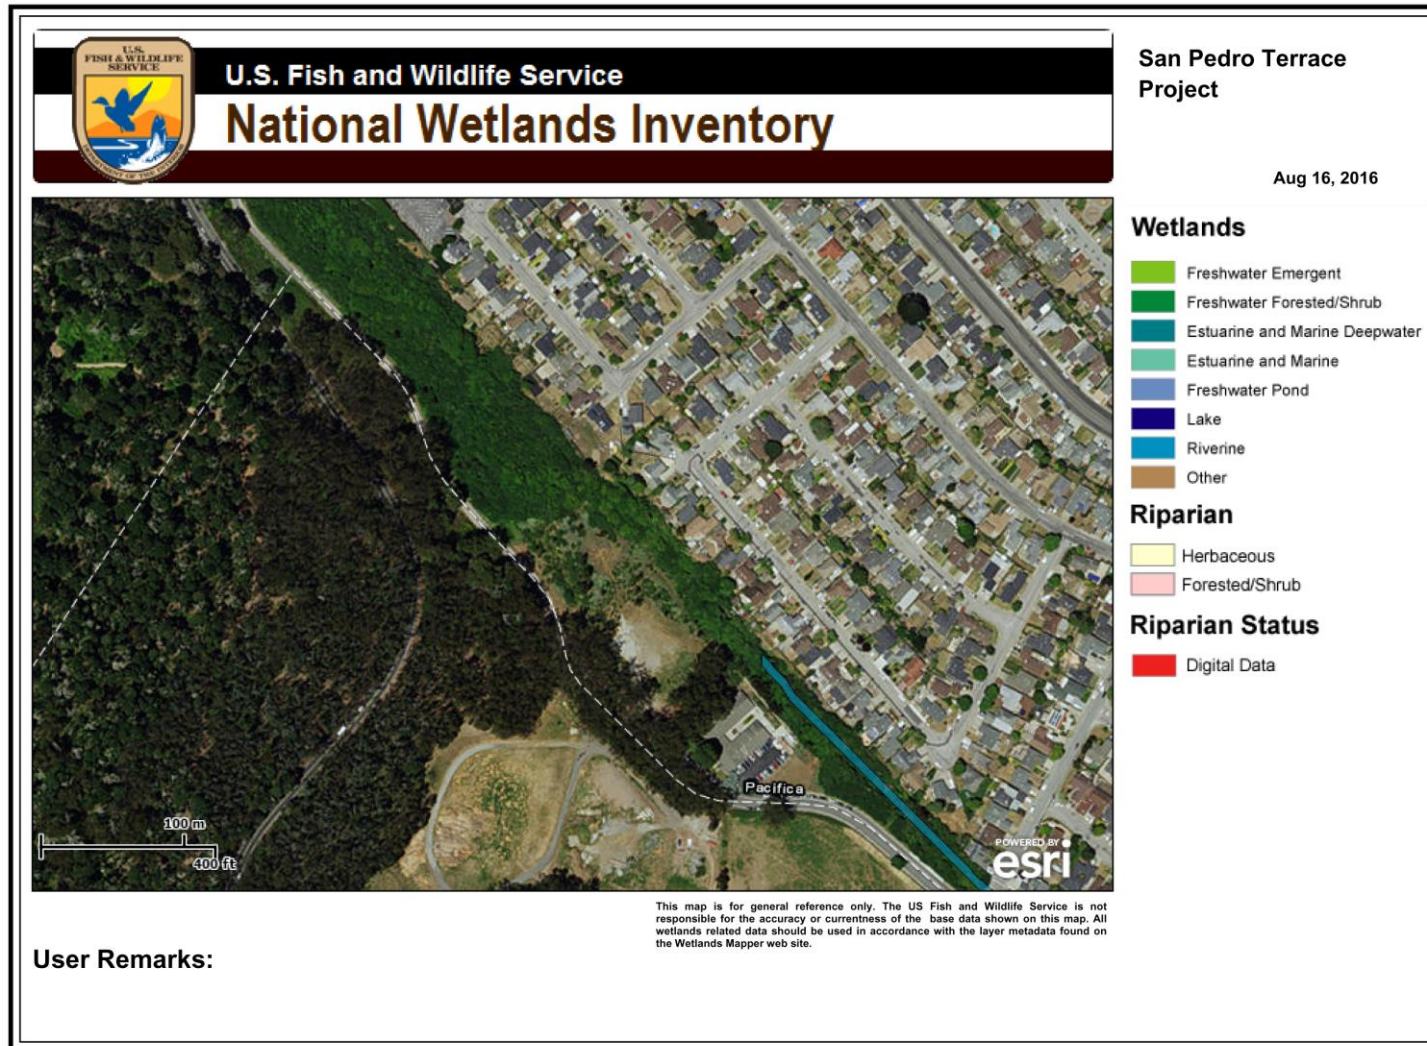
Figure 5: National Wetlands Inventory Map

The National Wetland Inventory website was accessed in order to determine the known or suspected presence of wetlands in the project vicinity (USFWS 2016). The NWI map is provided in Figure 5.

The NWI map shows an anomalous data point, where San Pedro Creek appears to simply stop almost immediately prior to the project site. In fact, the creek does continue, adjacent to the project location. The NWI Classification for this area is R4SBAX, which is defined as follows:

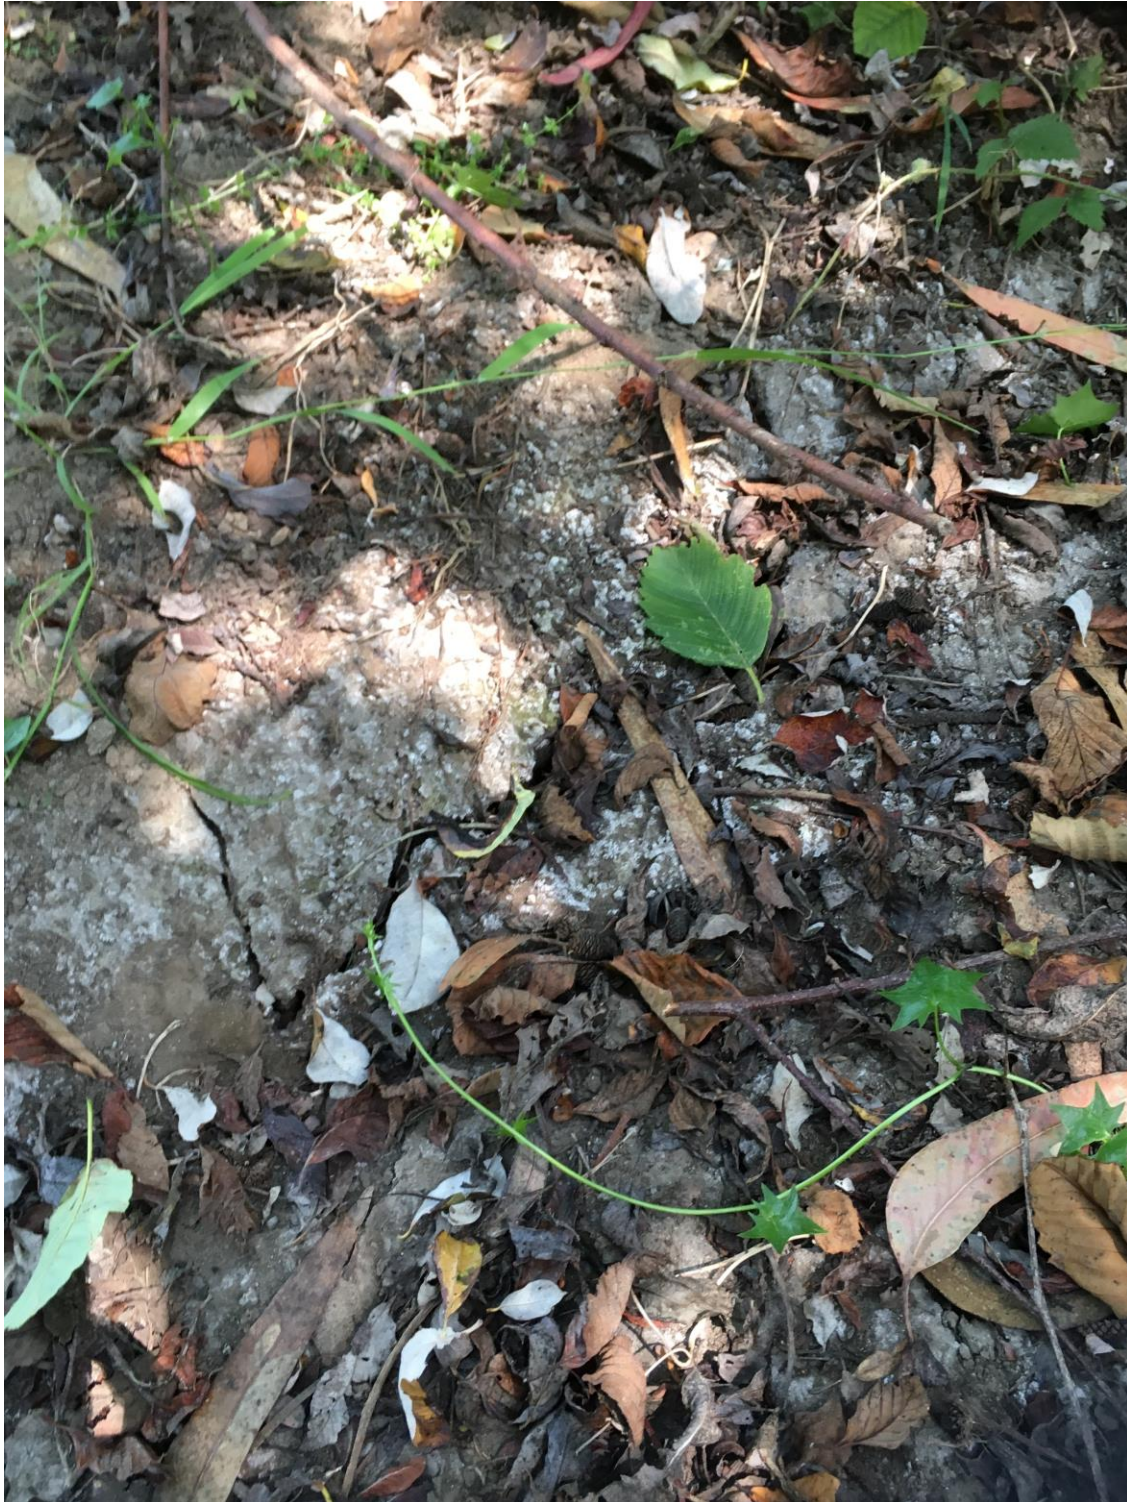
Photo 7: Hydric Indicator (Primary) – Salt Crust

Table 4 summarizes the hydrological indicators observed at each sampling point. Photos 7, 8, 9, and 10 show the hydrological indicators observed.

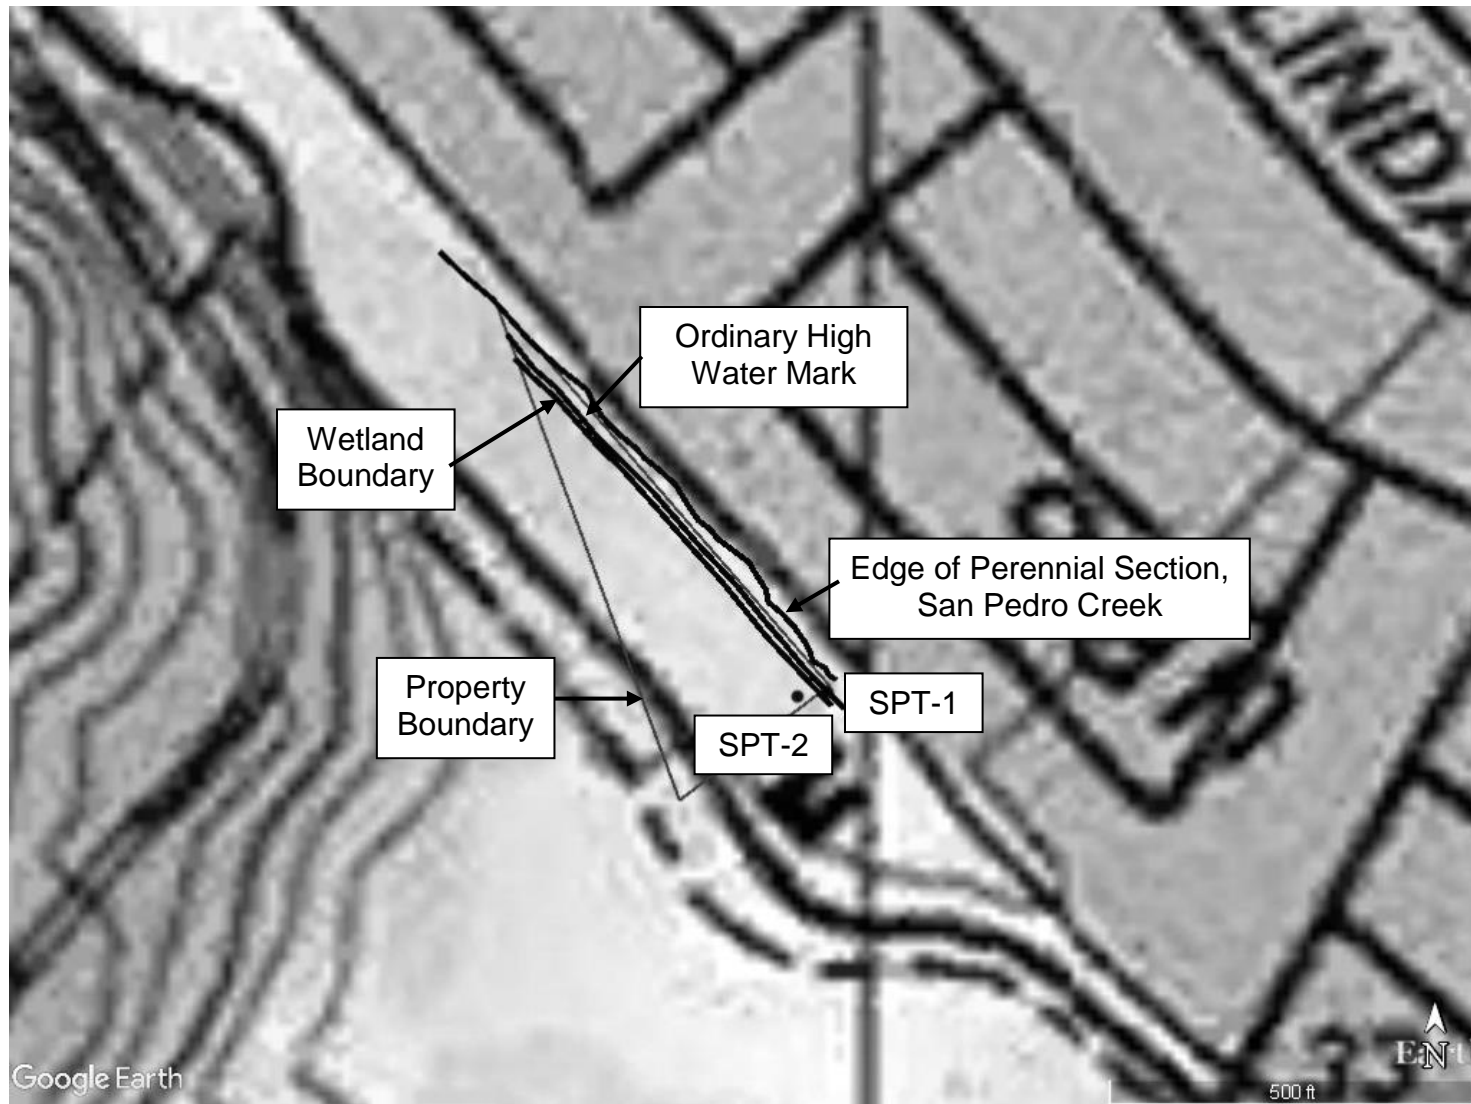
Figure 6: San Pedro Terrace Wetland Delineation Map over USGS Topographic Map

The flat area encompassed between San Pedro Creek itself and the sloped area on the north east portion of the property has been determined to qualify as a wetland under the federal definition. Sampling point SPT-1, which was located within this area, shows indicators for vegetation, soil, and hydrology. Sampling point SPT-2 was situated on the sloped area, and it showed no indicators for wetlands.

Figures 6 and 7 provide the wetland delineation map for this project, including both the ordinary high water mark and the edge of the wetland. No additional dredging or filling of wetlands are proposed for this project besides what is associated with the storm water drain. Impacts to ACE jurisdictional wetlands occur within wetland habitat and below the ordinary high water mark, but no impacts occur within the perennial section of San Pedro Creek.
