Technical Memorandum

October 3, 2022

To	Ryan Marquez, City of Pacifica	Contact No.	925 849 1019
Copy to	Paul Henderson	Email	satish.chilka@ghd.com
From	Satish Chilka PE	Project No.	11223688
Project Name	Pacifica Pier Handrail Repairs		
Subject	Condition Assessment of Pier Handrails - 2022

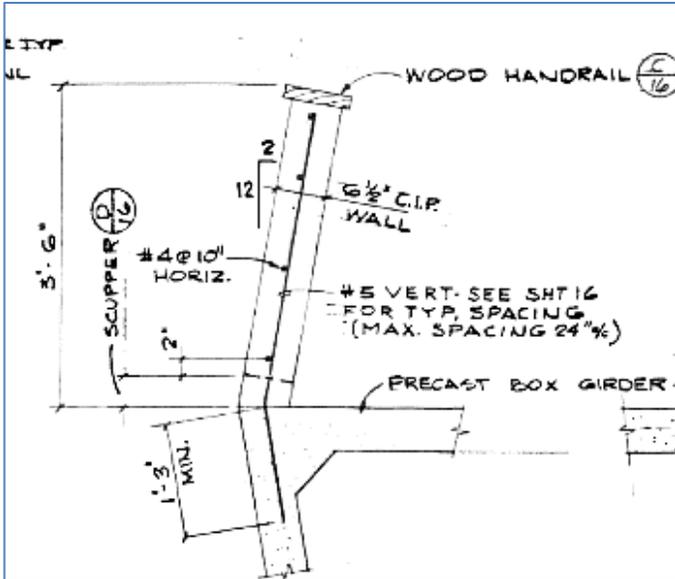
Figure 2: Existing Handrail Connection to Deck

Existing as-built drawings of the pier structure (dated 03/27/1972) are available as a reference for the original condition of the handrail. The handrail consists of cast-in-place concrete wall panels 6-1/2" thick and 42" tall, leaning inward over the deck. Panels are typically 18'-6" long, with shorter 4'-0" long panels occurring aligned with pile locations at 60'-0" on-center. The base of the typical panel has (3) 3'-0" openings with (2) 3'-0" supports between them, and the connection to the deck is reinforced with (2) #5 dowels at edge supports and (3) #5 dowels at interior supports. Refer to Figure 2 for a detail view of the existing handrail condition, and Figure 3 for an elevation view.
