City of Pacifica San Mateo County Library

Library Facility Assessment

November 12, 2014

GROUP 4

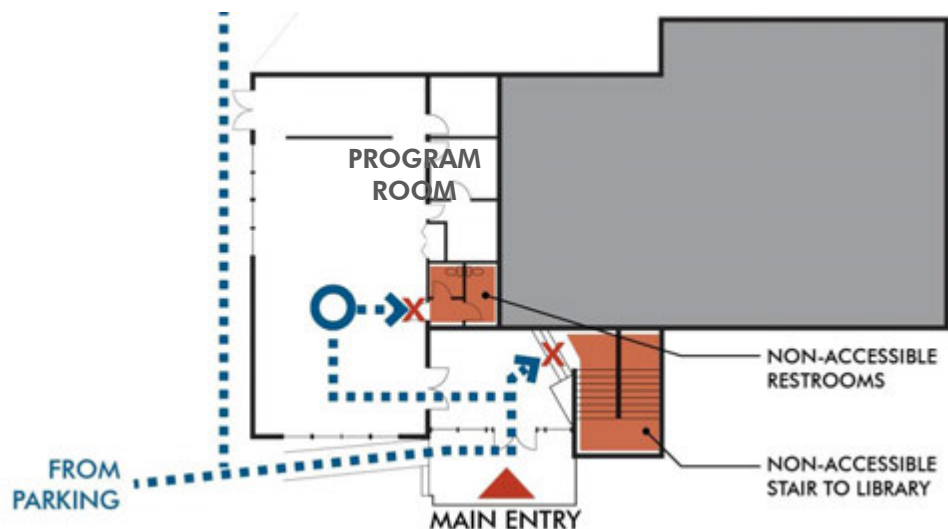
LOWER LEVEL & PARKING LOT

Inadequate + Inaccessible Parking
The limited number of spaces limits the use of the facility

Inaccessible Entries
Both entrances are inaccessible, and to enter the 2nd level of the Library from the parking lot requires the use of stairs or a steep sidewalk

Inaccessible Paths of Travel
Lack of accessible paths of travel to teen area, program room restrooms, parking lot, and between 1st and 2nd floors.

Non-Conforming Areas
Restrooms, stacks, paths of travel, and other spaces throughout the building do not meet code requirements

Inaccessible Exits
Program room emergency exit requires use of stairs

Non-Conforming Devices/Hardware
Handrails, door handles, push buttons, faucets, etc. do not meet code requirements

The building does not provide equal access to all Library patrons and staff.

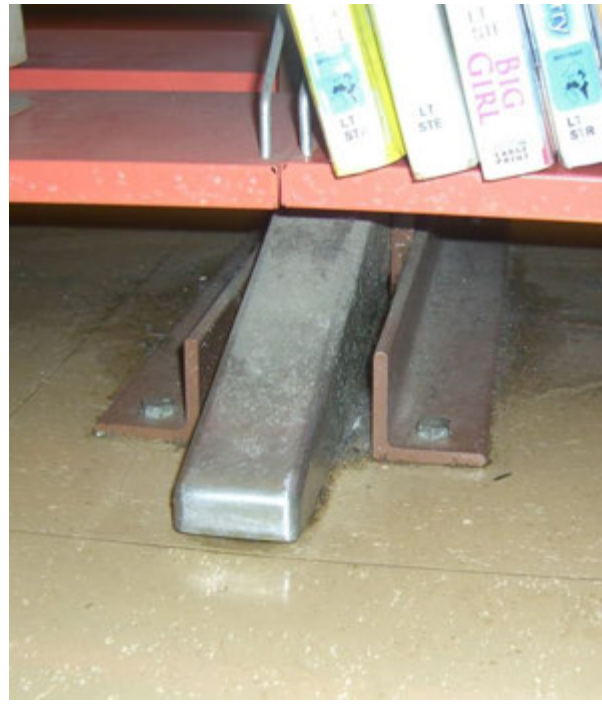
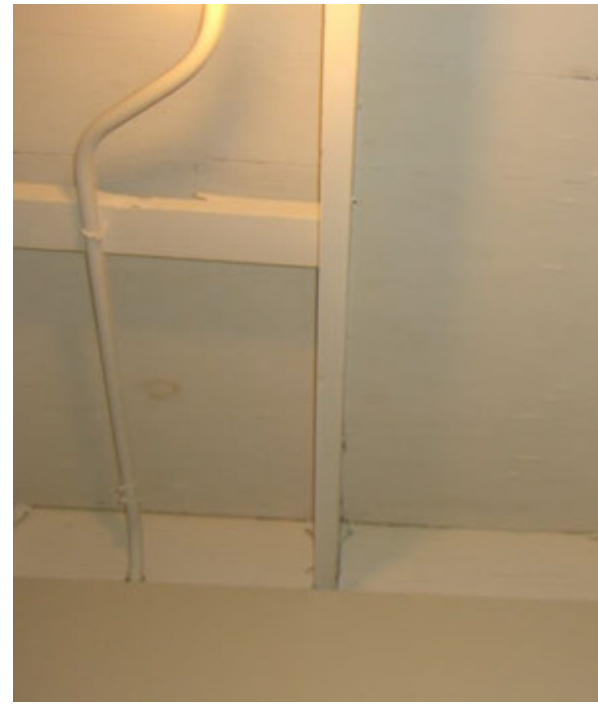
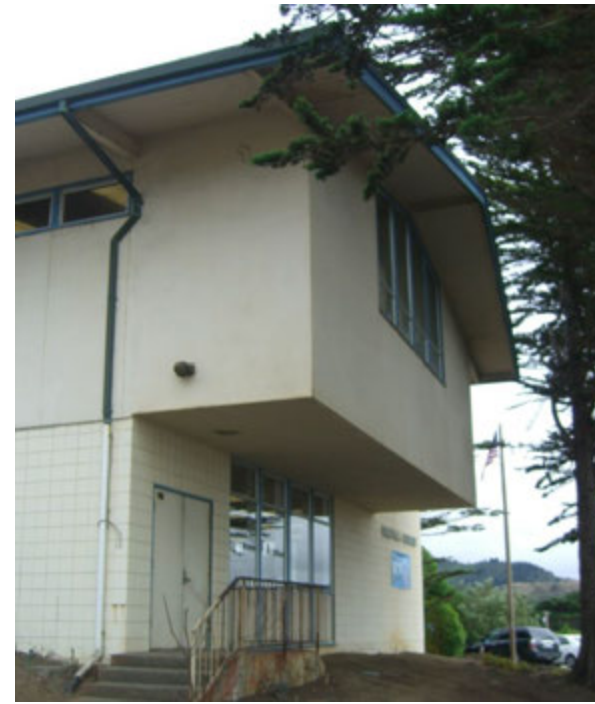
LIFE-SAFETY

Insufficient Fire Life-Safety

The building lacks fire sprinklers and has inadequate alarm and detection systems

Under-supported Cantilever

8' deep cantilever on second level does not meet current structural code

Non-Compliant Structure

Most structural elements from shear walls to floor diaphragms are not to current code and are under-engineered

Excessive Openings in Structural Walls

The number of windows and doors in most walls compromise the ability of those walls to support the building in a seismic event

Under-supported soffits

Parts of the ceiling are not sufficiently supported and might fail in an earthquake

Under-supported Tall Shelving

Shelving appears anchored, but further testing is required to confirm that anchors are sufficient for a seismic event

Overall, the building does not meet today's standards for life-safety

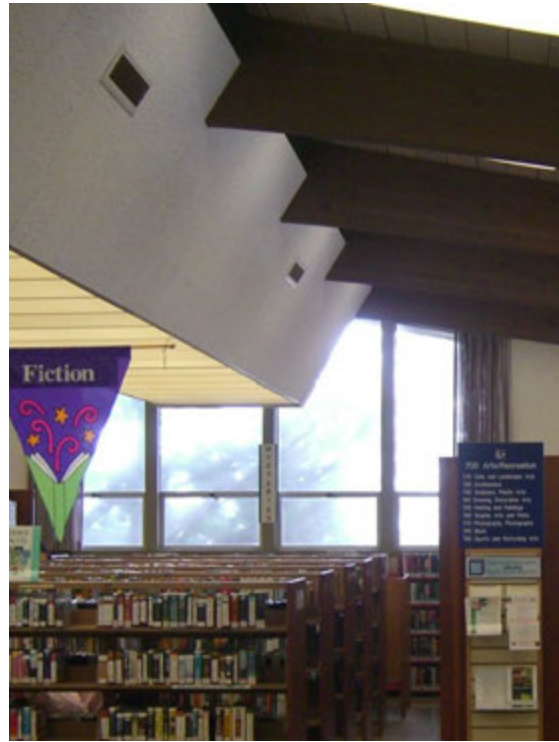
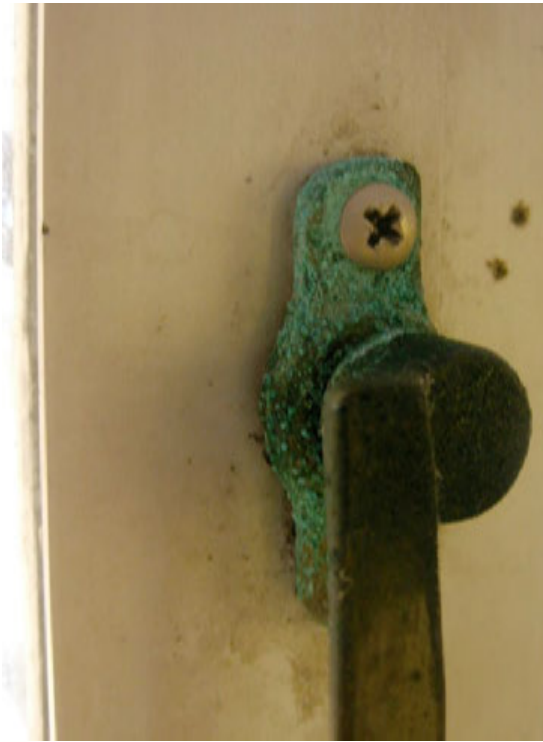
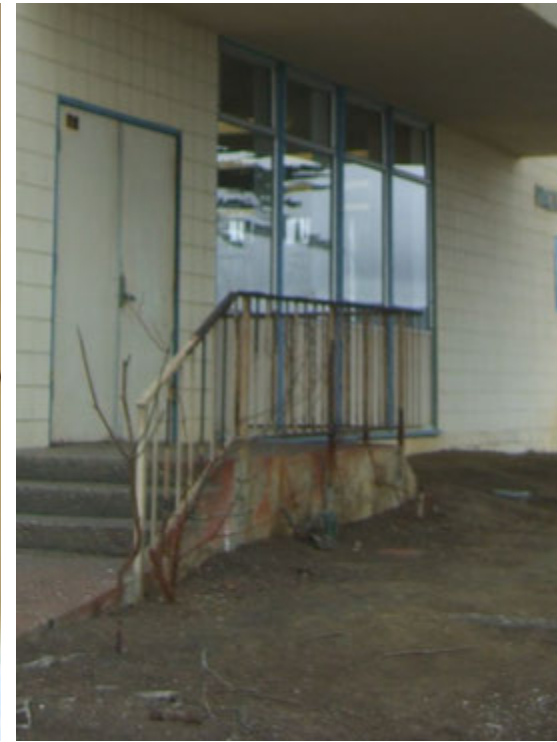
ARCHITECTURAL

Uneven Floors

Floors creak and flex noticeably as they are walked upon

Worn Finishes

Interior and exterior finishes are worn from age and frequently salt damaged

Poor Acoustics

Noise travels between floors; floors creak audibly in program room when people walk on it

Damaged/Discontinued Hardware

Window/door hardware is easily damaged by salty air, no longer manufactured, and therefore difficult to replace. Many windows are screwed shut.

The building's finishes and door & window hardware are in need of replacement or significant repairs

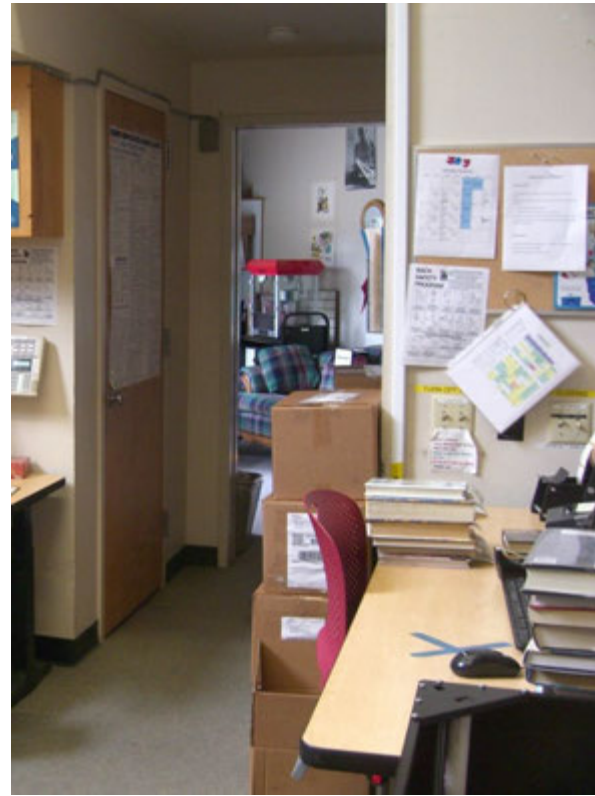
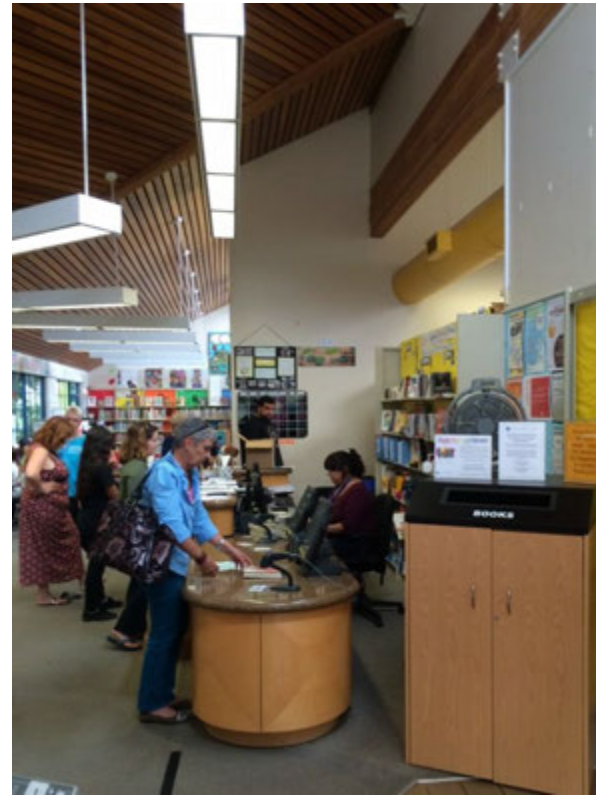
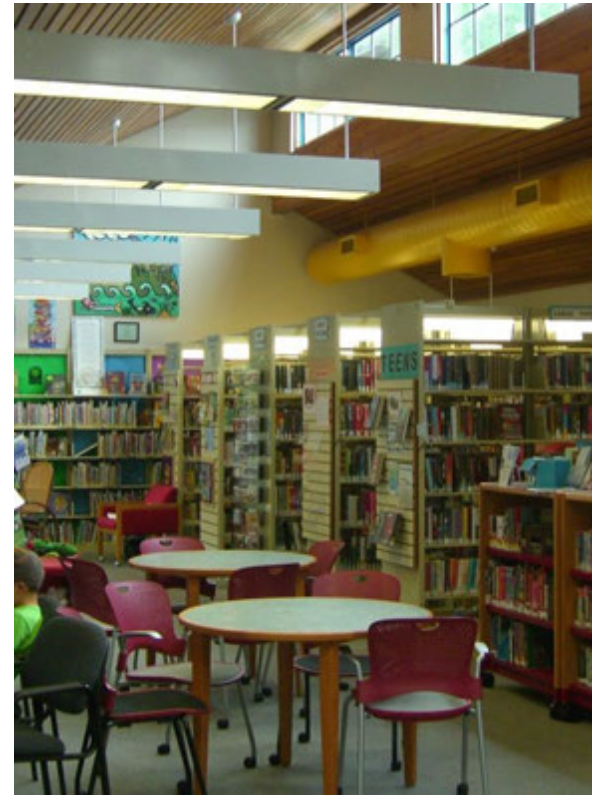
Inadequate Storage

Library has limited storage and some areas appeared crowded.

Undersized Spaces for Collections

Current collections seem to fit, but any increase in collection sizes to meet demand will not fit within the existing space

Inadequate Seating

Seating is limited with a total of 47 seats

Inadequate Program Space

Sanchez Library has no dedicated program space, and the Library is one room meaning that programs in one area will impact all library users

Undersized Entry/Service Desk

During high traffic hours, the entry and service desk area becomes very crowded

Undersized Staff Space

Staff space is crowded with book carts; book drop room sometimes overflows from circulation volume

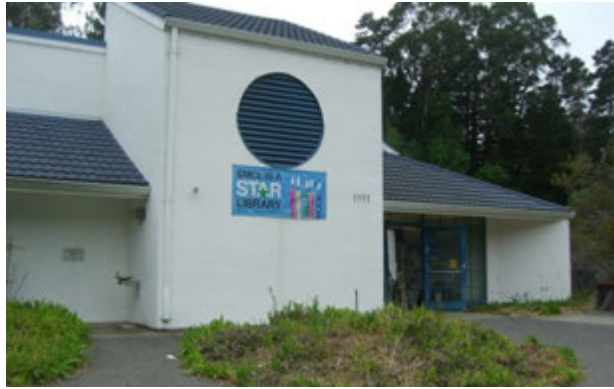
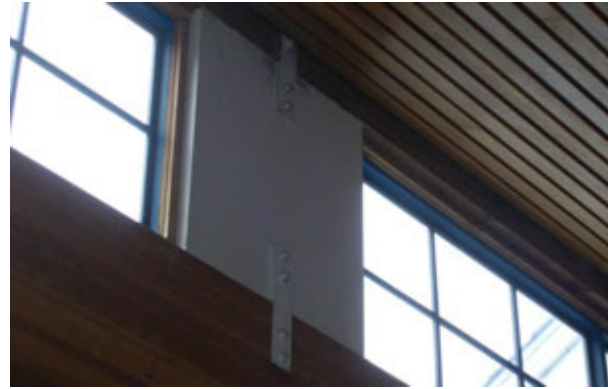
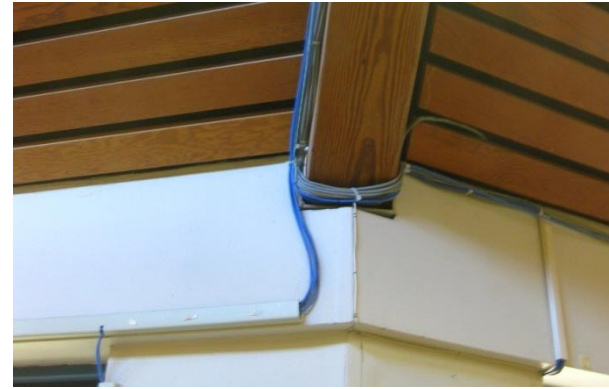
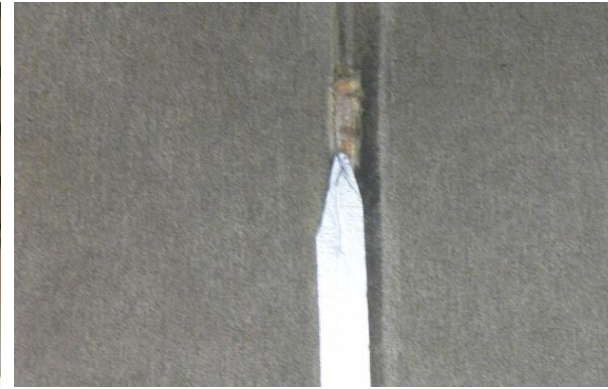
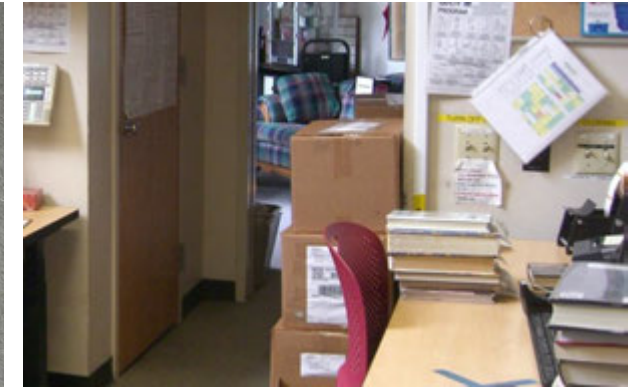
Worn Finishes

Some finishes are worn and require replacement

Damaged Hardware

Some minor window hardware appeared to be in moderate disrepair, but could be replaced

General Good Condition

Many parts of the building, like the ceilings and some walls, are in decent condition

Building finishes and window hardware need to be replaced, but the building is generally in good condition

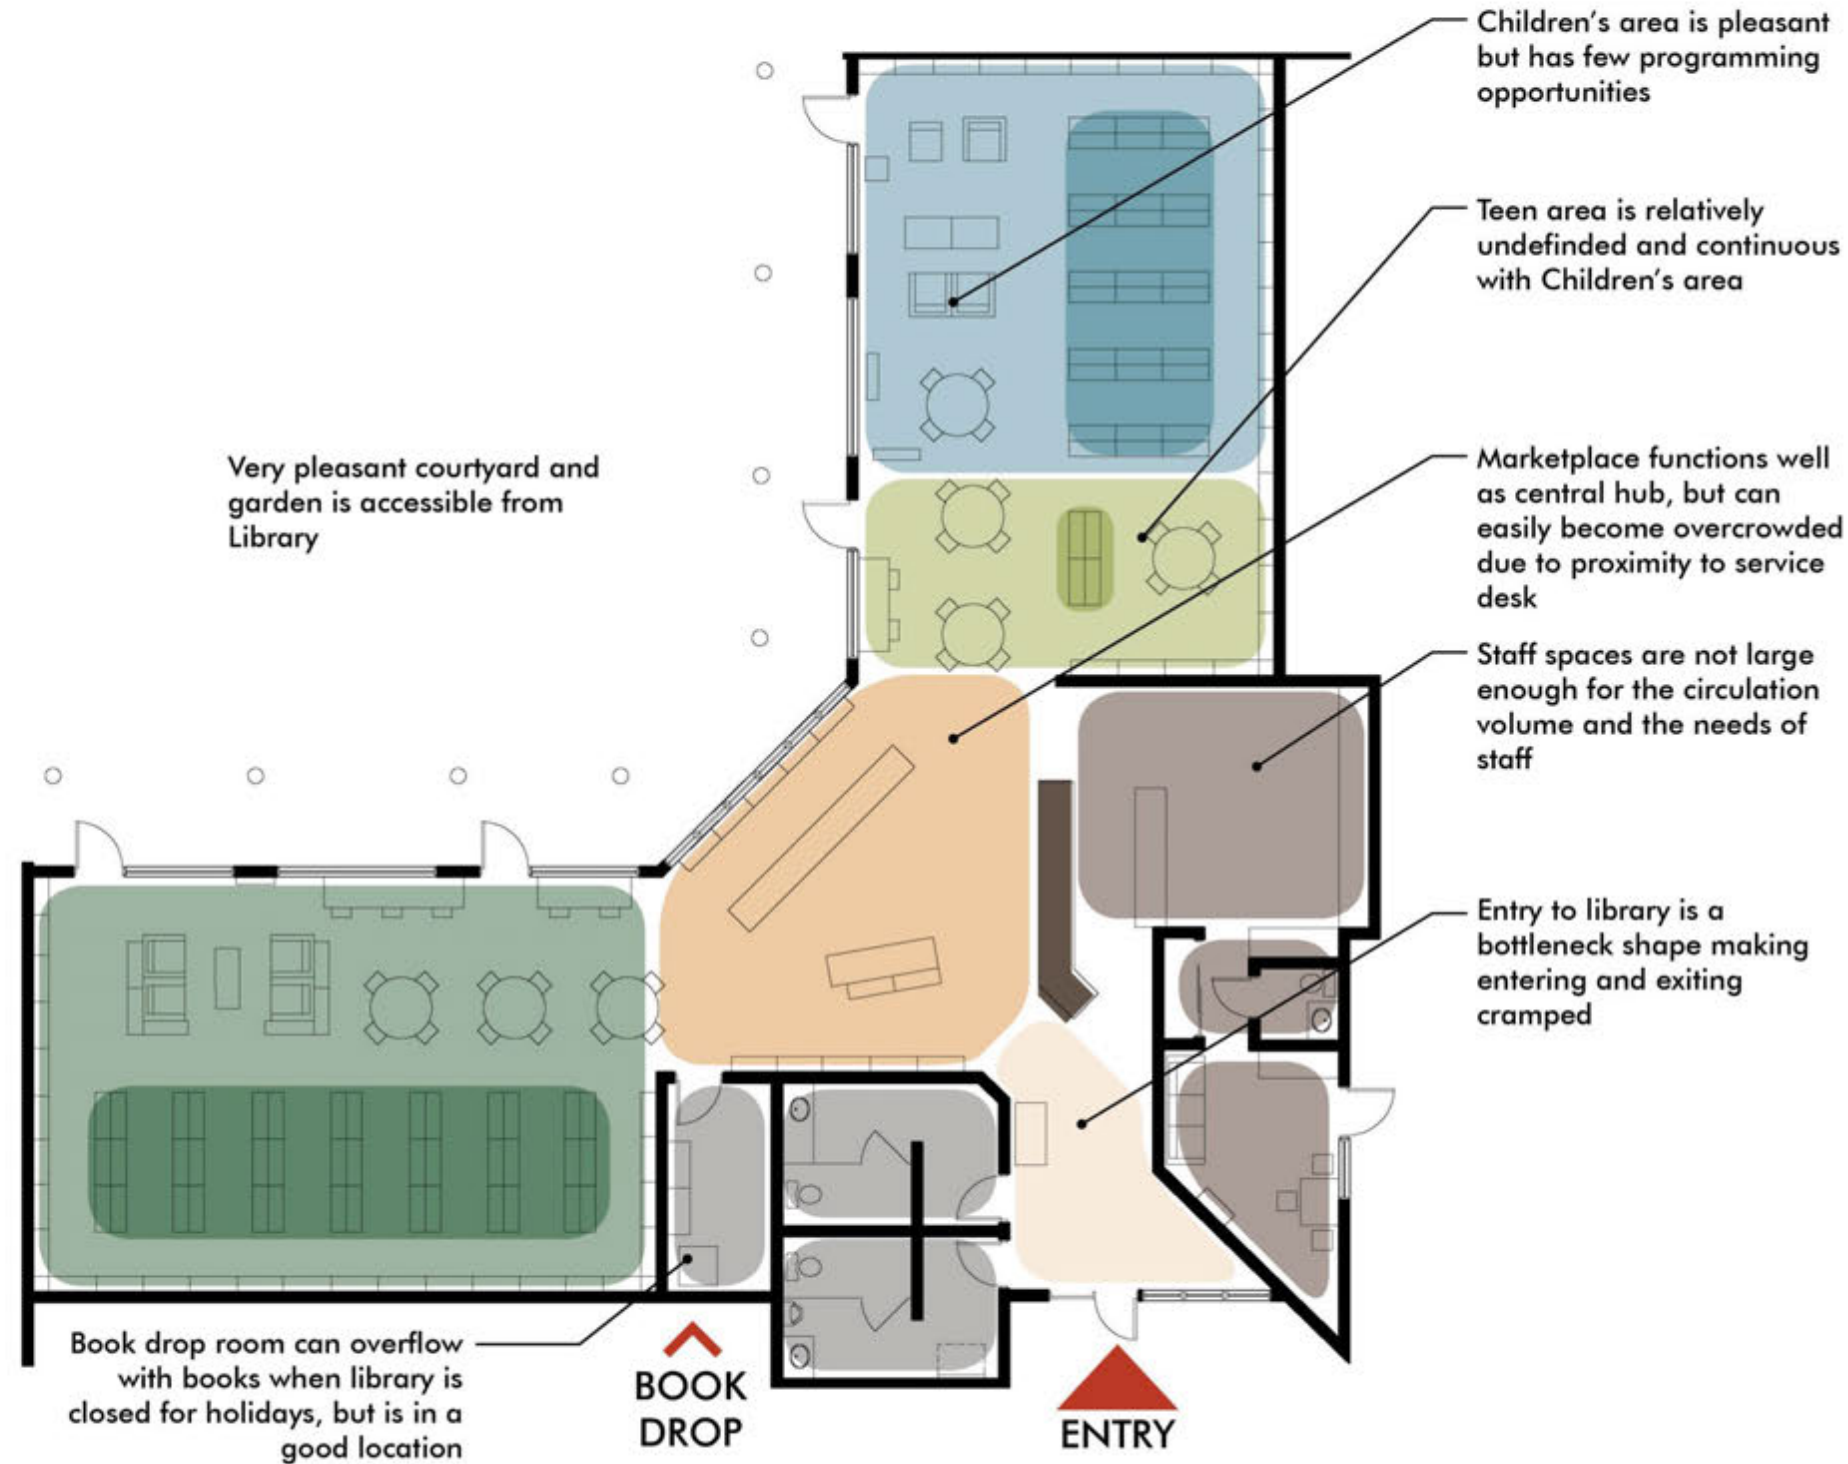
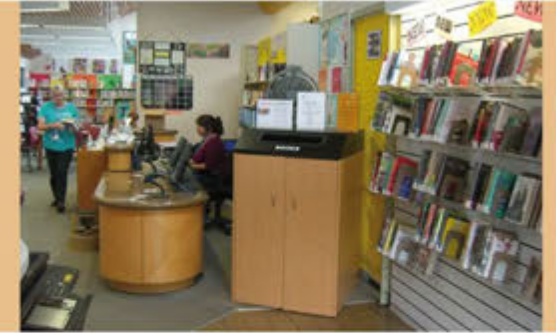
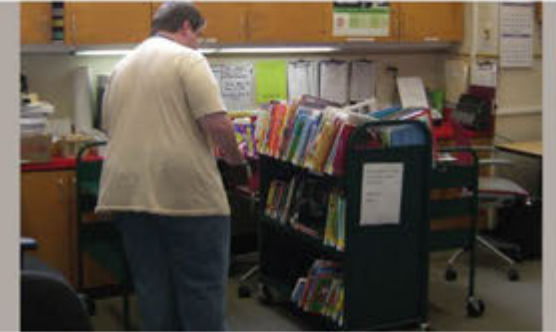
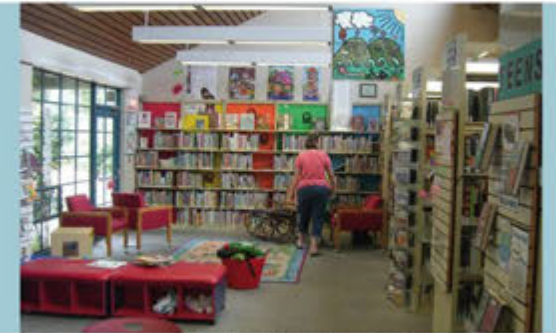
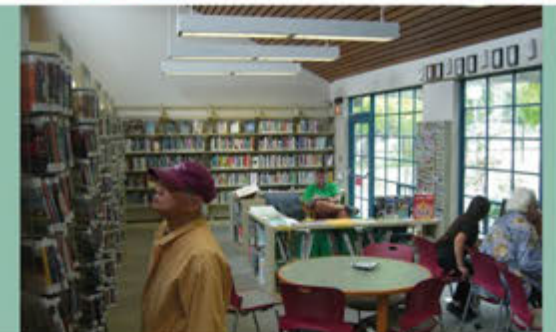
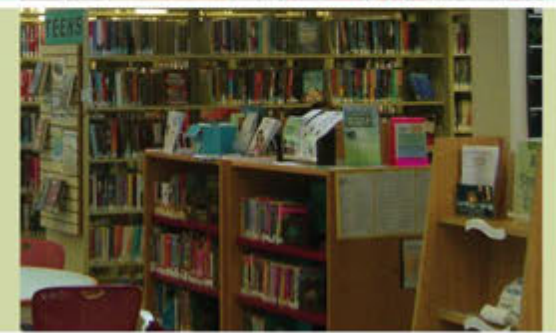
SANCHEZ LIBRARY PHYSICAL DEFICIENCIES

- Relatively limited physical deficiencies in building
- General wear & tear to finishes
- Modernized telecom systems are not well integrated into building - there are many visible wires
- Damaged window screens
- General ADA non-compliance - some areas could be upgraded
