PLANNING COMMISSION Staff Report

FILE: CDP-364-16

PROJECT LOCATION: 1300 Palmetto Avenue (APN 009-291-020)

PROJECT DESCRIPTION: Renovate the existing 93-unit mobile home park known as Pacific Skies Estates located at 1300 Palmetto Avenue. The renovation includes 93 new mobile home units in a reconfigured layout in order to move the westernmost units away from the coastal bluff, demolition of the common buildings, replacement of utilities, the connection of Third Avenue to Sixth Avenue, and landscaping, including a public trail along the bluff as required by California Coastal Commission-issued Coastal Development Permit CDP 3-83-172-A7.

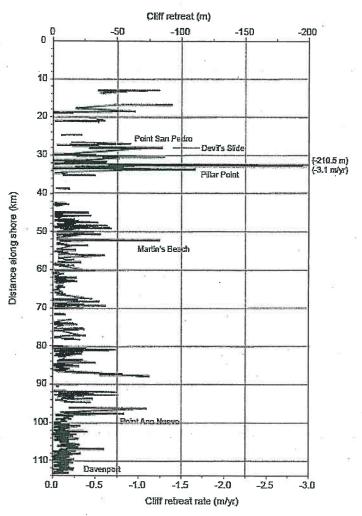
Figure 22. Cliff retreat rates and spatial distribution of rates for the San Francisco South region (see Figures 9 and 108 for reference).

According to this study, at points nearest to the location of the project site, which is 15 km south of the entrance to San Francisco Bay, the erosion rate is about 1.35-1.45 meters/year or 4.43-4.75 feet/year (the cliff immediately in front of the park was not measured, probably due to its current armored state). This is much higher than the rate of sandy beach change proposed by the Applicant (1.38 ft/yr), and translates to sea cliff retreat of 133-142 feet over 30 years. This amount of erosion is based on historic rates and it is the Commission's general practice to use the high end of measured historic rates for expected erosion in the future, as rates are expected to

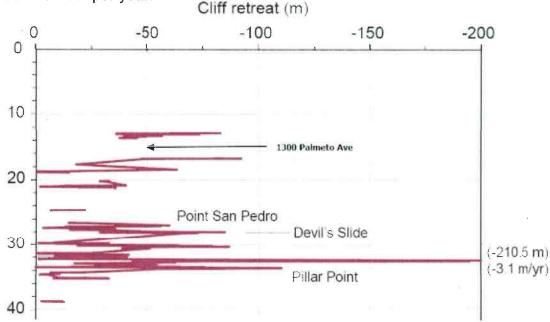
The 2007 USGS report cited by Dr. Johnsson does not provide any project site specific information. The figure below superimposes an arrow depicting the location of the project site on the cliff retreat rate figure from the 2007 USGS report. You will note that there is NO retreat estimate within 2 kilometers to the north or south of the project site. It is not scientifically acceptable to assign a cliff retreat rate for cliffs that are 2 kilometers from the project site. Nor is it scientifically acceptable to assign the highest offsite cliff retreat rate when there is wild variation within that offsite location from less than a foot per year to more than $4\frac{1}{2}$ feet per year.

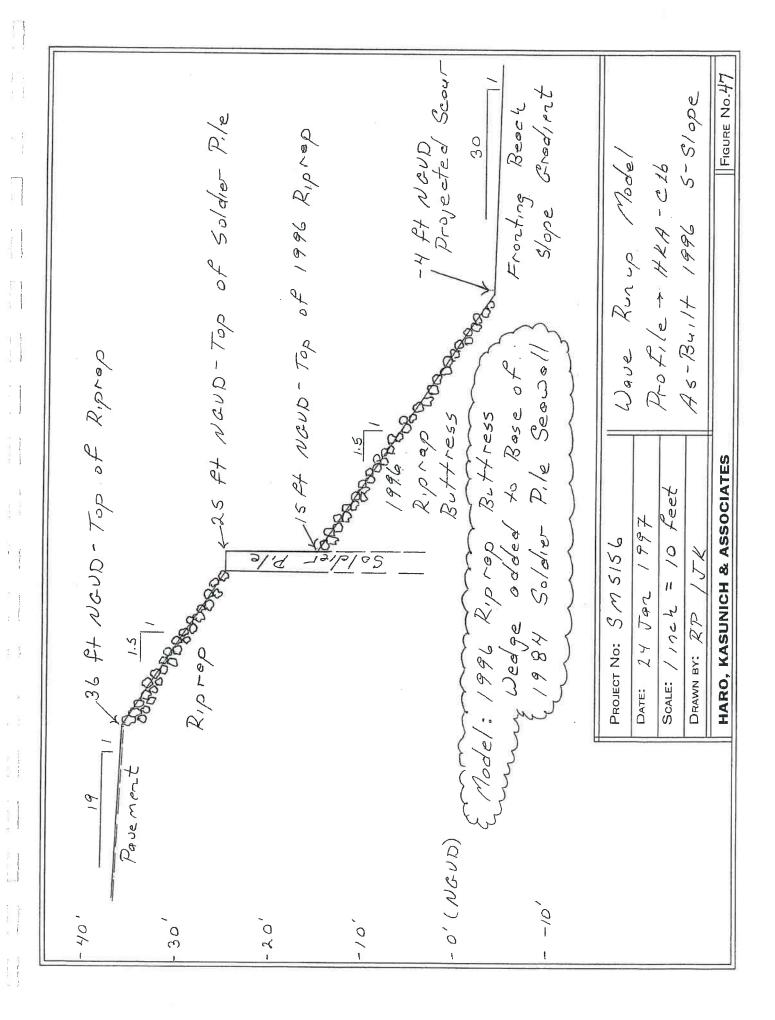
PACIFIC SKIES ESTATES SEAWALL VARIABLE SLOPE METHOD AS-BUILT 1996 5-SLOPE

SM5156 24 JAN 1997

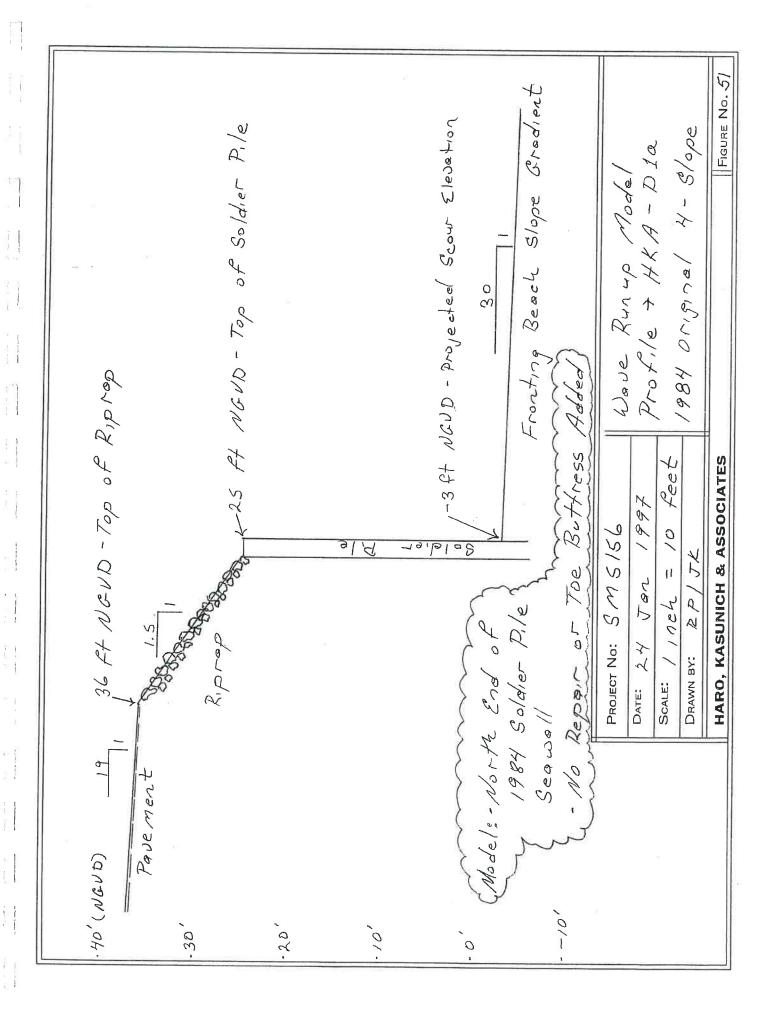
Column Labels for Wave Runup Level 3 Output

PACIFIC SKIES ESTATES SEAWALL VARIABLE SLOPE METHOD 1984 ORIGINAL 4-SLOPE

SM5156 23 JAN 1997 Input Conditions: Variable Slope Cross-Section, 1 profile(s). Stillwater Level, 1 condition(s). Wave Conditions (T), 4 Hbmax wave combination(s). Case 1 Profile HKA-D1 For SWL = 7.0 ft NGVD For Hbmax w/ T = 8.0 sec (Wave breaks on slope No. 4) (1) (2) (3) (4) (5) (6) (7) (8) (9) (10) (11) (12) (13) (14) 8.5 8.0 10.4 11.3 1.3 .00414 30.0 1.4 2.89 1.14 .92 25.7 32.7 5 Case Profile HKA-D1 For SWL = 7.0 ft NGVDFor Hbmax W/T = 12.0 sec (Wave breaks on slope No. 4). (1) (2) (3) (4) (5) (6) (7) (8) (9) (10) (11) (12) (13) (14) 7.1 12.0 11.1 11.4 1.6 .00153 30.0 1.4 3.70 1.14 .91 27.2 34.2 5 Case 3 Profile HKA-D1 For SWL = 7.0 ft NGVDFor Hbmax w/T = 16.0 sec (Wave breaks on slope No. 4) (1) (2) (3) (4) (5) (6) (7) (8) (9) (10) (11) (12) (13) (14) 5.8 16.0 11.4 11.4 2.0 .00070 30.0 1.4 3.91 1.14 .92 23.7 30.7 5 Case Profile HKA-D1 For SWL = 7.0 ft NGVDFor Hbmax w/T = 20.0 sec (Wave breaks on slope No. 4) (1) (2) (3) (4) (5) (6) (7) (8) (9) (10) (11) (12) (13) (14)

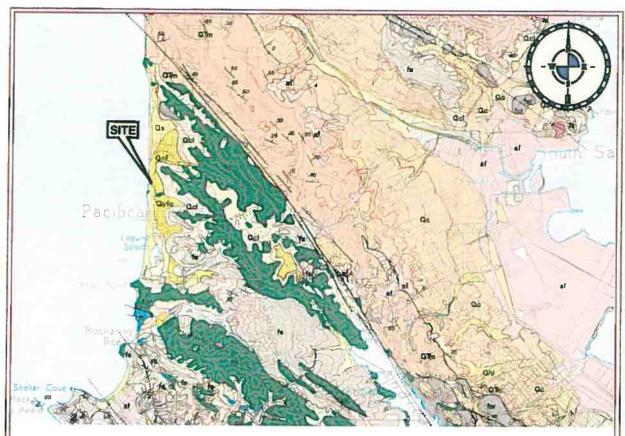
PLATE

LEGEND

- Qcl Colluvium (Holocene) Loose to firm, friable, unsorted sand, silt, clay, gravel, rock debris, and organic material in varying proportions.
- Qyfo Younger (outer) alluvial fan deposits (Holocene) Unconsolidated fine sand, silt, and clayey silt
